Final Report: Main House Group II (Exteriors)

Katie McCarthy Watts, Jane Trask, Andrew Ashcraft

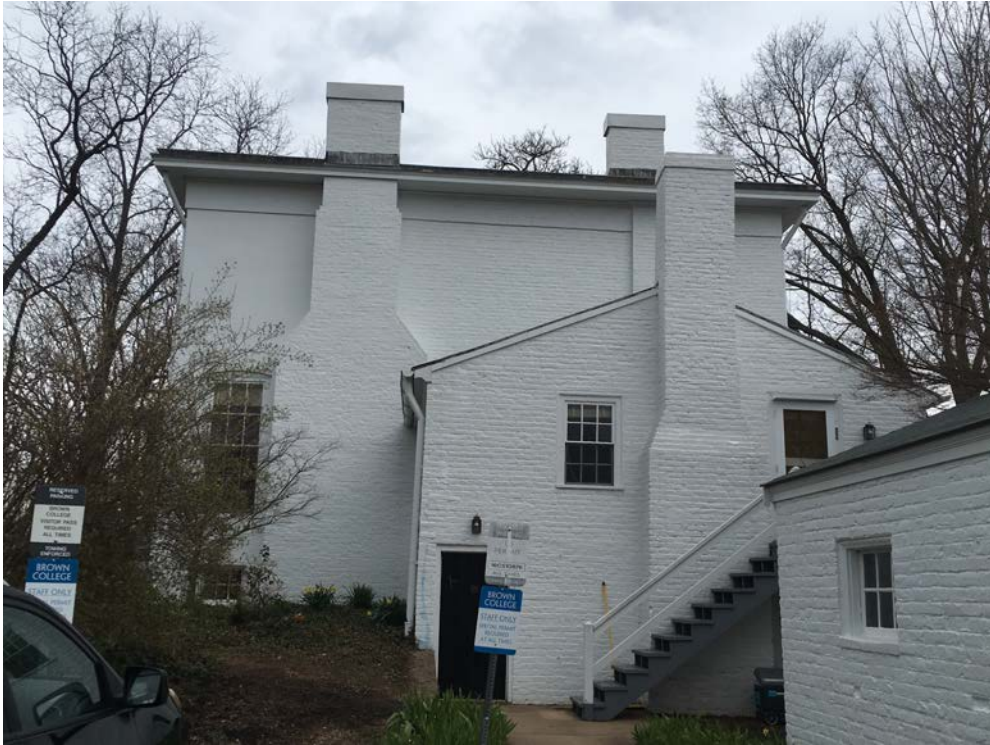
North Elevation- Katie McCarthy Watts

The North elevation is dominated by the kitchen addition and two mismatched chimneys. The kitchen had been presumed to be an early twentieth century addition to the main house, as modern appliances and technological advances decreased the risk of fire and the need for household staff (whether paid servants or enslaved African Americans). However, the kitchen appears on Sanborn Fire Insurance Maps before the twentieth century begins. While we began thinking the North elevation was only telling a twentieth century story, closer inspection proved otherwise. Below the red arrow on the chimney in the photo below is Flemish bond brick, indicative of the 1790s original house. Above this line the brick switches to running bond, indicative of the nineteenth century expansion into a full two-story. Evidence from the interior of the dining room and the large stone hearth in the basement (large enough perhaps to be an original cooking kitchen before the separate outbuilding is listed on the 1800 insurance plat) all agree that this side of the

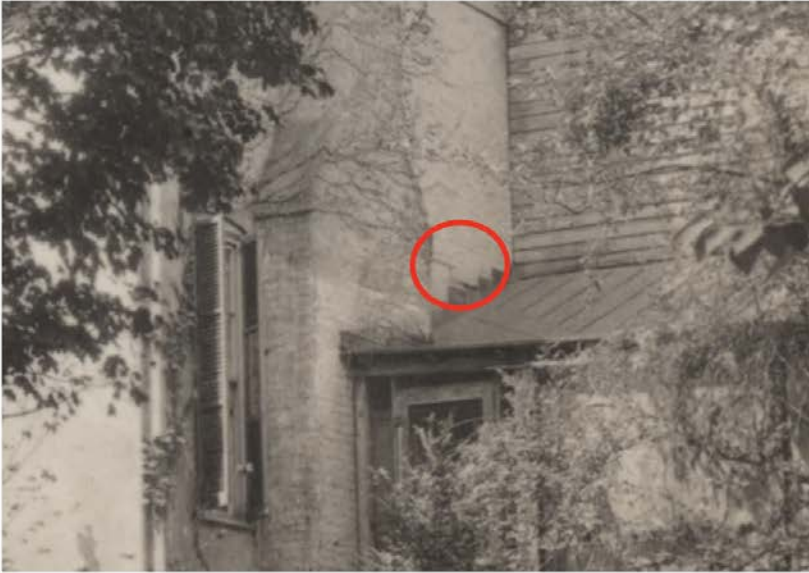
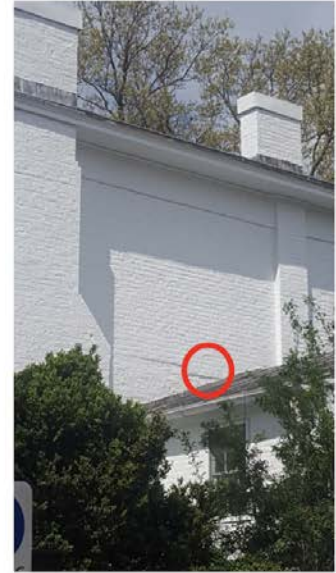
Documentary evidence suggests that by 1819 there was a 17' x 27' shed addition off of the original house. Evidence along the North elevation shows signs of this addition. Above the current kitchen roof is a brick soldier course that protrudes more than the surrounding brick (circled in red in photo below). Below the soldier course appears to be Flemish bond brick. This likely shows where the shed addition was, and where it was converted to a full two-stories in the first

half of the nineteenth century. The soldier course is also evident in the undated historic photo with

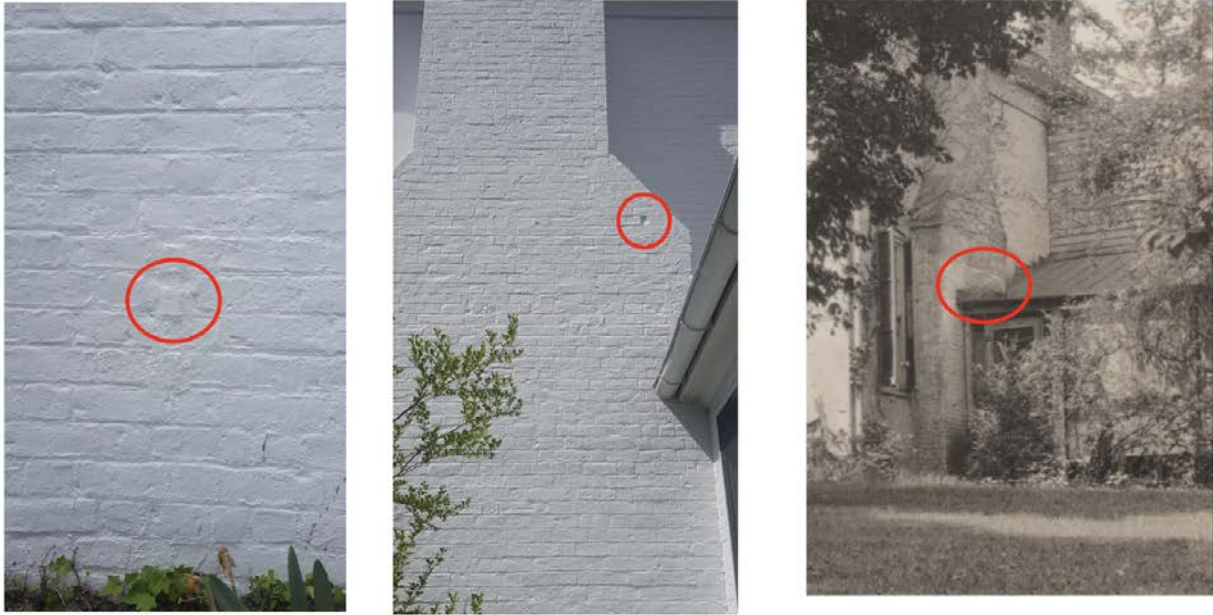
Further architectural evidence on the North elevation confirms the two-story frame kitchen with a porch. The bricks on the large front chimney are messy, with lines of divots along the upper coursing (right photo), almost in line with the current kitchen roof. This may have been where the flat part of the porch roof extended out, across the chimney (see historic photo). There is also evidence on the lower part of this chimney where the porch or stairs to the porch may have been notched in (left photo).

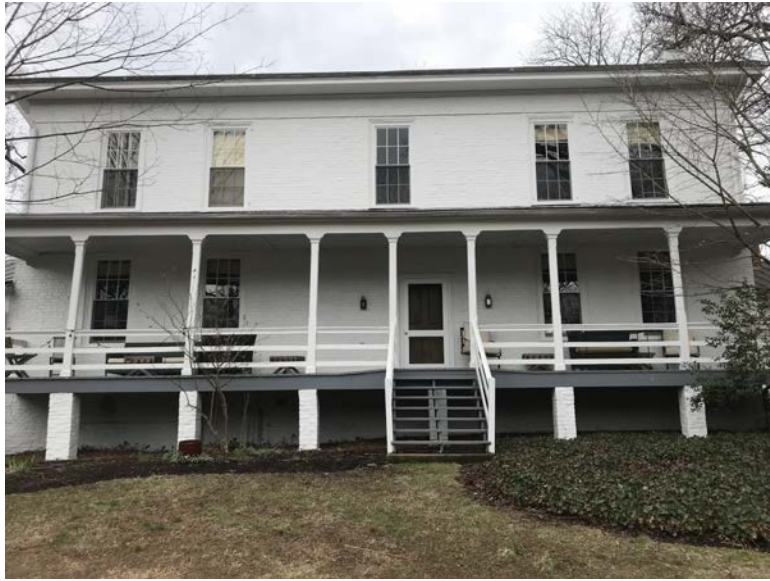
The rear elevation of the main house at Monroe Hill bears a number of scars and irregularities that are important for confirming suspicions about the house's development, but these scars also present many questions that we are unable to answer at this point. In the photograph to

the left, the porch that shades the first story of the house is in clear view. At the beginning of this project, we believed that this porch was a twentieth-century story, like much of the north elevation described above, but also like that elevation, we found that there is

more to the story than that. Though it was not this exact porch that existed on the house, it is clear that there was a porch added onto the rear elevation of the house in the 1860s or 1870s. It appears on the December 1896 Sanborn map shown above, and documentary evidence shows a request for a porch in 1877 and 1879. It is first mentioned in 1877, when Professor Thomas Price (resident at time) unsuccessfully petitioned the Board of Visitors for funds to build a porch. Two years later, he attempted to procure funding again, this time asking for money for both a front and back porch. Ben Ford, in his crucial archaeological report on Monroe Hill, asserts that this request is for the upper levels of both the front and back porches, seen in the image below, but there had been no mention yet of the first-floor back porch. Therefore, it is unclear if the porch went up in two stages, or all in one after 1879. Today, it is a single story.

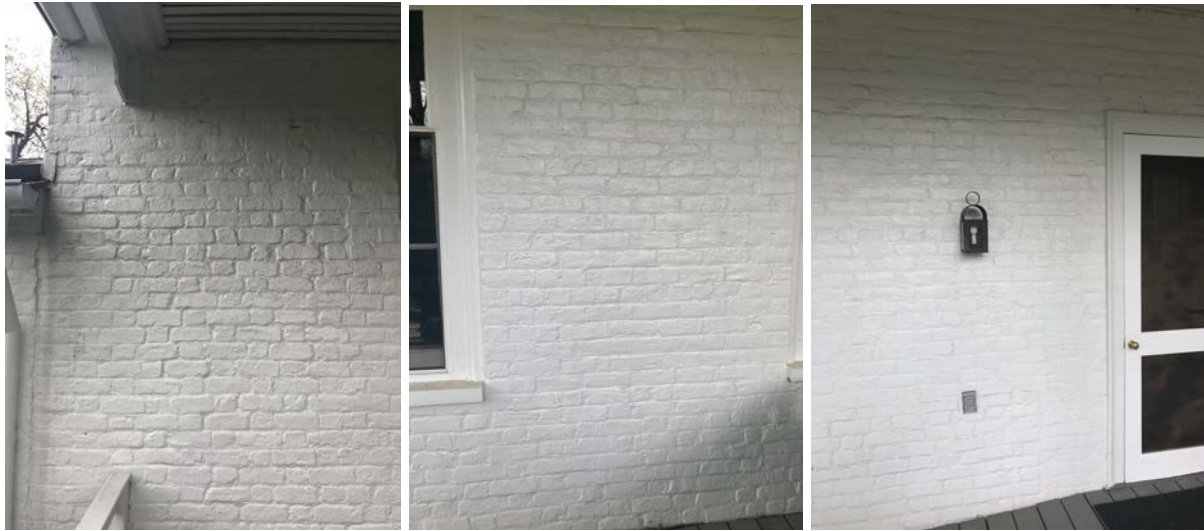
Certain aspects of our group's proposed chronology for Monroe Hill are supported by features of the rear elevation. The most clear evidence is found in the Flemish bond brickwork on the northern half of the elevation, shown in the set of three photographs on the next page. Flemish

bond covers the whole patch on the north side of the north-most window, between the sill and the seam between the main house and the kitchen addition. Moving south beyond that, the Flemish bond extends only below the window level. The entire length of the patch measures 27 feet, which is the width dimension of the original 1790s house and shed addition. This indicates that the first shed addition was attached to the west side (rear) of the original house, directly in line with the 27-foot width of the original house. Flemish bond thus likely covered both the original house and the first shed, though it is impossible to see on the front elevation due to the stucco covering.

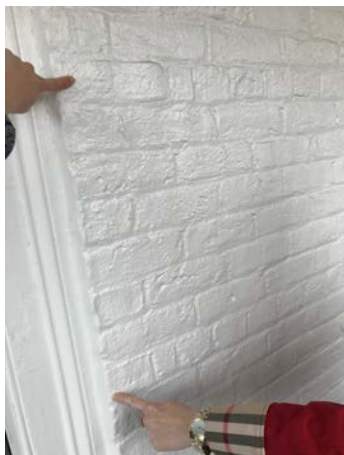
Above this lower sill level on these windows, there is common bond of varying numbers, an example of which is seen to the lower left. This indicates that when the shed was extended into a full

two stories in 1843, the Flemish bond wall was retained up to the window level, but the inclusion of new windows with the extension likely made it necessary to redo the wall from this point up. It explains why the Flemish bond is only on the outside of the first window and below sill level.

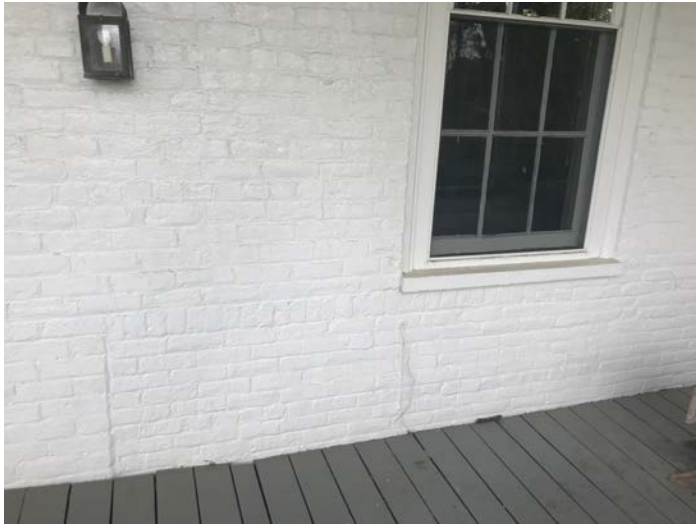
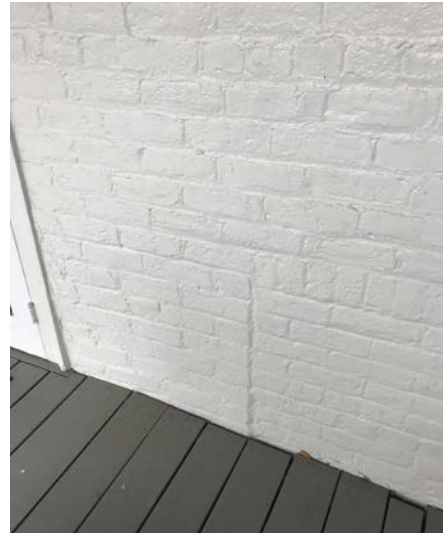
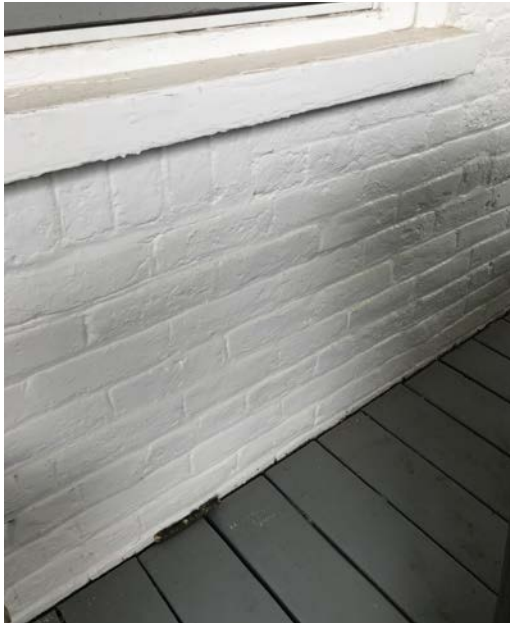
Another interesting feature of the rear elevation is a soldier course embedded in the wall on the south side of the door. Pictured to the right in full, and in detail below, the course is below the window sill and extends about six feet.

It is possible that this is a former garden wall, a vestige of the time when this quarter of the house was left open with an L-shaped house overall. It could be that there was a garden or courtyard here and this would have been a retaining wall that was incorporated into the permanent house construction when the shed was added here in 1843. There is a defined seam on the left of the patch (to the right of the door), which matches one on the left side of the door as well. This could be some infill that

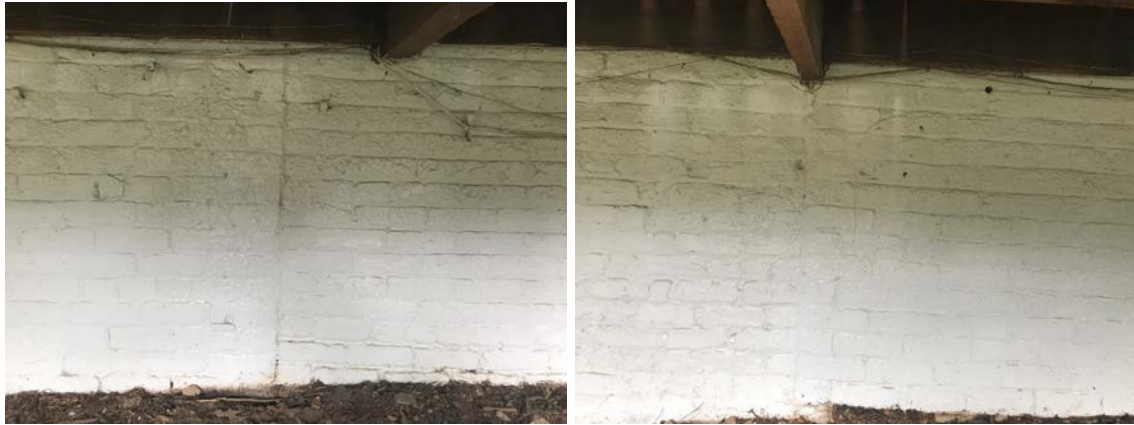
In addition to the brick scars described above that help support the claims made by the class, the rear elevation also bears some unexplained scars, about which I can only make suggestions. These are primarily found under the porch. Some of the scarring below the porch seems to be the result of modern utility interventions, but it is important to keep track of them in case Above are pictured the set of matching seams found below the porch on either side of the door. The southern one is expressed above porch level as well and seen as the north boundary of the soldier course.

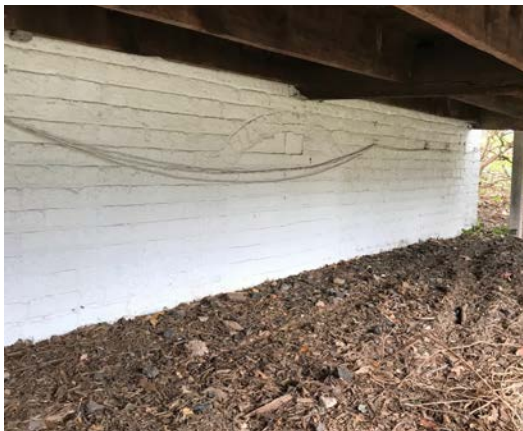
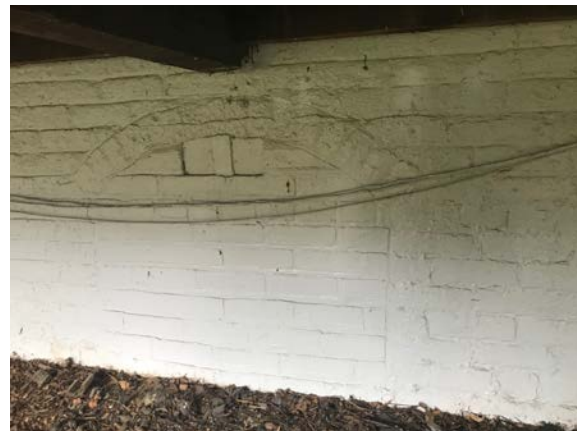
Another of these scars is a filled-in arch located below the porch between the two windows on the south end of the elevation. The left image below shows the arch in its setting and the right provides more detail. This arch could be the remnant of a cellar window, but we were unable to gain access to the crawlspace under the main house this semester to investigate further.

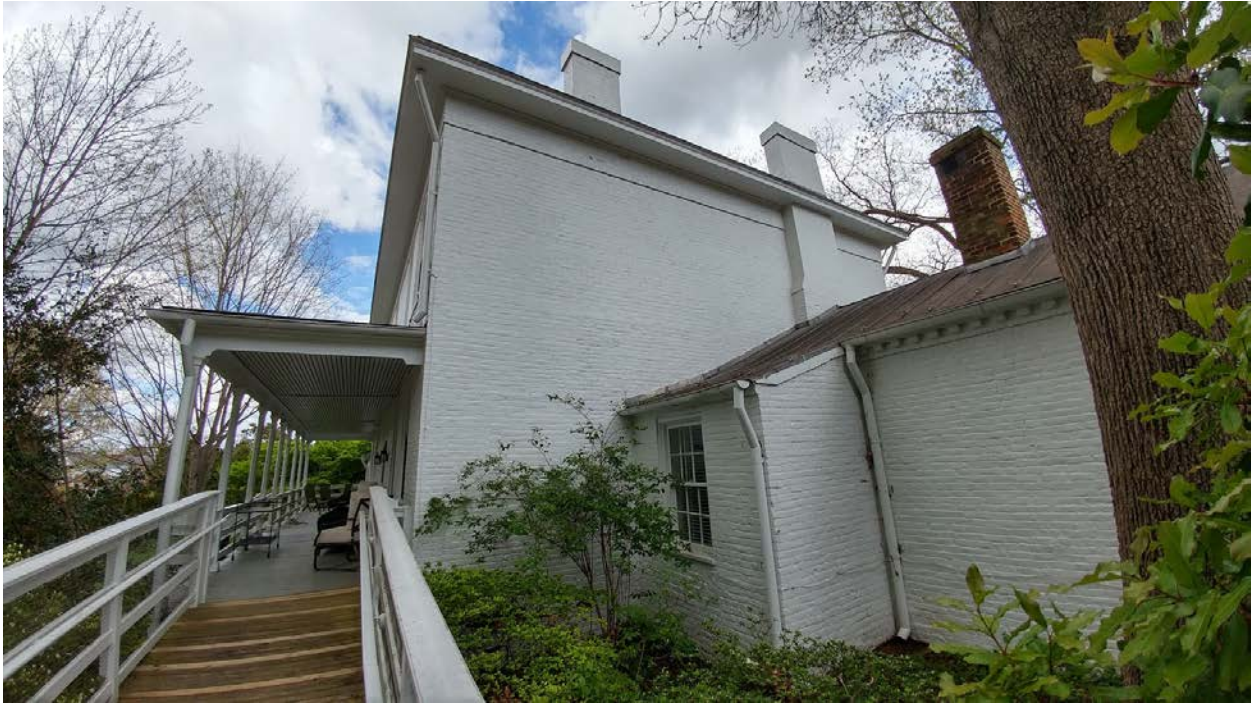
South Elevation: Andrew Ashcraft

Beneath its uniform white paint, the south elevation of the Monroe Hill House bears the scars of multiple building campaigns. The present day elevation is a product of the nineteenth, twentieth, and twenty first centuries, with two centuries of activity beginning with an 1823 addition to the south of the original 1790s Monroe House and ending with a modern ADA ramp granting access to the rear porch. Forward of the front chimney, the elevation is obscured by a smooth white render, likely applied in the 1840s to mask seams and unify the appearance of the front facade. Work on the front portico of the house has uncovered two distinct periods of render: an earlier, lime based finish likely dating to the 1840s (and the corresponding addition of the front portico), and a later, portland cement based finish, possibly a product of the 1870s when the main block of the house was completed.

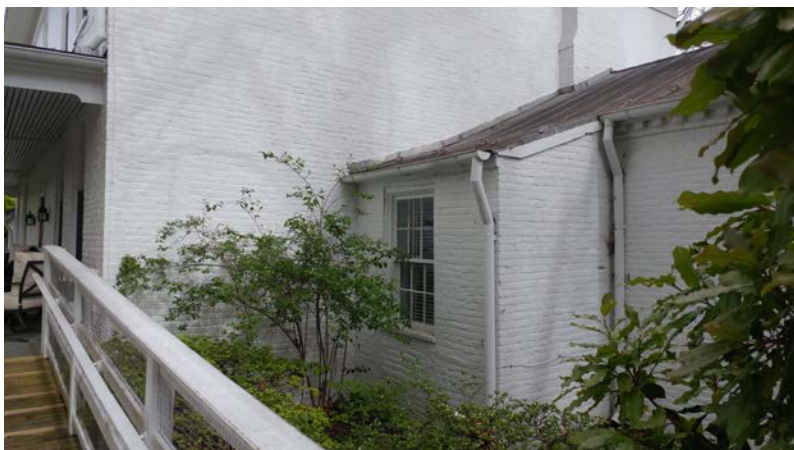
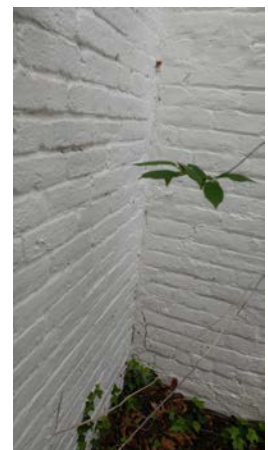
Much of the elevation is obscured by the 1849 addition of the student rooms, documented by another group in the class. A small addition to the student rooms occupies the rear corner where the 1849 addition meets the main house, sharing a north wall with the main house and a east wall with the student rooms. This addition is later than the student rooms but of unknown construction. However, as it appears on the earliest (1896) Sanborn maps, it dates between 1849 and 1896.

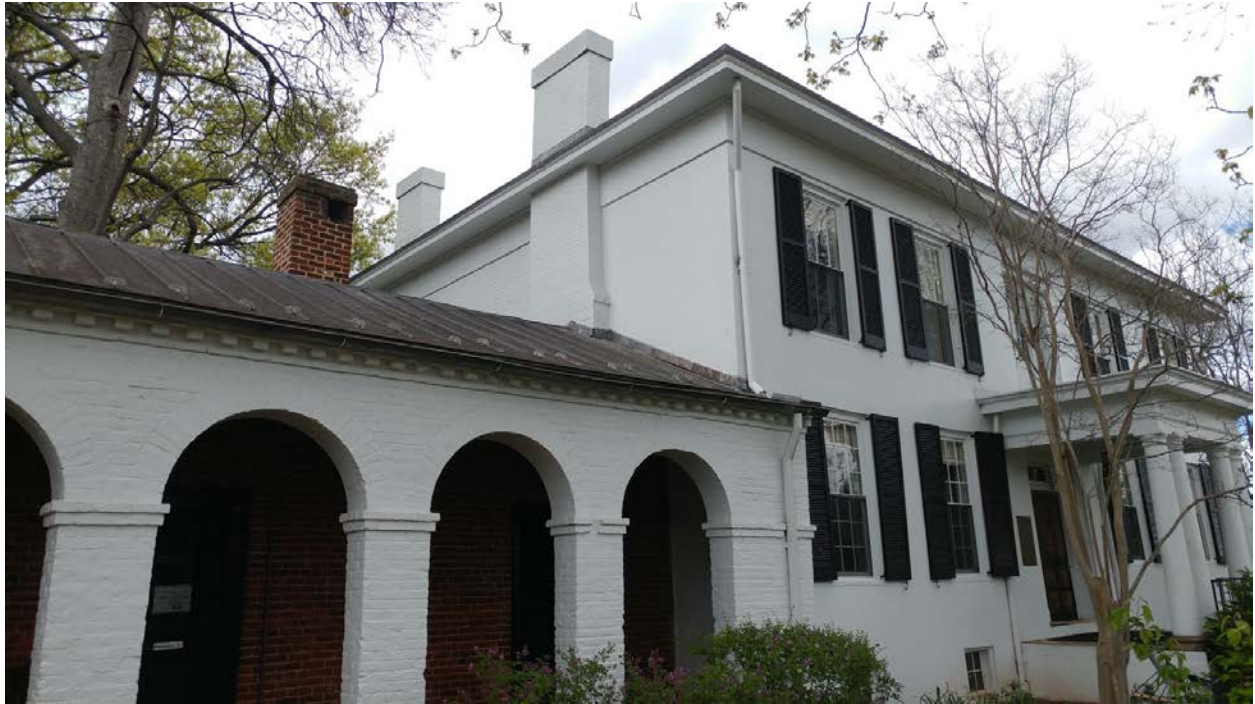
A 27x20' addition to the south provides the full width of the present front facade. Such an addition would mirror the original 1790s building and, together with the pre-1819 27x17' rear shed, form the house into a modified L plan. The lower portion of the forward chimney dates to this period. Broken, staggered horizontal and vertical seams on the wall provide evidence that southeast portion of the house was not constructed to its present height in a single building campaign.

Additionally, the chimney features a two-brick thick outward corbeled section, a common way to cap a chimney during this period. Further evidence of brick bonding for this period is obscured by the student room addition and the render described earlier. However, a more thorough analysis of

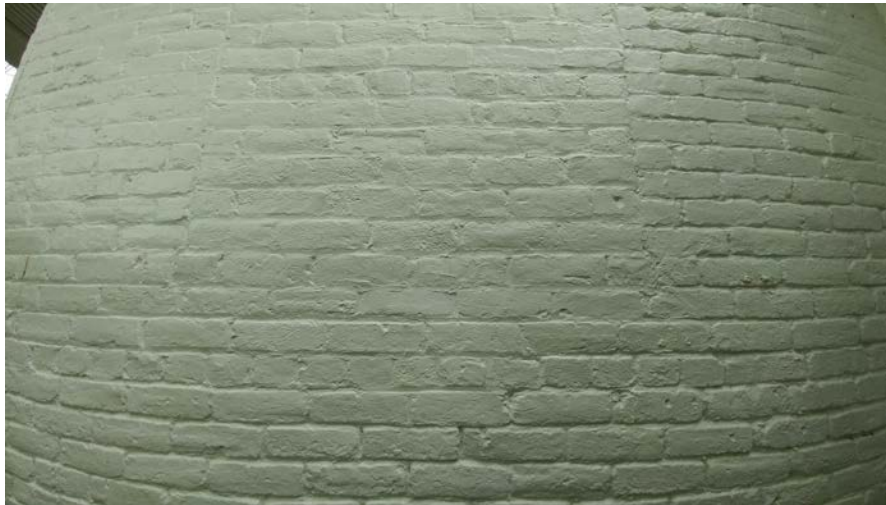
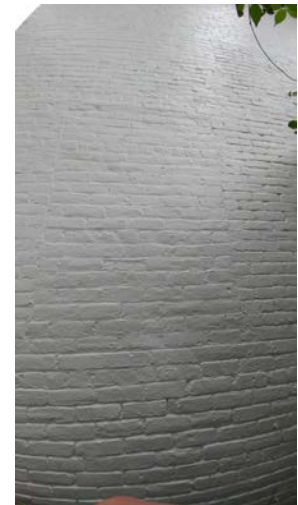
A well-defined vertical seam separates the front of the elevation from the rear (periods I and III). A stair-stepped seam separates the lower rear portion from the upper rear, indicating that the rear of the south elevation was constructed in two distinct building periods, first in a one story shed addition which was later raised. Vertical seams indicate a window opening in this period of construction, the only evidence for a window on the south elevation, which was later filled (see period V). Irregular (5-7) course common bond throughout.
