Field Report: Documentation of the Main House at Monroe Hill

Elizabeth Nowak
Meghan Page
Tabitha Sabky
ARH 5604—Louis Nelson
Spring 2018

As part of an effort to expand the historic narrative of the University of Virginia with an emphasis on the enslaved persons experience, Professor Louis Nelson's Spring 2018 Field Methods class constructed a chronology of Monroe Hill. The site, located just west of the Academical Village, consists of three major buildings: the main house, James Monroe's law office, and two dormitory ranges. Archival and architectural evidence date part of the main house and the law office James Monroe's 1790s occupation of the hill, while the dormitory ranges date to 1848.

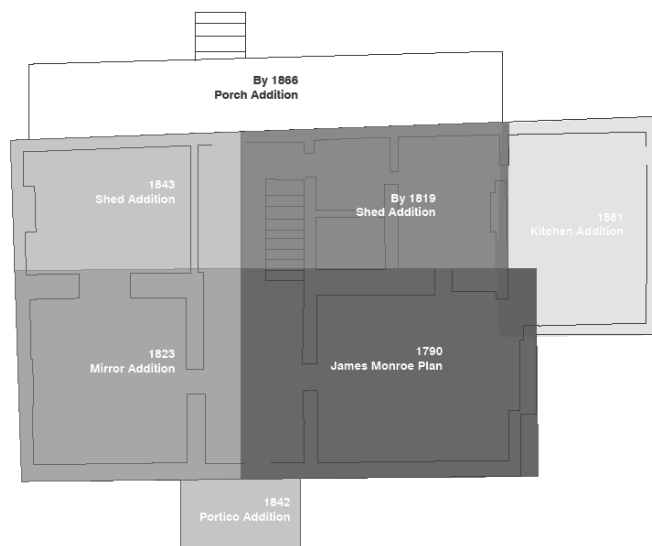
Figure 3 First Floor Plan (Drawn from scan data; not to scale)

The first major finding was locating the original 1793 house within the current building. The original footprint exists within three spaces: the dining room, the central hall passage, and the second floor bedroom. The thick walls in the dining, which are roughly uniform in size and are 1'5"-1'11" thick, lead us to believe that they were once exterior walls and built in one campaign. Compared to the other interior walls in the house, which are between 7"-9" and irregular. The archival evidence shows a 1800 report of a 20x27 structure. This report matches the measurements taken from the dining room and central hall passage. 27 feet from the dining wall/chimney wall to a shift in floorboard in the central passage as well as 20 ft. from front wall to another irregularity and change in floorboard in central passage as well as terminates at end of dining wall. There is also major evidence in the current floorboards. In the current central hall passage there is a rift in the floorboards, where we think the original house terminated. There are also cut out of floorboards, which would have originally gone in the opposite direction, but since replaced to match the central passage. We believe that this change in floor board direction is proof of the original entrance into the home. There is also evidence in the floorboards of the original staircase. There are two posts in the floor, where the staircase structure would have been.

The second finding, which was the result of so much irregularity in the construction of Monroe Hill, is that there were three to four major building campaigns. The first is the 1793 Original James Monroe House, which is currently located within the current dining room and extends halfway through the central hall. In 1814 John Perry purchased Monroe Hill and added a brick shed 27x17 in 1819.

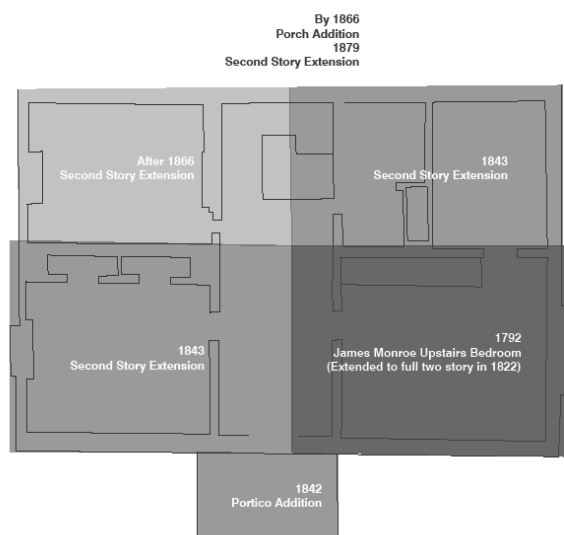
Figure 5 Second Floor Plan (Drawn from scan data; not to scale)

second floor consisted of two rooms which would be located within the current master bedroom of the site, which measures just shy of 27 x 20 feet. Irregularly cut floorboards near the doorway into the master bedroom correspond with posts in the dining room below. Together, these suggest the original placement of a staircase. The width and length of the suggested staircase suggest it likely had two narrow runs and a small landing. The original floorboards in the second-floor central passage have been removed and replaced removing some of the evidence to support this conclusion. The combination of documentary evidence and the placement of a newel post at an obtuse angle to what would have been the first stair suggest that the original house was only one and a half stories. It is possible that the law office and the main house had mirrored or nearly mirrored layouts, and that the law office exterior approximates the original James Monroe house.

It is not until the 1840s that any major changes happen to the second floor of the structure. These two building campaigns are visible mostly through archival and ornamentation evidence. After the 1820's addition of the south parlor physical and archival evidence show that in 1842 it was raised to a full second story. The first of which is in 1842. This is also supported by the archival evidence from 1841-1842 talking about paying \$645 for the "addition to proctors dwelling." (Apr. 1843 – J. Lobban) Next in 1843 the 1819 20 x 17 addition was raised to a second floor or at least a story and a half which is evident by the distinct change in wall thicknesses on the north wall going from 1 foot 8 inches on the east to 1 foot 2 inches on the west side which is the same as the second floor of the south parlor room. It is also at this point the downstairs central passage must have been added because on the second floor the walls slope inward by 2 inches on each side east to west which becomes a problem when the second-floor passage is later added.

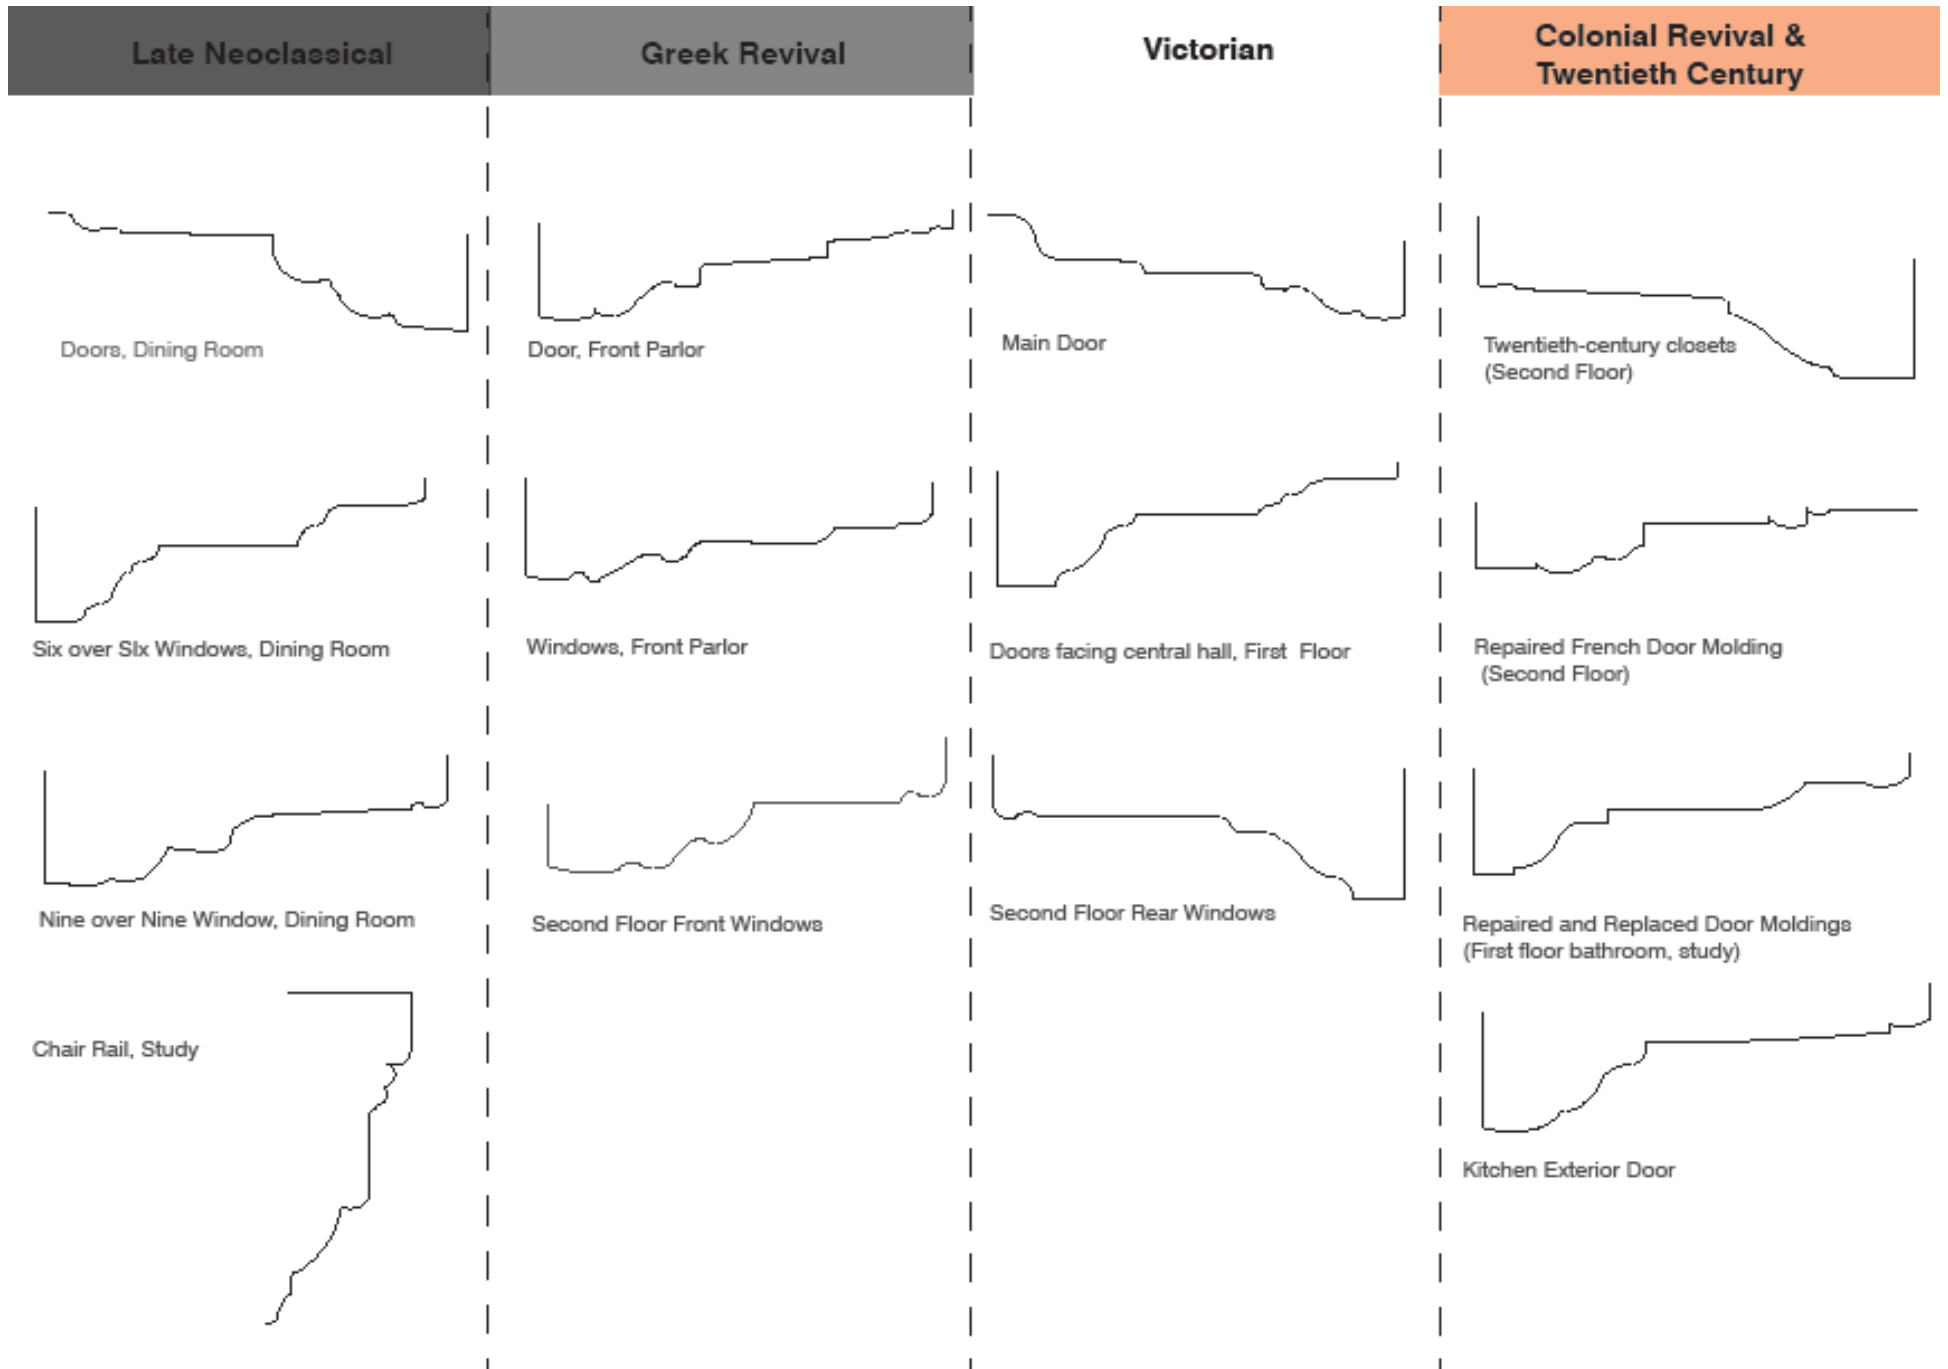
Figure 7 Molding profiles of Main House

The molding profiles in the main house support many of the conclusions made in the rest of this report regarding the original footprint of the 1790s James Monroe residency, as well as the apparent pattern of building expansion. For example, a majority of the window and door moldings in the house appear to be Late Greek Revival. The peak of this style is located in the southwest room, where the molding profiles are most stark and exaggerated. The southeast room, which is believed to comprise the original footprint of the 1790s James Monroe house, is characterized by late Neoclassical/early Greek Revival molding

Moldings on those doors which face into the central passage on the first floor match. The paint build up on these moldings suggest they are original to their period of construction. As these profiles appear to have a similar profile as those found inside the southeast chamber, it seems that these moldings were either a) matched to earlier decorative finishes to give a sense of wholeness to the building or b) moldings within the southeast chamber were replaced or updated in a later construction period.

The southwest chamber has by far the most distinctive moldings. While the molding on the door which faces the central passage appears to be the same late Neoclassical/early Greek Revival style as other moldings in the house, the molding on the interior of the door is decidedly late Greek Revival. The same profile is found on both of the six-over-six windows and the same style is present in the mantelpiece. These moldings all appear to be original to their date of construction. The profiles in this room are not found anywhere else in the main house or any other building on the site. These profiles have the most exaggerated ellipses.

The northeast chamber and its immediate adjoining rooms show the most recent changes to the first floor. Obvious recreation moldings are found in the modern bathroom, which are styled to mimic the molding profile found on the doors and windows in the immediate spaces. Similar modern recreations can be found throughout the house as apparent repairs on moldings. In most instances, only a portion of a door molding will have a modern repair and will retain original elements of the molding and/or frame. In cases of obviously new construction (e.g. the modern closets in the upstairs bed chambers), obviously modern moldings are used.

The second floor of the main house reflects the most homogeneity in molding profiles. All of what appear to be original door frames have matching molding profiles. Similarly, all four windows along the southern side of the house share the same profile. The windows along the rear of the house on the first and second floor also share the same molding profile.

Taken together, the molding profiles reflect three major decorative styles in the main house: transitional Neoclassical, mature Greek Revival, and twentieth- and twenty-first-century recreations. Many of these moldings appear to be original to their installation, which could help substantiate the overall timeline of expansion and change within the house. Perhaps the most notable finding in this respect is the similarity in the simple profiles of the rear windows and moldings found in the law office and the detached range.

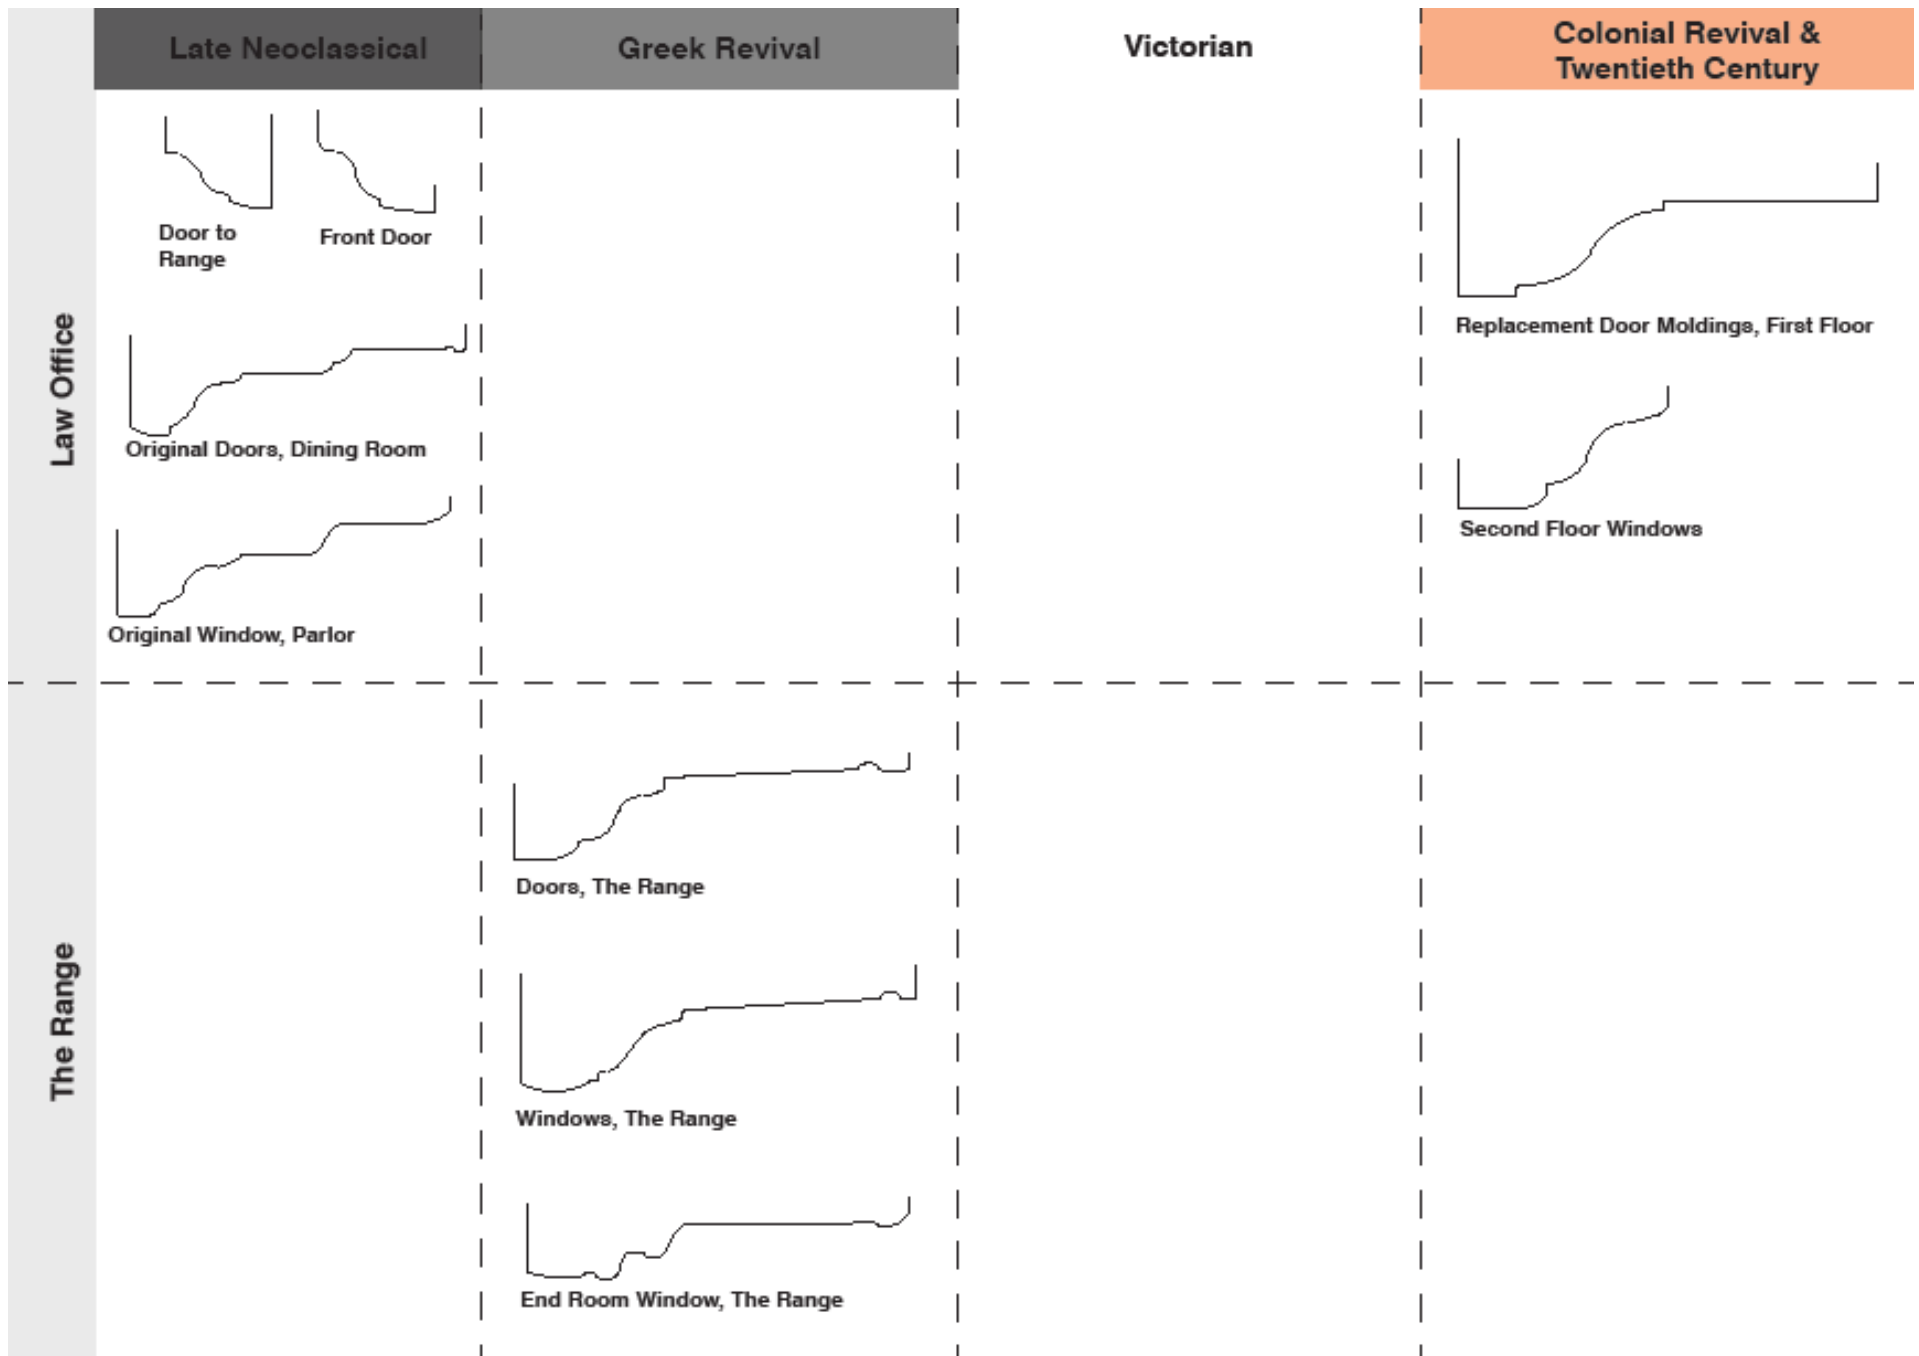
Figure 8 Molding profiles of the Law Office and Student Ranges

Moldings recorded in the law office at this time reflect a number of building periods. The dates associated with these moldings may differ from any overall building campaigns within the structure. The most intact room appears to be the largest, formal chamber in the house. Window molding profiles all appear to match. This profile is also found on windows in the main house and on door and window moldings in the detached range.

It is important to note here, however, that archival photographs suggest that major damages occurred to at least one window in the law office and that major changes may have been made to the full interior of the detached range. The fact that these moldings match may only suggest they were installed as part of the same campaign. It is plausible that these moldings could have been replaced by similar moldings from elsewhere on grounds. (Curiously, a very similar profile was observed on a mantelpiece in a room in Brown College, which likely dates to the late 1920s or early 1930s.) The front door to the law office appears to have the oldest molding in the house and is distinctly late Neoclassical and sports similar cymas as ones found in the main house.

1. Not all of the doors in the passage are equipped with door moldings. There is no apparent pattern for this inconsistency.
2. The profiles for the door and window moldings are relatively plain.
3. All of the door and window profiles share the same profile with the exception of the northernmost room in the range. This room, inexplicably, has the most ornate of all the moldings and has multiple beads. It is unclear at this point whether or not these might be original or if this room, which currently functions as an office, was outfitted for a faculty of higher standing than others in the building.

At this point, there is insufficient evidence in the moldings to support any conclusions regarding periodization of building campaigns in the law office or detached range. Likely, many of the moldings were replaced, repaired, or restored throughout the twentieth-century. Archival evidence suggests that the law office and the two ranges have seen the most change in use, tenants, and design on the site. Inconsistent moldings support this conclusion.
