Final Report: Main House Group II (Exteriors)

Katie McCarthy Watts, Jane Trask, Andrew Ashcraft

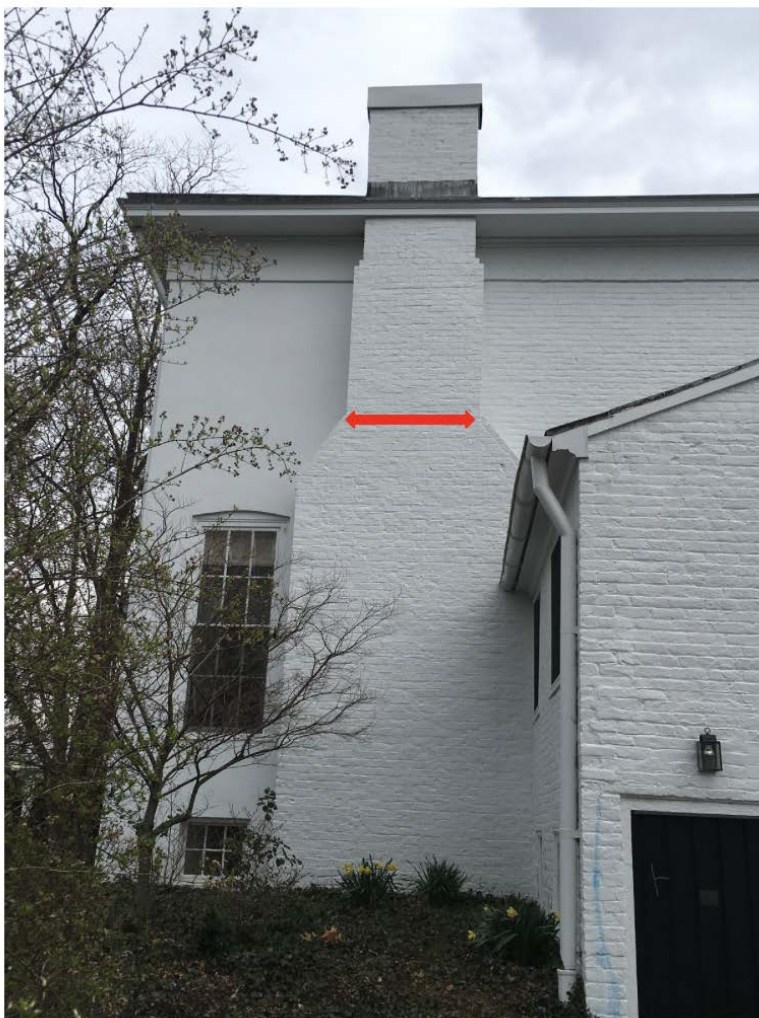
Documentary evidence suggests that by 1819 there was a 17' x 27' shed addition off of the original house. Evidence along the North elevation shows signs of this addition. Above the current kitchen roof is a brick soldier course that protrudes more than the surrounding brick (circled in red in photo below). Below the soldier course appears to be Flemish bond brick. This likely shows where the shed addition was, and where it was converted to a full two-stories in the first

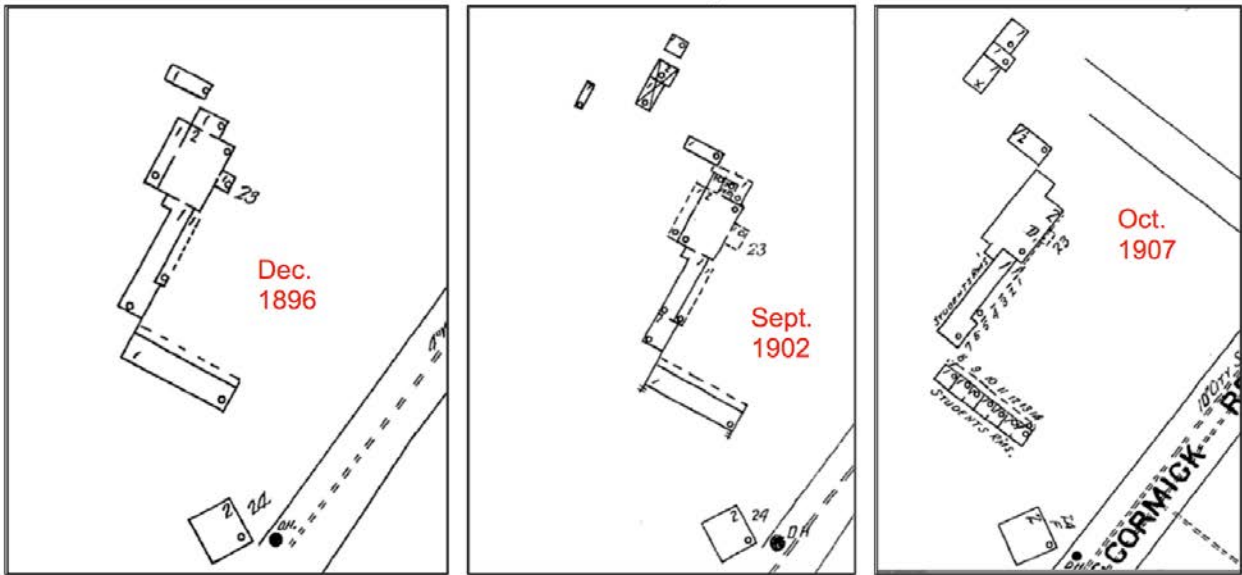
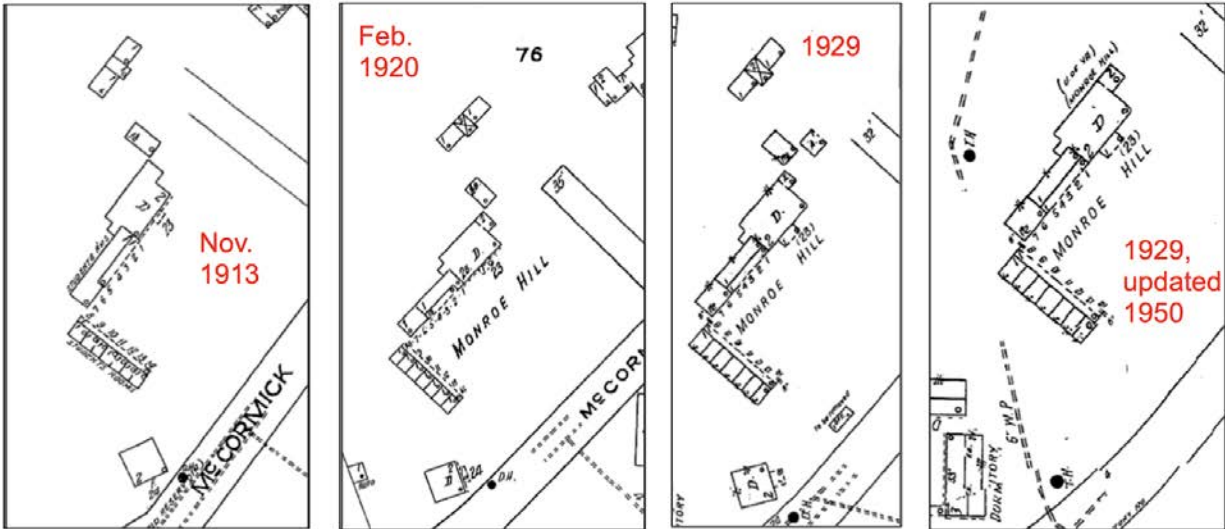
For example, throughout the seven Sanborn maps below, the shed addition to the first range room between the main house and the law office jumps back and forth as to whether it is drawn as attached to the range or attached to the main house. While the existing architectural evidence suggests it was always a part of the range room, perhaps we do need to take another look at this structure as we investigate the south/side elevation assigned to Andrew and work with the range groups. The Range group found evidence that William Thornton took two range rooms over as his own, to serve as a library and office, so perhaps this was why the shed addition goes back and forth in the Sanborns. The kitchen and rear porch also go back and forth between being listed separately from the main house, or drawn within it. For Jane's rear elevation, there is evidence of a rear porch of some kind as early as December 1896, also previously thought to be a twentieth century structure.

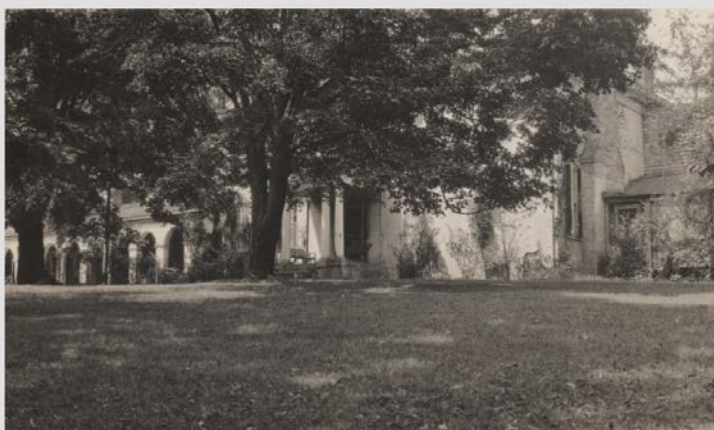
Monroe Hill, Special Collections, University of Virginia Library, Charlottesville, Va.
<http://search.lib.virginia.edu/catalog/uva-lib:2155244>

Curiously, by 1907, the Sanborn map goes back to representing the kitchen as a simple bump out on the North elevation, however, it is included as part of the main house, labeled as two stories. There is a second historic photo from Special Collections clearly showing a two-story frame kitchen with a porch around it, but unfortunately it is an undated photo. It corroborates the photo dated 1940, but causes some confusion as to when this second story was put on the kitchen (since it is one story with a basement today). The second story could have provided sleeping quarters for the cook and his or her family. There is no fence around the kitchen in this photo.

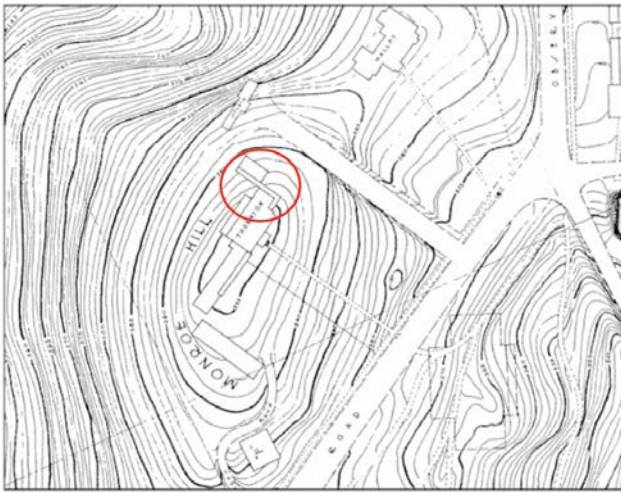
1909 Jackson & Laird Topography Map

The 1909 Jackson and Laird topographical map (below) agrees with the 1902 Sanborn, showing the kitchen addition with an L-shaped connection to an outbuilding behind and to the side of the main house. By 1929, the Brown College dormitories start appearing on the maps, and have expanded significantly by 1950. The two ranges of student rooms are also more elaborated as time goes on, including a numbering system as early as 1907 and continuing through 1950.

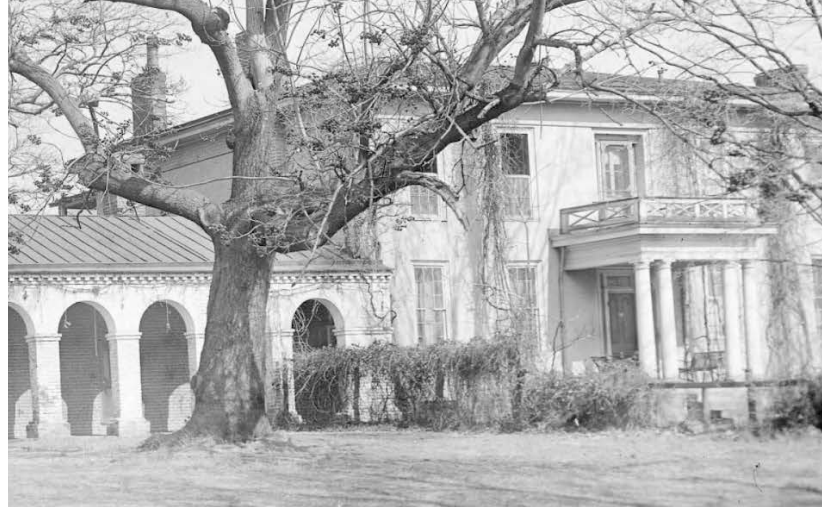
To return to the general description of the elevation today, this porch stands up on eight riser blocks, leaving some of the lowest courses of brick found on the house visible only on this elevation. On the main floor, there are four windows

and a door. Although the door is flanked by two windows on either side, it is not centered within the space, crowding the south side. The top floor shows five windows which appear to be the same size. The outer two windows on each side are directly above their ground-floor counterparts, but the center one is not placed directly above the door. Instead, it is centered between the pairs of windows. Upon careful observation, it became clear that the spacing between the two pairs of windows outside the central elements on both levels are not regular. The left side windows on both levels are further apart than those on the right side, seen clearly in the photograph on the previous page. A belt course six courses of brick high runs across the top of the face, between the upper edge of the window and the bottom of the cornice. Aspects of both the kitchen and the range are visible from the rear elevation, and it becomes clear that the kitchen and the range are about the same height (about 16 feet off the ground, though the sloping ground complicates the exact measurements).

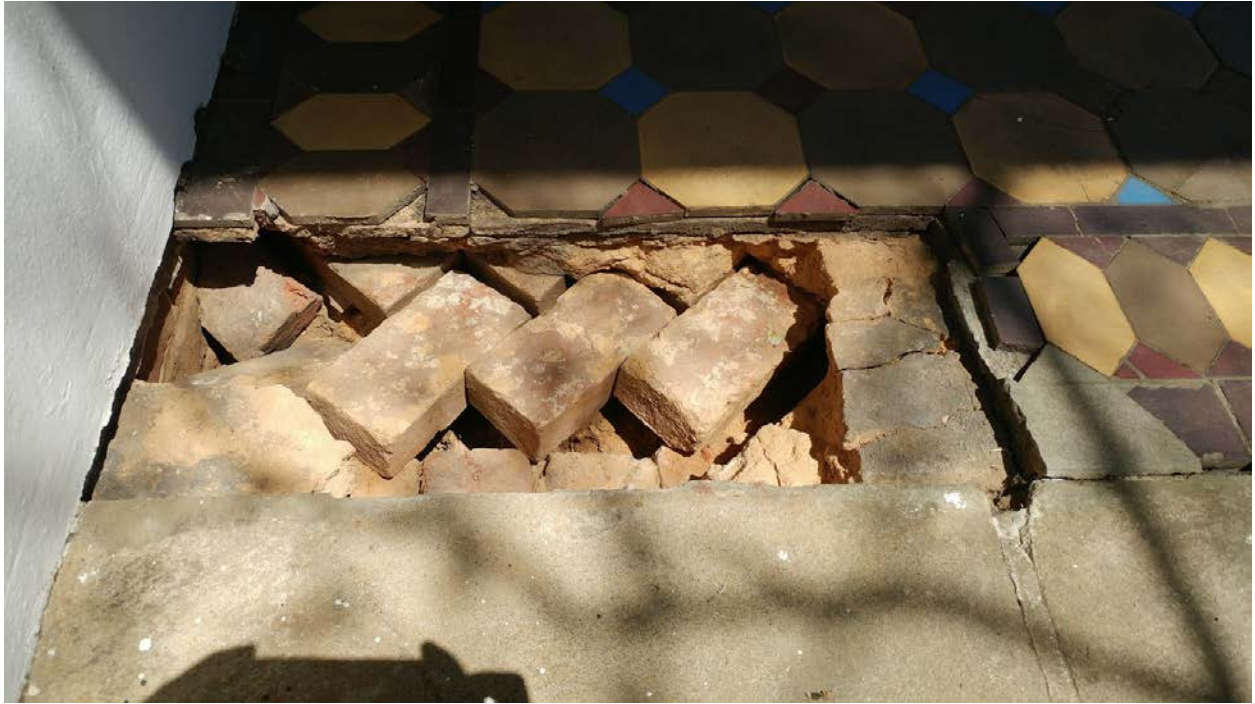
Beneath its uniform white paint, the south elevation of the Monroe Hill House bears the scars of multiple building campaigns. The present day elevation is a product of the nineteenth, twentieth, and twenty first centuries, with two centuries of activity beginning with an 1823 addition to the south of the original 1790s Monroe House and ending with a modern ADA ramp granting access to the rear porch. Forward of the front chimney, the elevation is obscured by a smooth white render, likely applied in the 1840s to mask seams and unify the appearance of the front facade. Work on the front portico of the house has uncovered two distinct periods of render: an earlier, lime based finish likely dating to the 1840s (and the corresponding addition of the front portico), and a later, portland cement based finish, possibly a product of the 1870s when the main block of the house was completed.

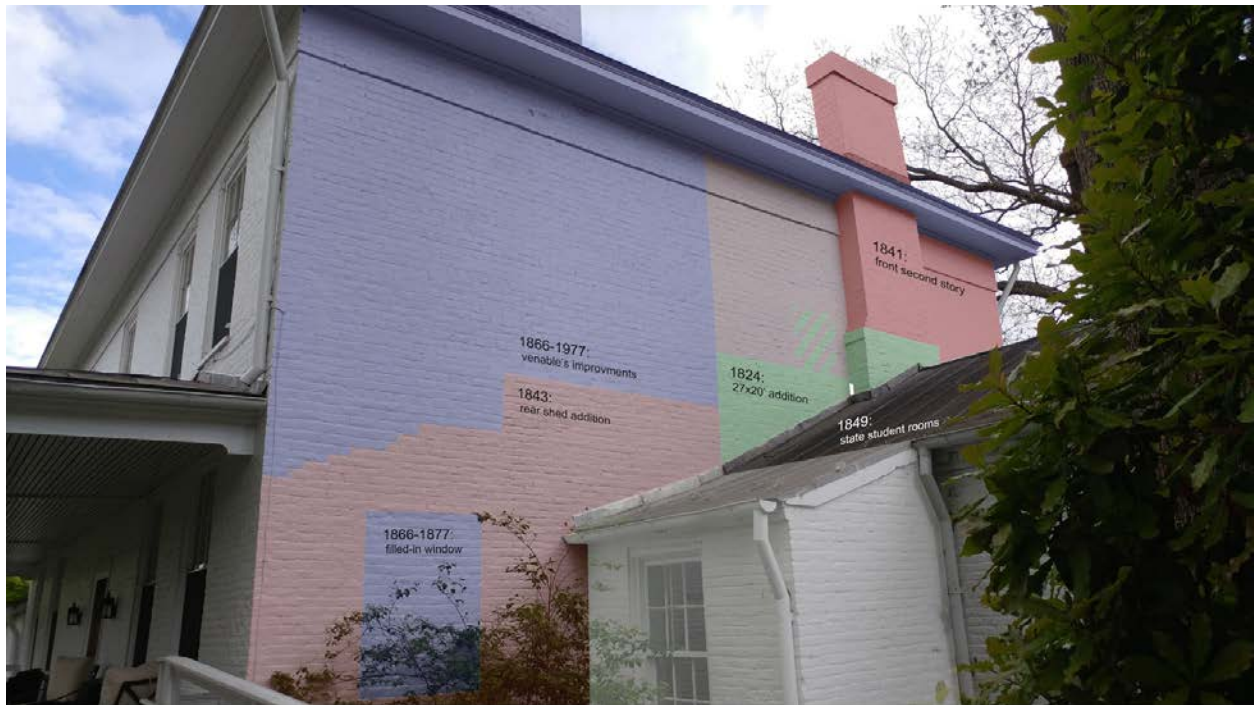
Period I: Lower eastern elevation and forward chimney. 1823-25

A 27x20' addition to the south provides the full width of the present front facade. Such an addition would mirror the original 1790s building and, together with the pre-1819 27x17' rear shed, form the house into a modified L plan. The lower portion of the forward chimney dates to this period. Broken, staggered horizontal and vertical seams on the wall provide evidence that southeast portion of the house was not constructed to its present height in a single building campaign.
