MONROE HILL BRICK ANALYSIS

Aisha Sawatsky
ARH 5604 Field Methods in Historic Preservation
Louis P. Nelson, University of Virginia
May 13, 2018

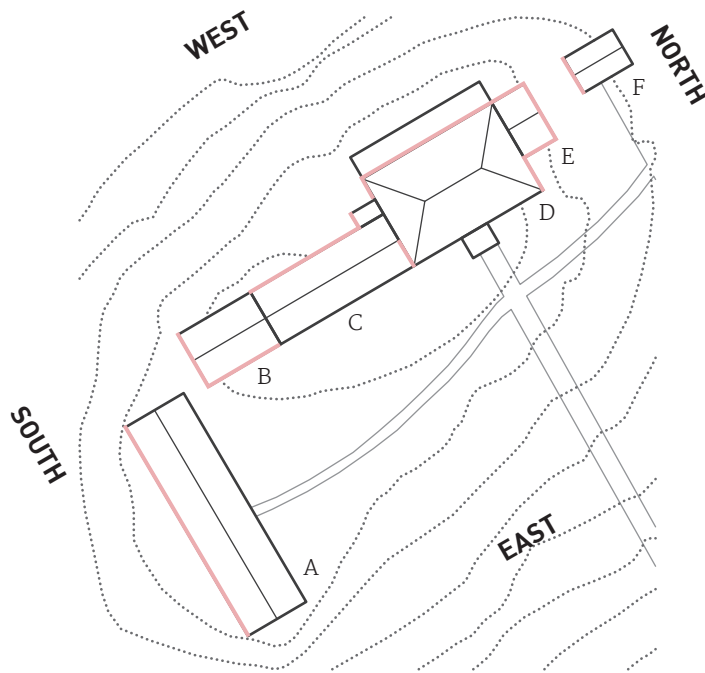
FIGURE 01: Site Map of Monroe Hill

- A. Long Range
- B. Law Office
- C. Short Range
- D. Main House
- E. Kitchen
- F. Garage

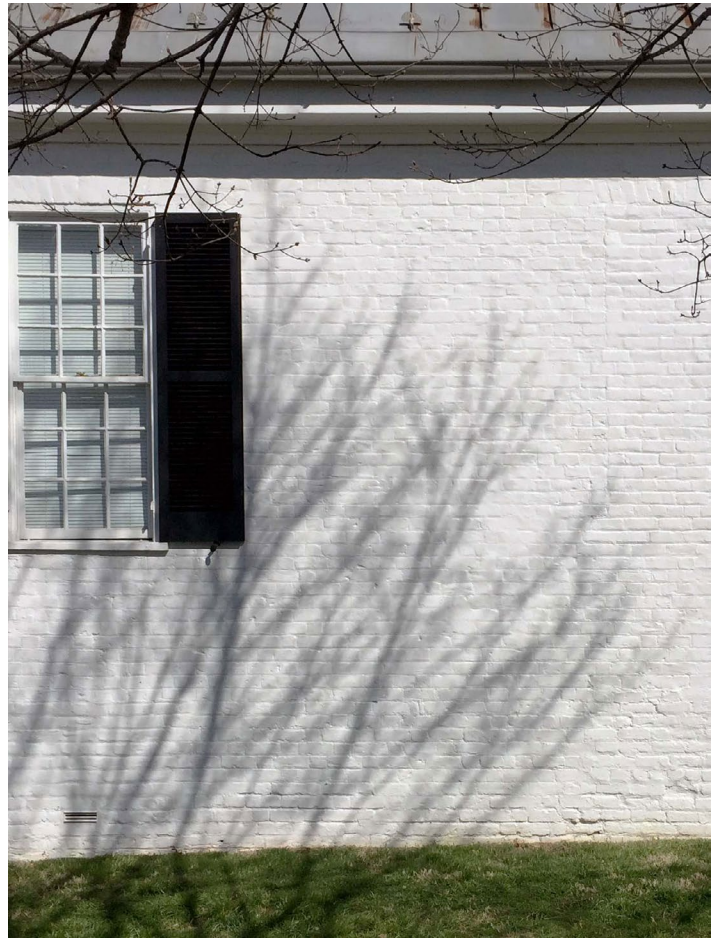
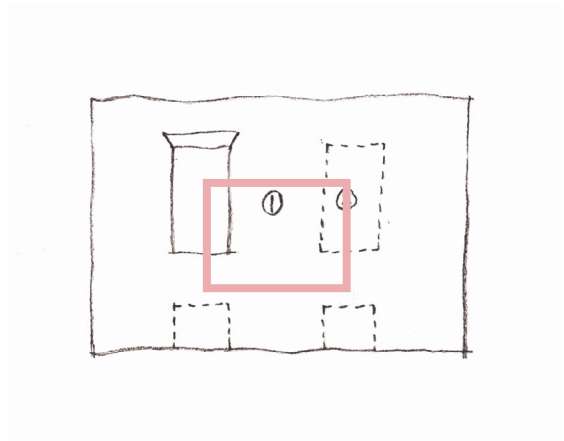
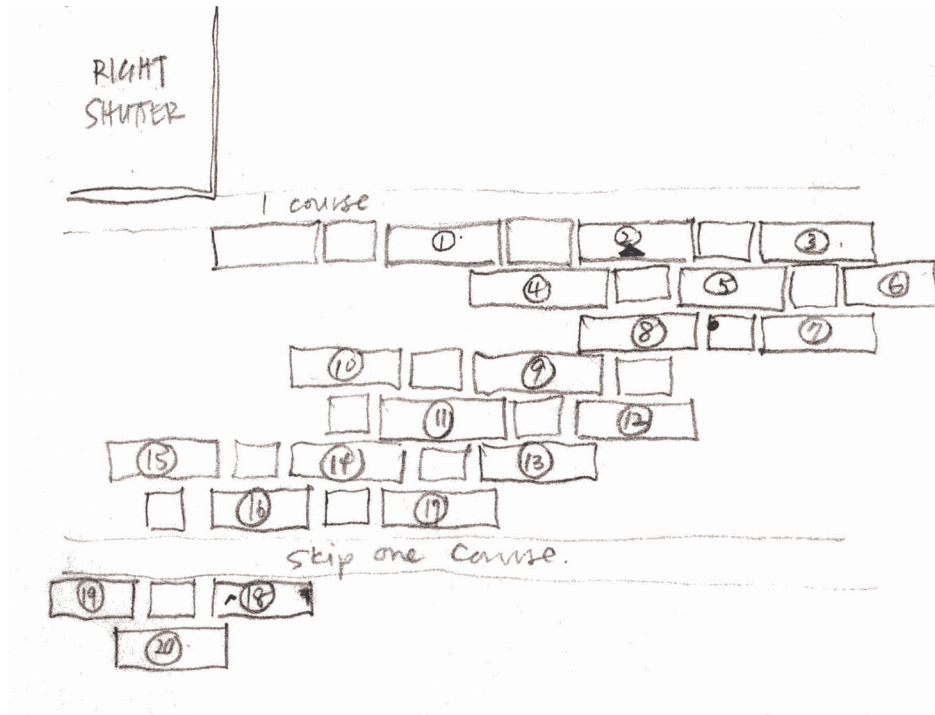
Law Office East 1

BOND Flemish
FINISH Painted
DATE April 5, 2018 [Measure 2]
NOTES Only stretchers measured.
Law Office accepted to be constructed ca. 1790 with documentary evidence.
Several former openings are blocked in on this wall.

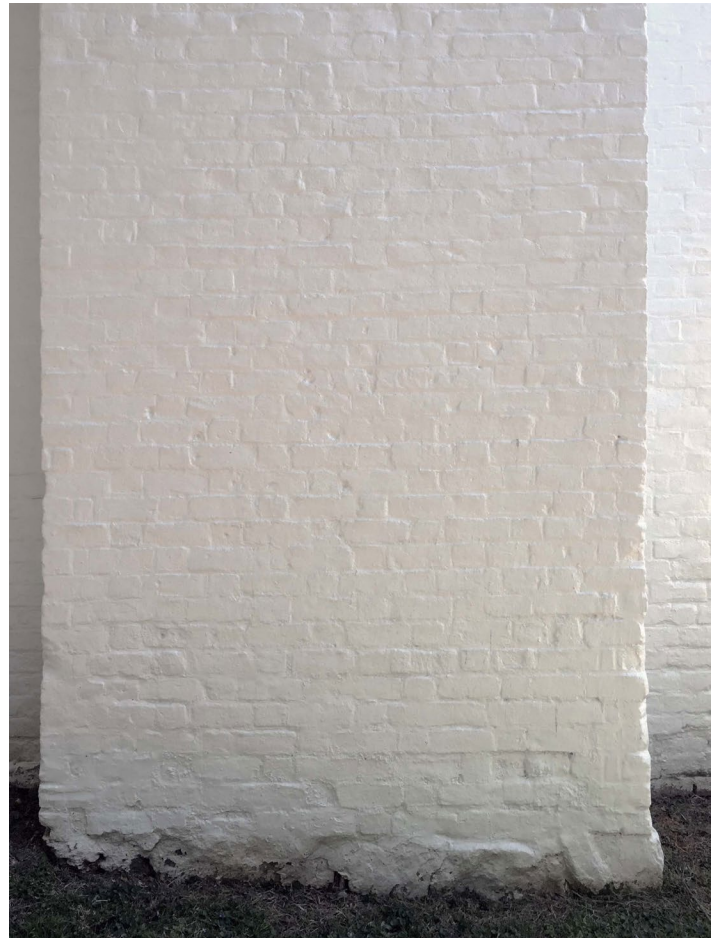
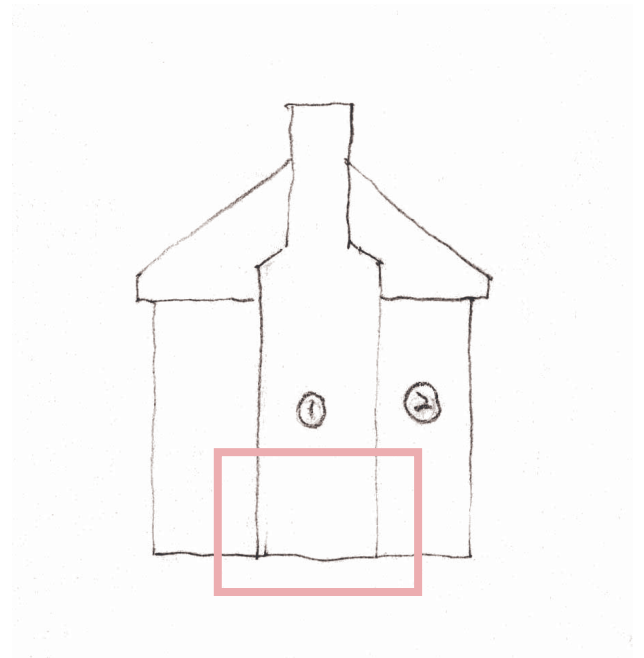
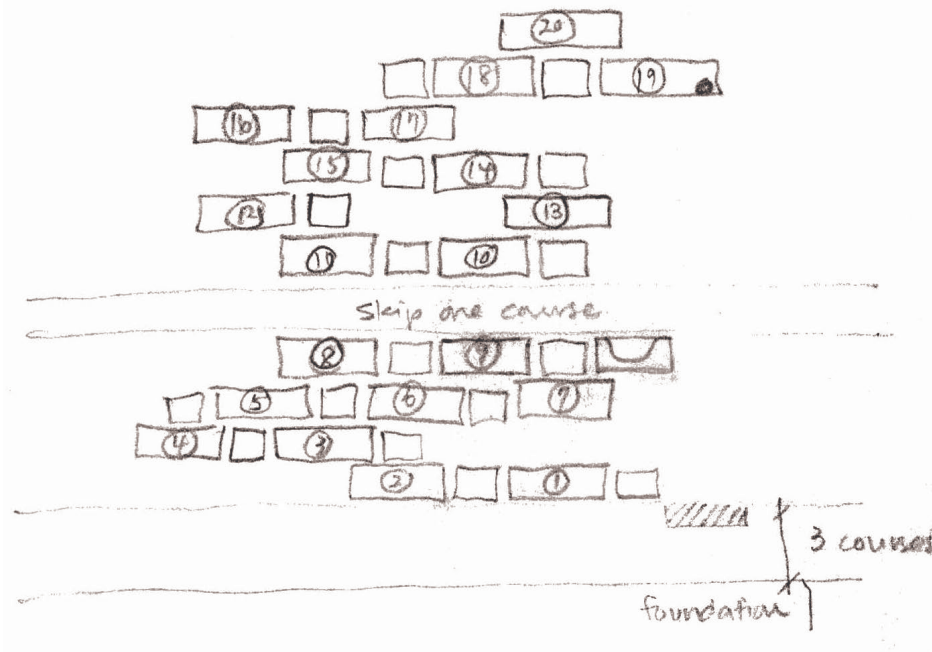
Law Office South 1

BOND Flemish
FINISH Painted
DATE April 5, 2018 [Measure 3]
NOTES Chimney base.
Only Stretchers measured.
Law Office accepted to be constructed ca. 1790 with documentary evidence.

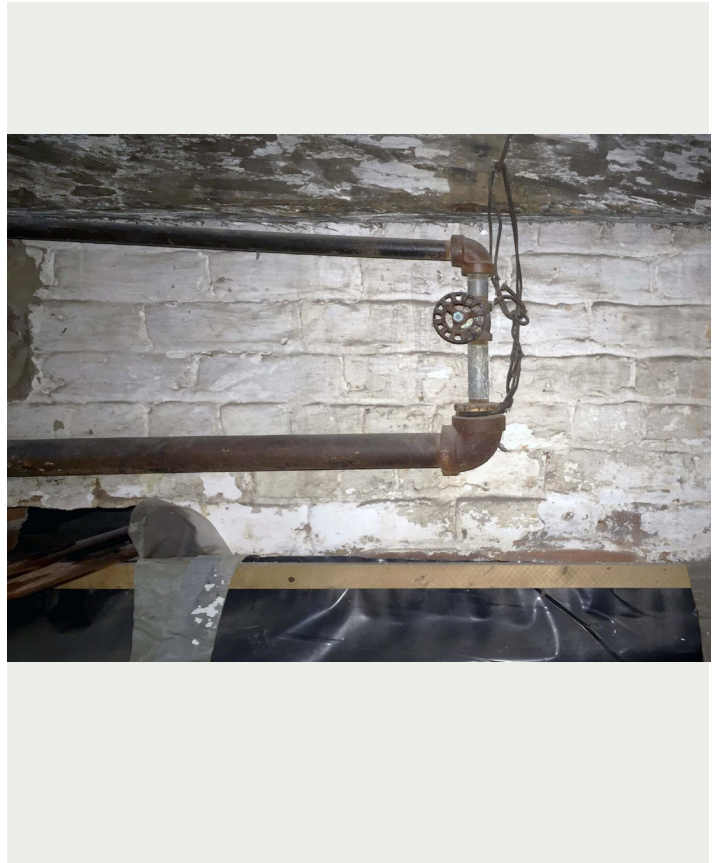
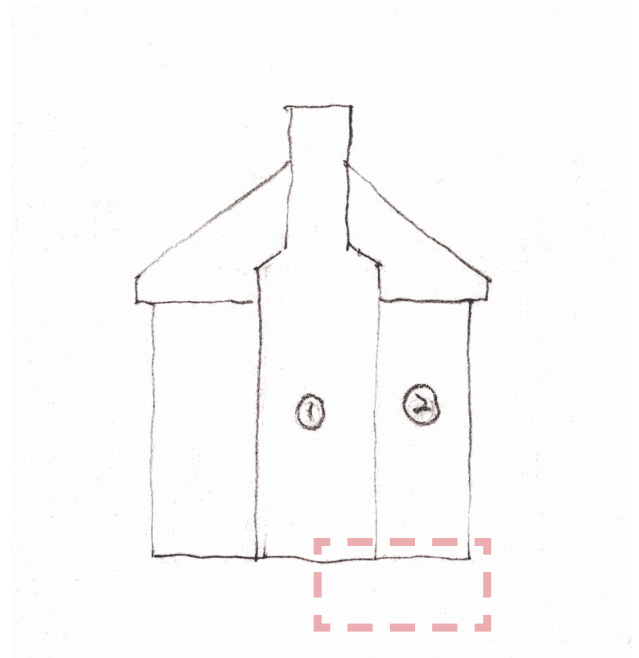
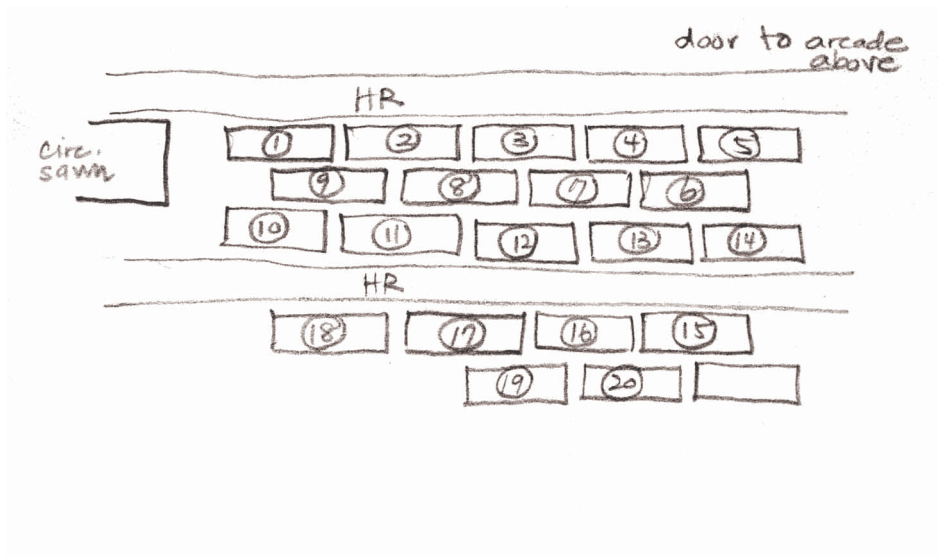
Law Office North 1

BOND 3-course Common?
FINISH Whitewashed
DATE April 12, 2018 [Measure 13]
NOTES Interior of North cellar wall.
Beam with circular saw marks shown intersecting with this wall, indicating that changes to the floor structure above likely occurred after the Civil War (post-1865).
Actual brick wall believed to be part of the single 18th C building campaign of the Law Office (ca. 1790).

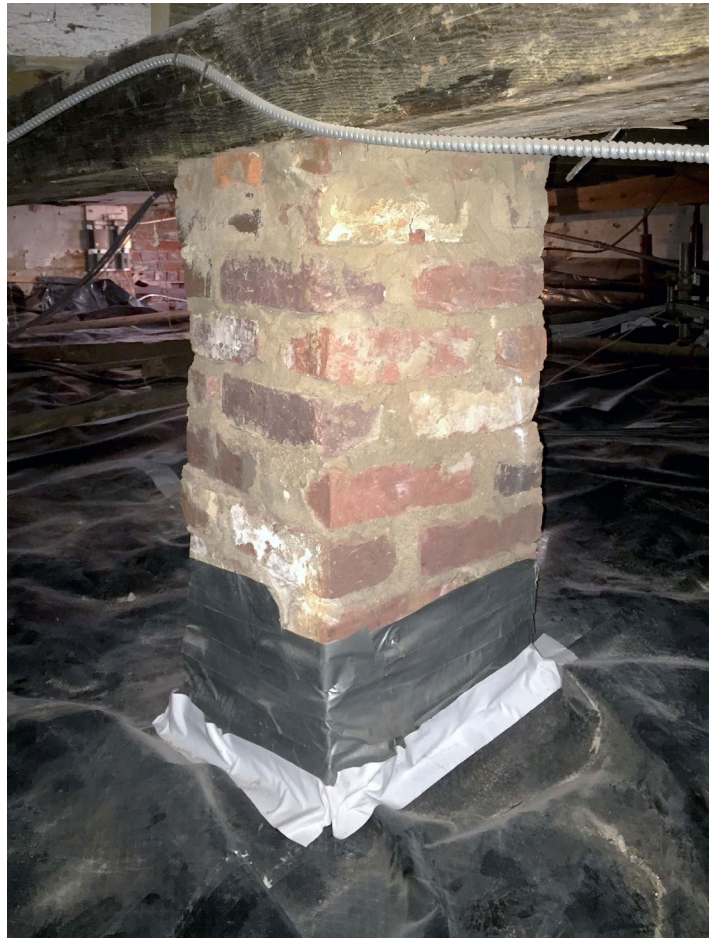
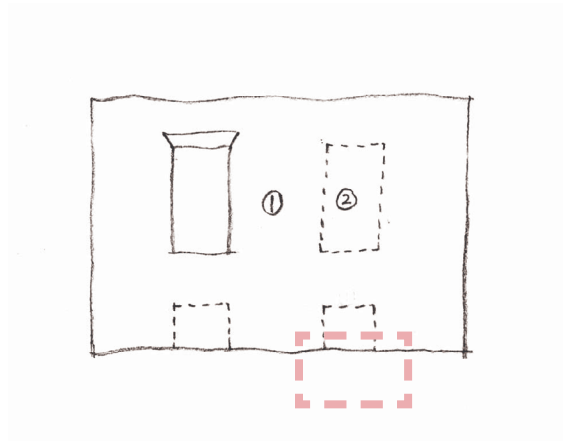
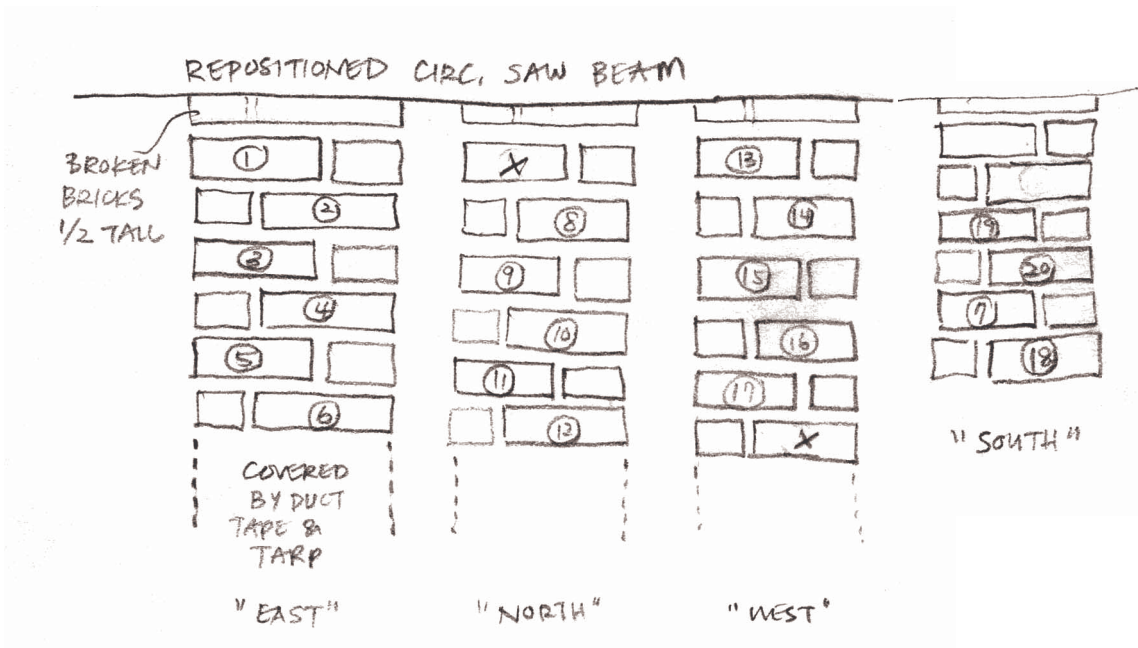
Law Office North 2

BOND Running
FINISH Unfinished
DATE April 12, 2018 [Measure 14]
NOTES Northeast cellar pier supporting a beam with circular saw marks, indicating that changes to the floor structure above likely occurred after the Civil War (post-1865).

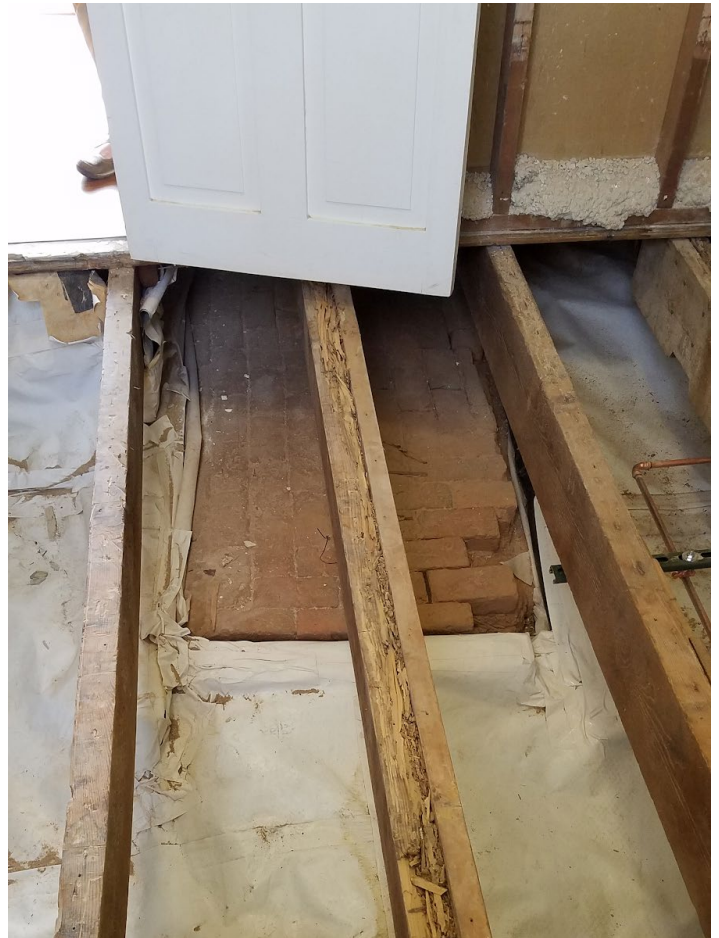
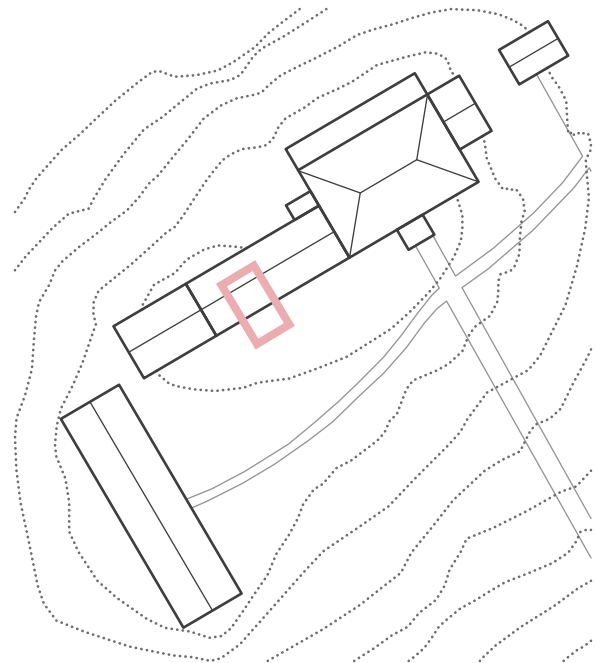
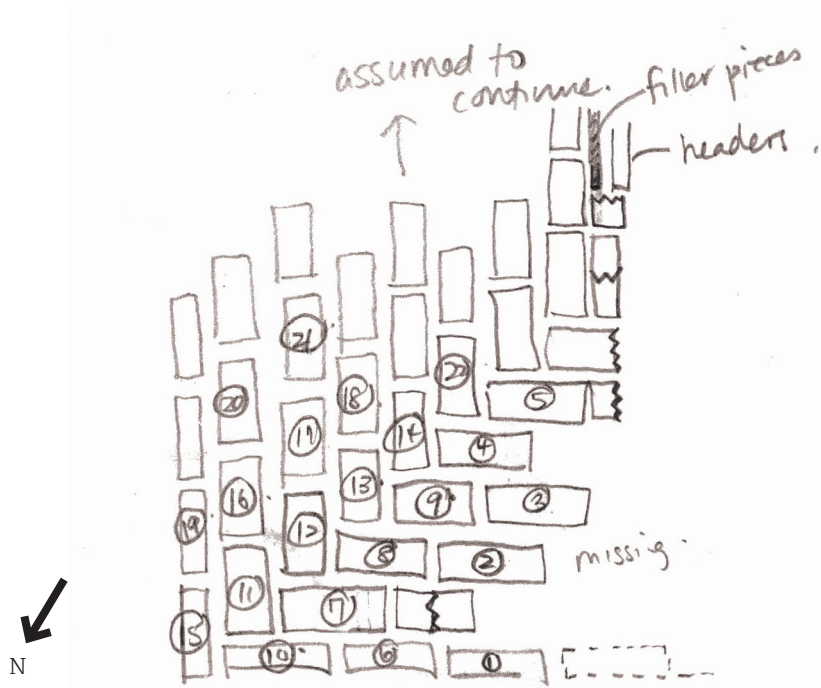
Short Range Path

BOND Running
FINISH Unfinished
DATE March 1, 2018 [Measure 1]
NOTES Path beneath Short Range (measured in the second room from the Law Office) dates the brick to pre-1848, from documentary evidence of payment to George W. Spooner for construction of state student dormitories between July 1848 and January 1849. Visible portion of the path runs from a southeast to a northwest direction, apparently making a right-angle turn toward the Law Office beneath the Short Range.

Range, which was constructed using unfinished bricks and laid in a running pattern that mostly exposed the shiner (length and width) rather than the stretcher (length and height). It became somewhat difficult to eventually compare all of the brick patches to each other when data was consistently missing for some samples — most exterior bricks did not have width measurements. In hindsight, it would have been prudent to measure the available widths of bricks in header courses that were adjacent to the sample patch.

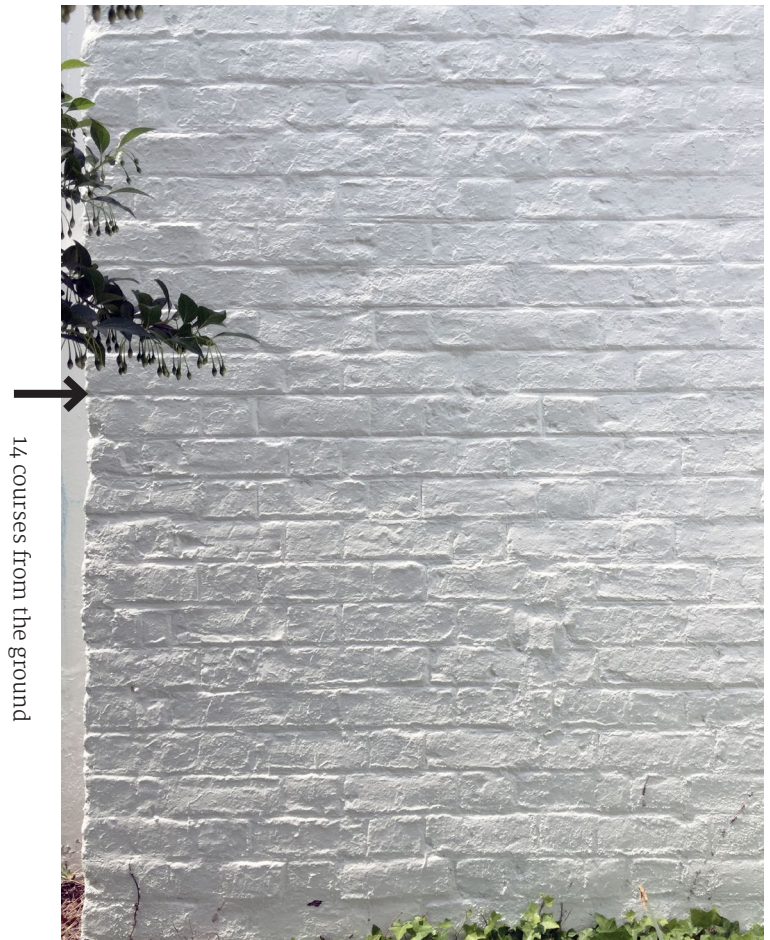
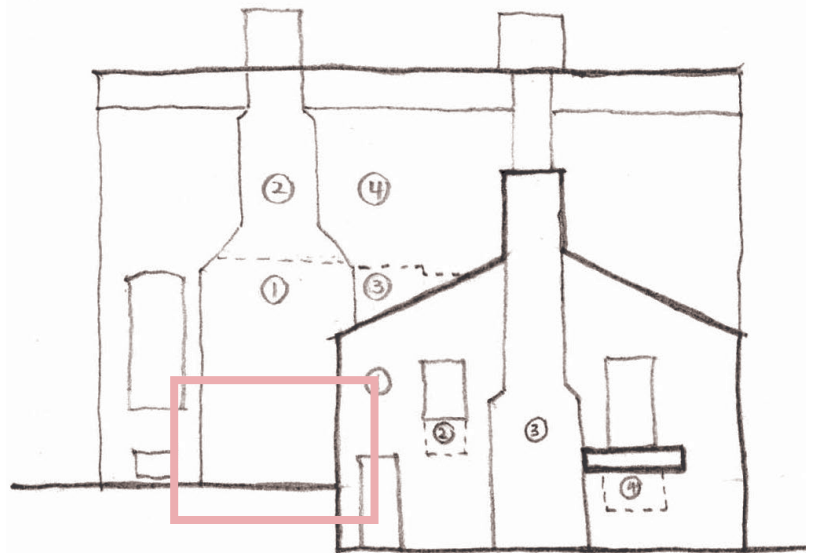
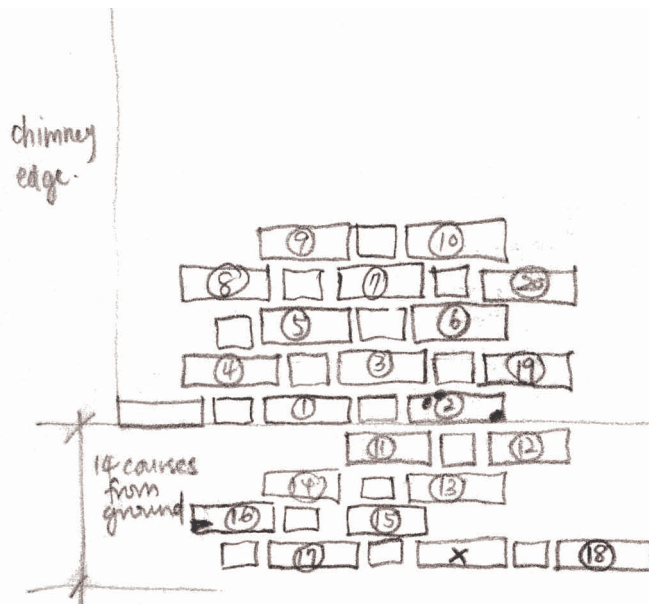
Main House North 1

BOND Flemish
FINISH Painted
DATE April 5, 2018 [Measure 4]
NOTES Chimney base.
Only stretchers measured.
[Refer to sketch] Brick bond changes from Flemish to Running after corbeling at transition between first and second floors. Documentary evidence and field measurements indicate that this Northeast quadrant of the Main House dates to the 18th C, contemporary to the Law Office.

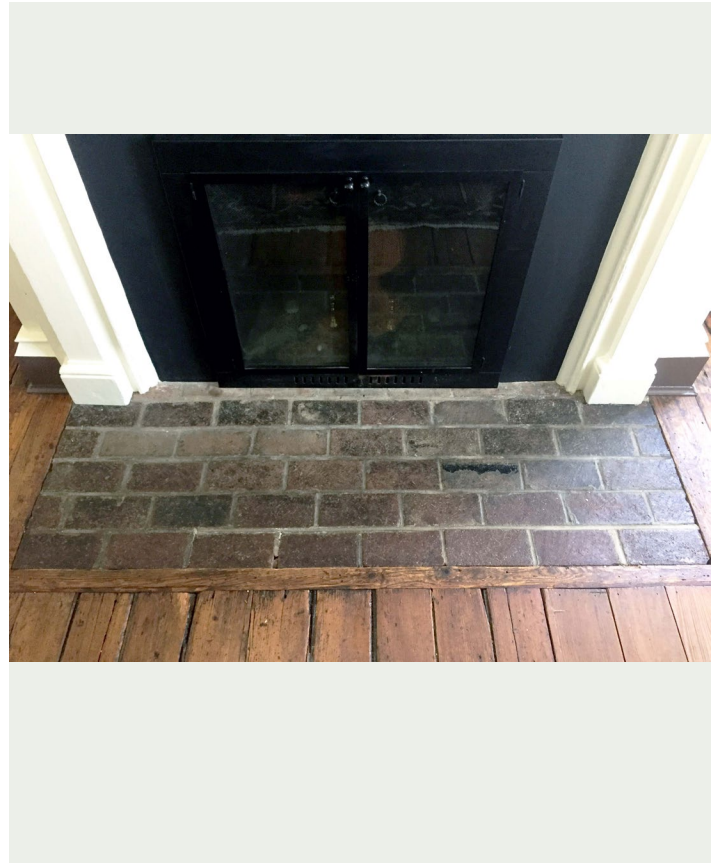
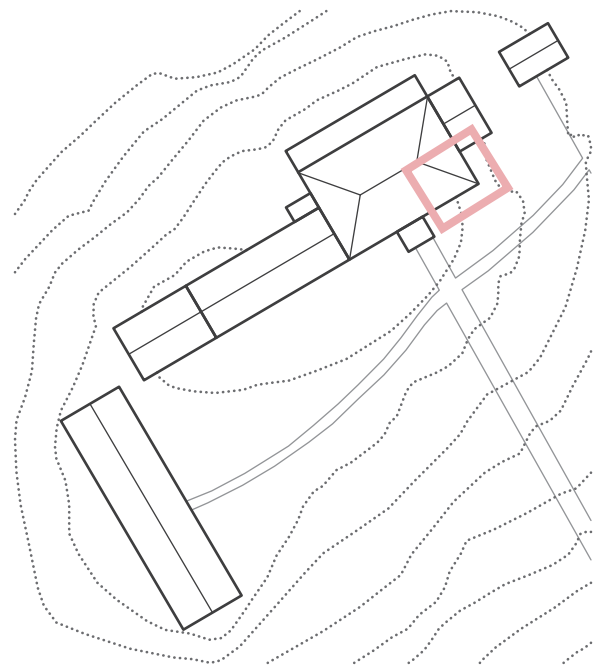
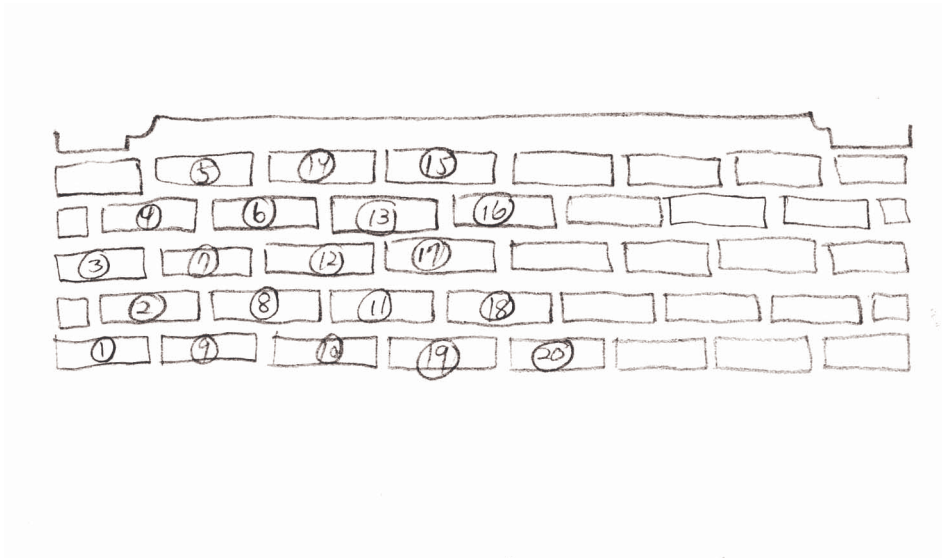
Main House Ground Floor, NE Hearth

BOND Running
FINISH Rubbed
DATE April 12, 2018 [Measure 22]
NOTES Currently dining room.
Documentary evidence and field measurements indicate that this Northeast quadrant of the Main House dates to the 18th C, contemporary to the Law Office.

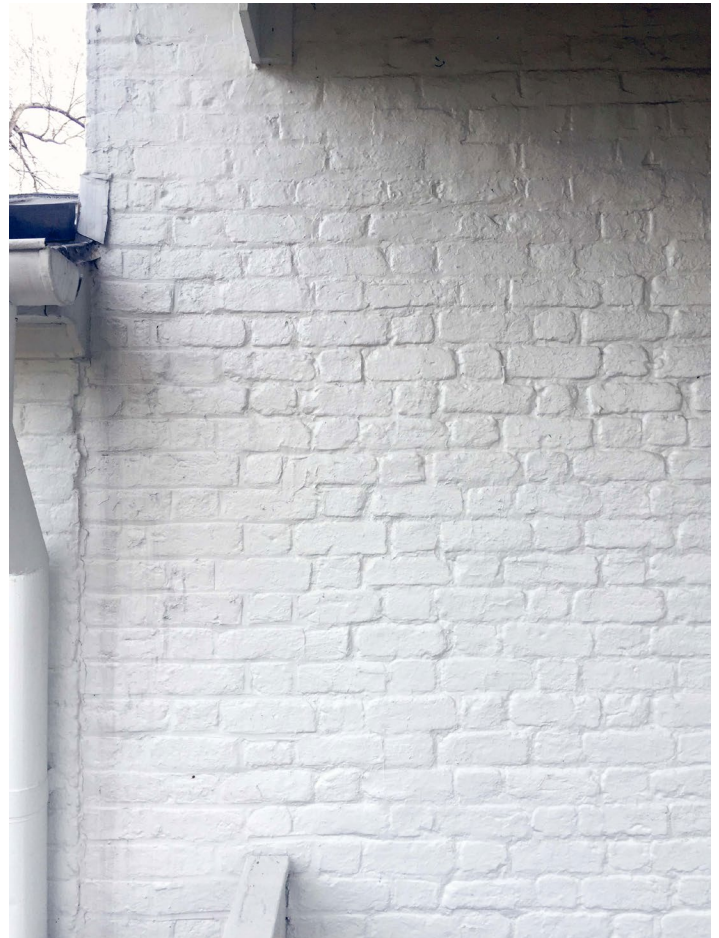
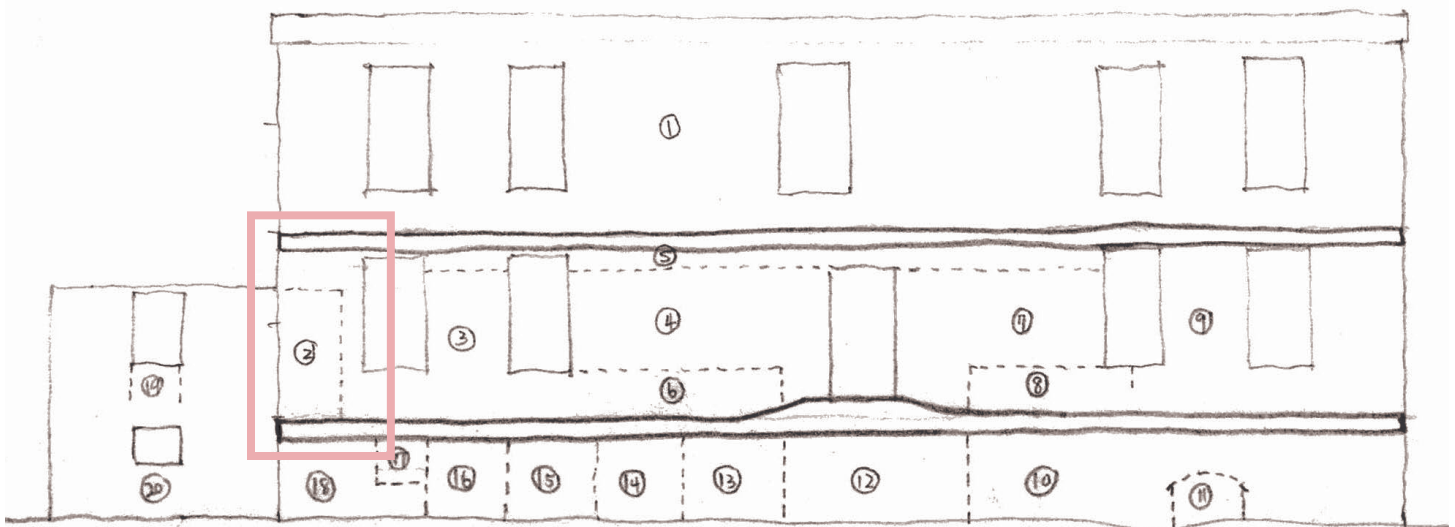
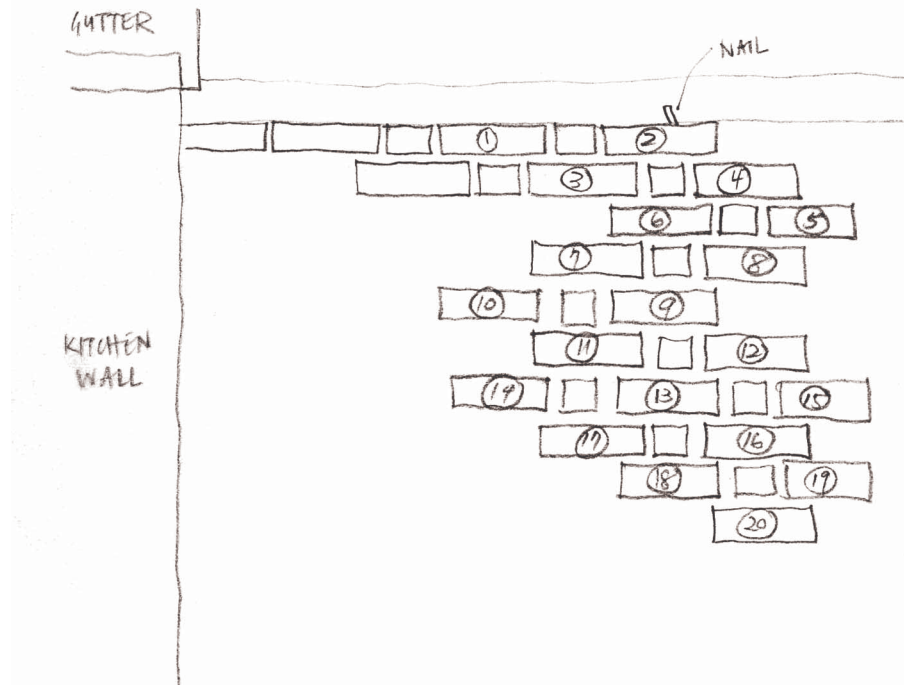
Main House West 2

BOND Flemish
FINISH Painted
DATE April 6, 2018 [Measure 8]
NOTES Only stretchers measured.
If the Northeast quadrant of the Main House is accepted to be the 18th C original build (contemporary to the Law Office), then the Northwest quadrant is likely to be the “brick shed addition” constructed between 1800–1819.

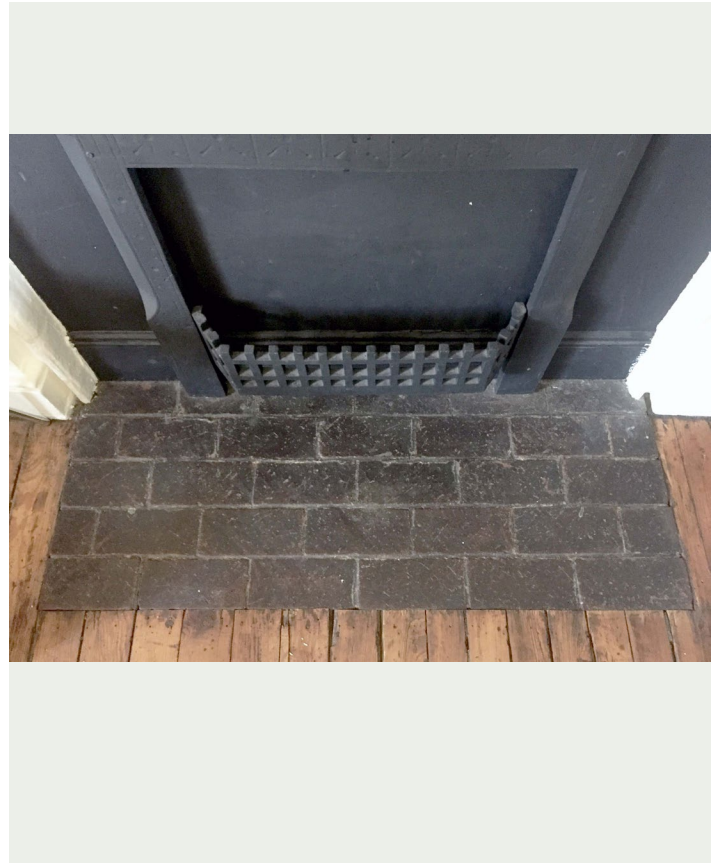
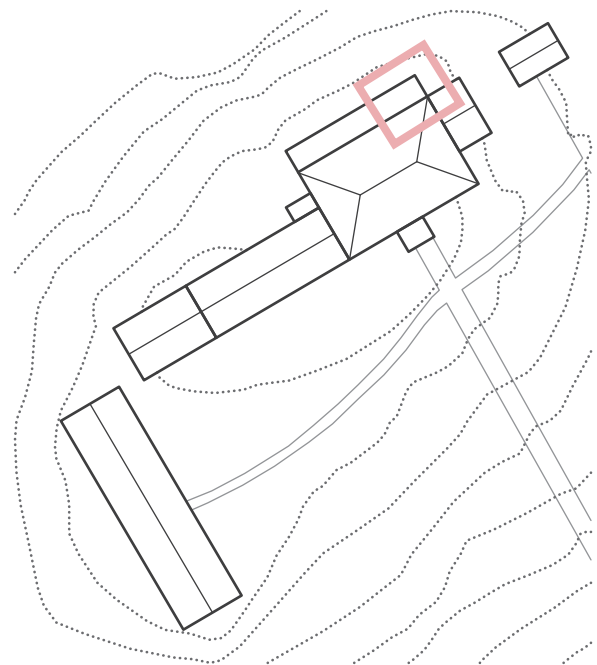
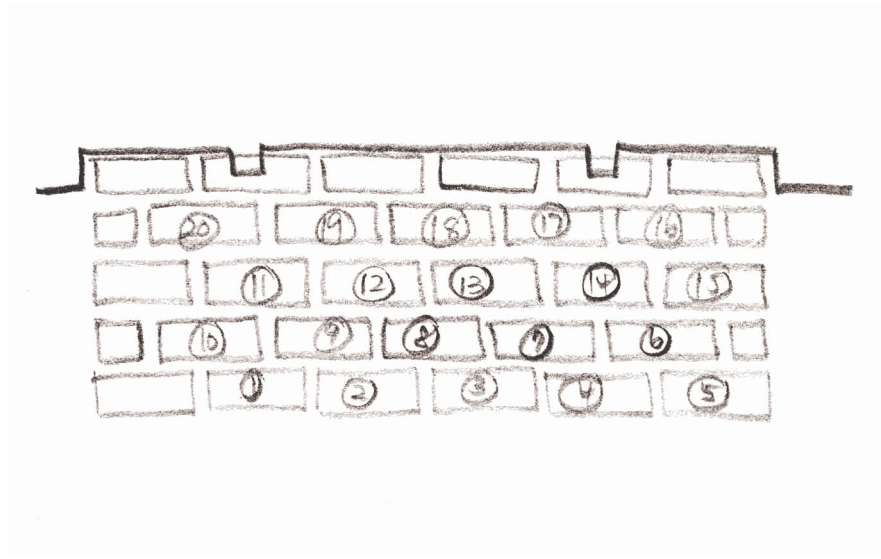
Main House Ground Floor, NW Hearth

BOND Running
FINISH Rubbed
DATE April 12, 2018 [Measure 21]
NOTES Currently study.
Documentary evidence in 1819 Annual Report describes a “shed” addition to the west [Northwest quadrant] of the existing 1790s building [Northeast quadrant]. No changes in brick appearance are visible in the outer hearth, though the inner hearth and firebox are completely blocked.

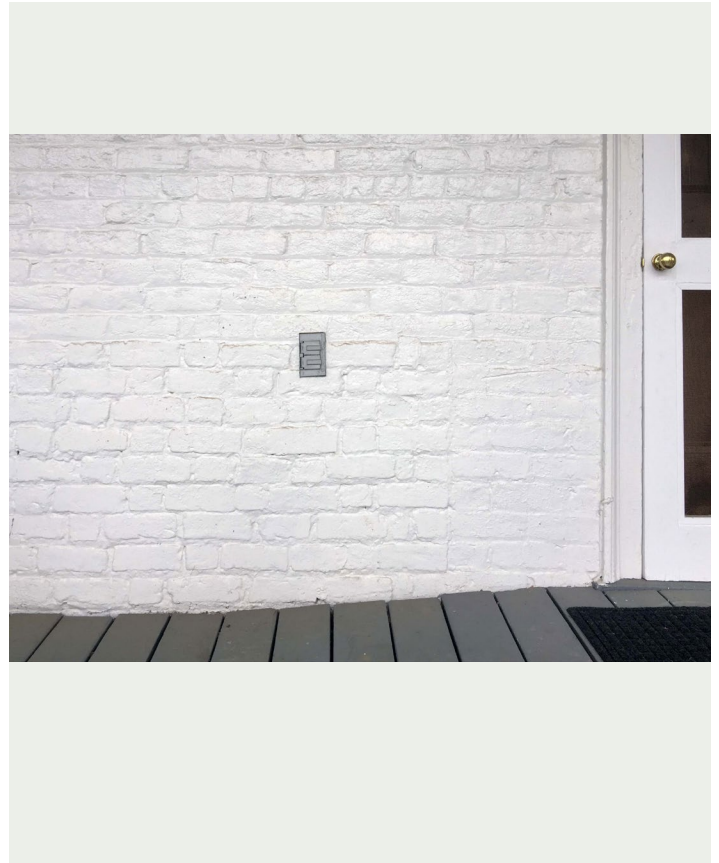
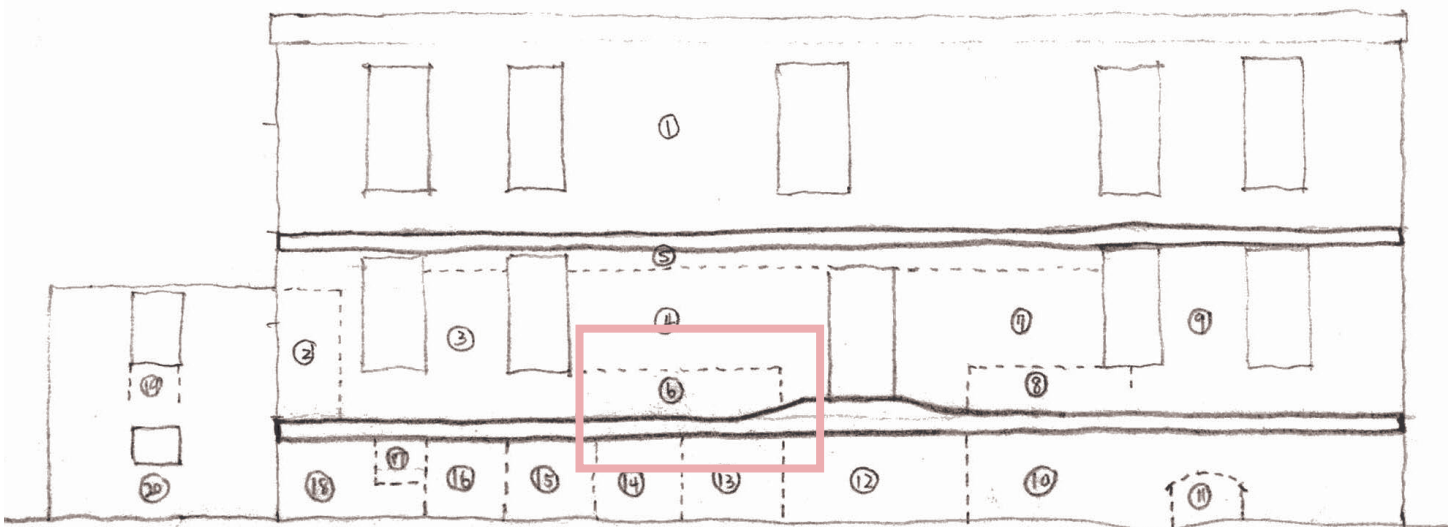
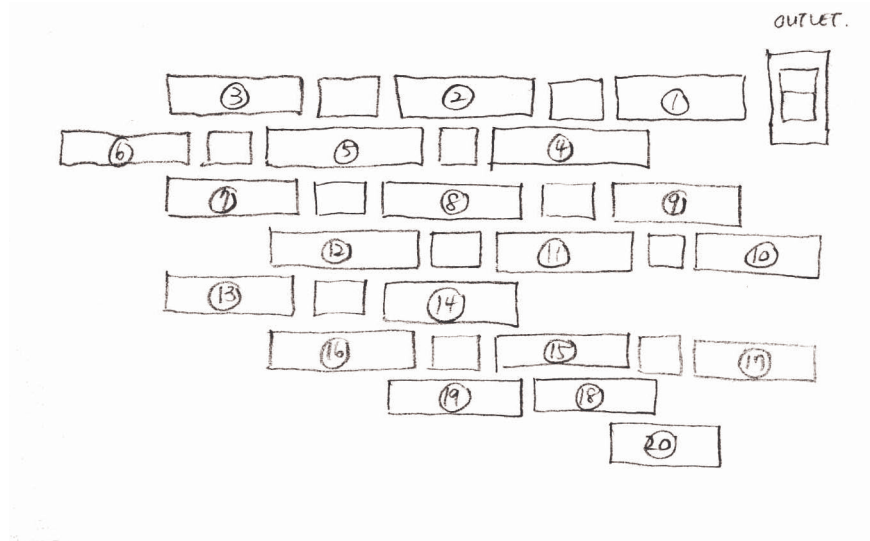
Main House West 6

BOND Flemish
FINISH Painted
DATE April 19, 2018 [Measure 29]
NOTES Only stretchers measured, left [North] of door above porch floor. Documentary evidence in 1819 Annual Report describes a “shed” addition to the west [Northwest quadrant] of the existing 1790s building [Northeast quadrant]. This Flemish bonded portion may be contemporary to or predate the 1819 shed addition as a garden wall. As the bricks are not capped in any way, it is also possible that a full building wall was demolished down to the current height and then incorporated into the later 1843 building campaign.

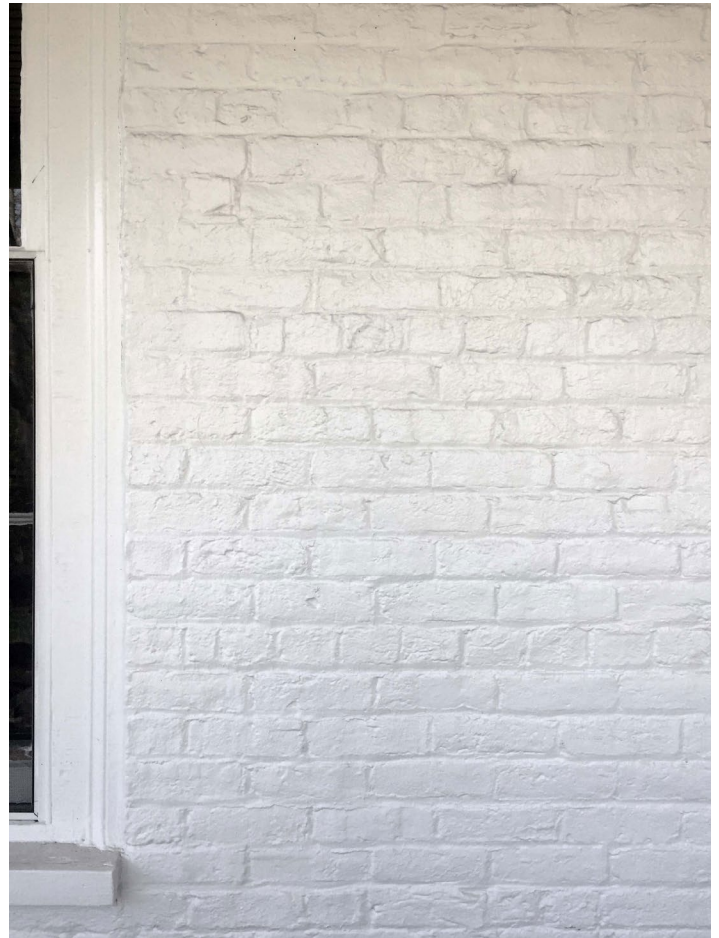
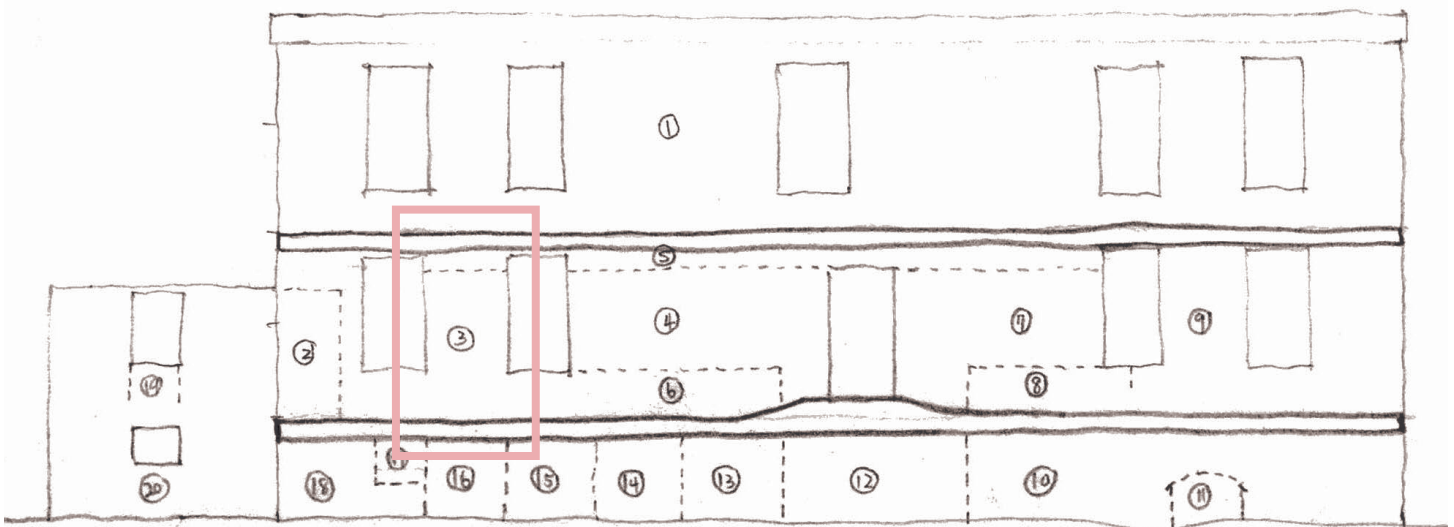
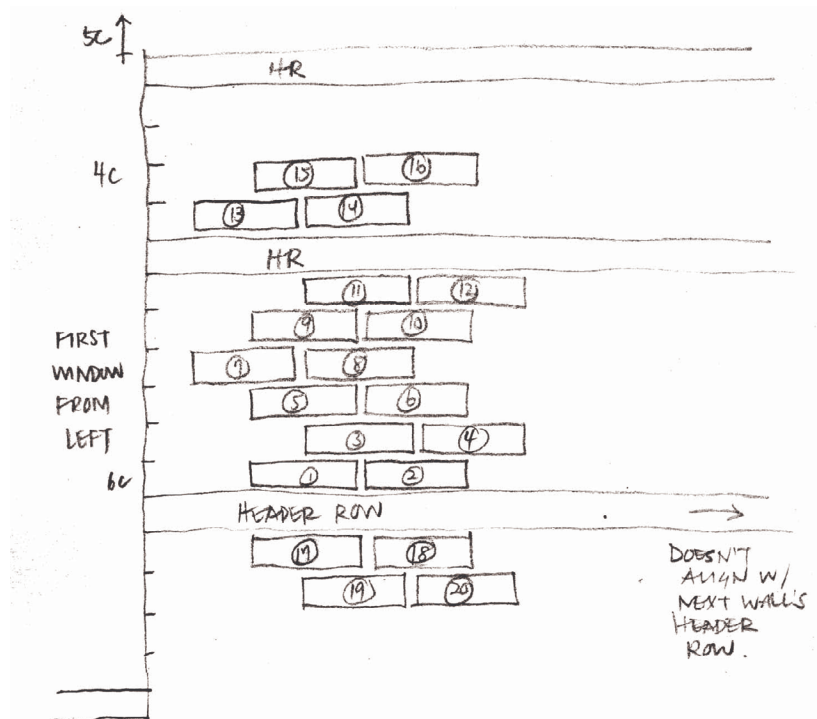
Main House West 3

BOND Uneven Common
FINISH Painted
DATE April 18, 2018 [Measure 27]
NOTES Documentary evidence in 1819 Annual Report describes a “shed” addition to the west [Northwest quadrant] of the existing 1790s building [Northeast quadrant]. The 1819 shed addition likely only remains in the Flemish bonded brick at the Northwest corner of the Main House. As this wall is constructed with Common bond, it may be part of the 1843 building campaign, when the shed addition [Northwest quadrant] was expanded to two stories.

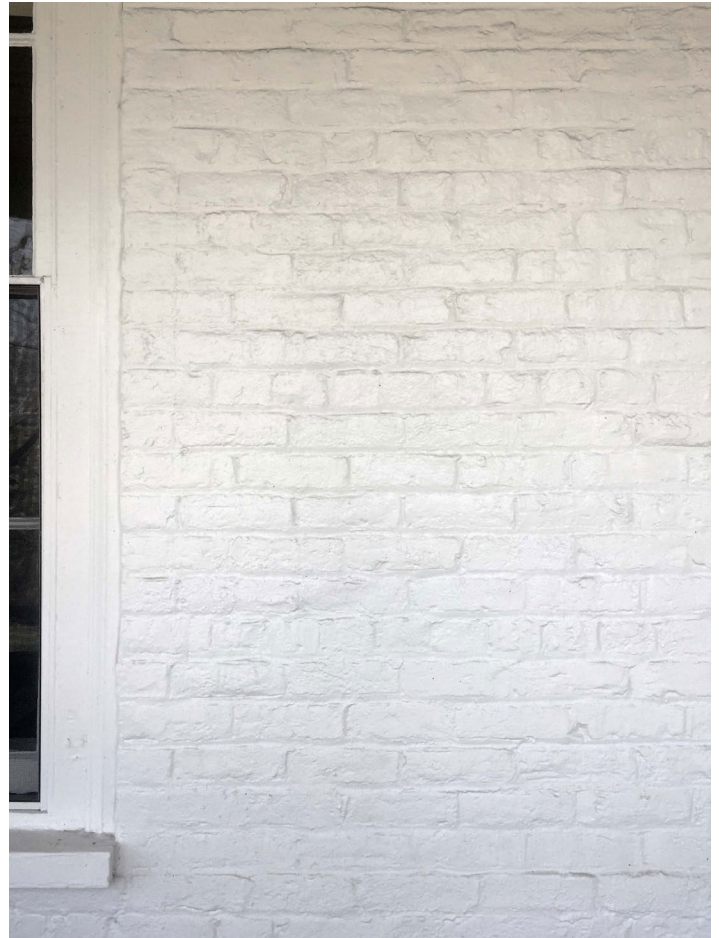
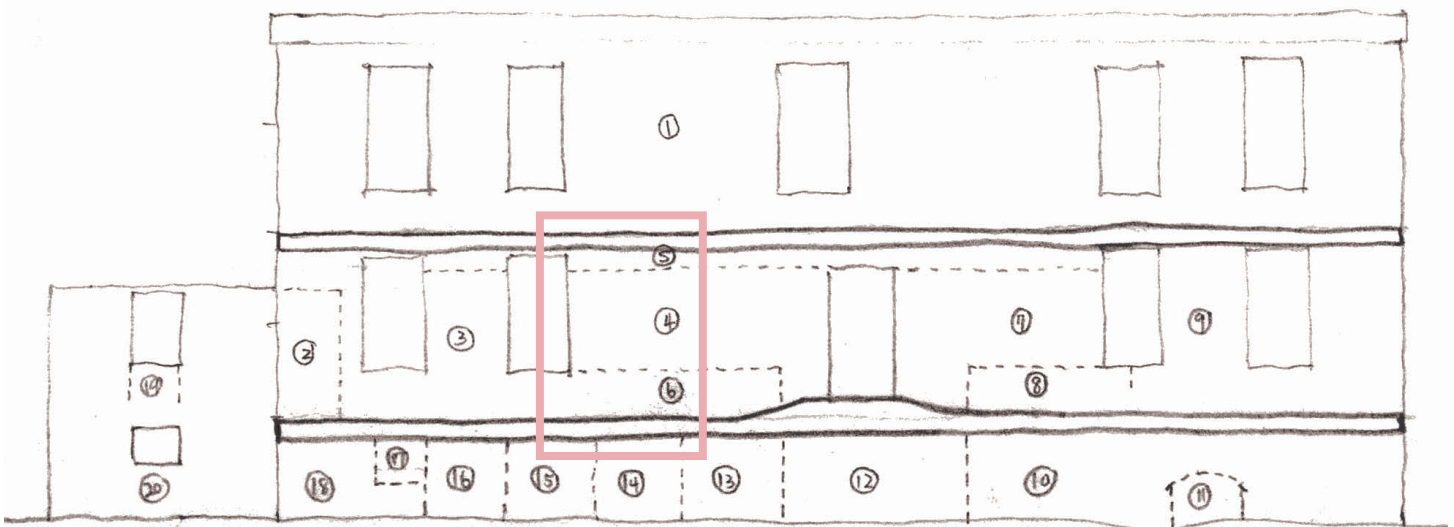
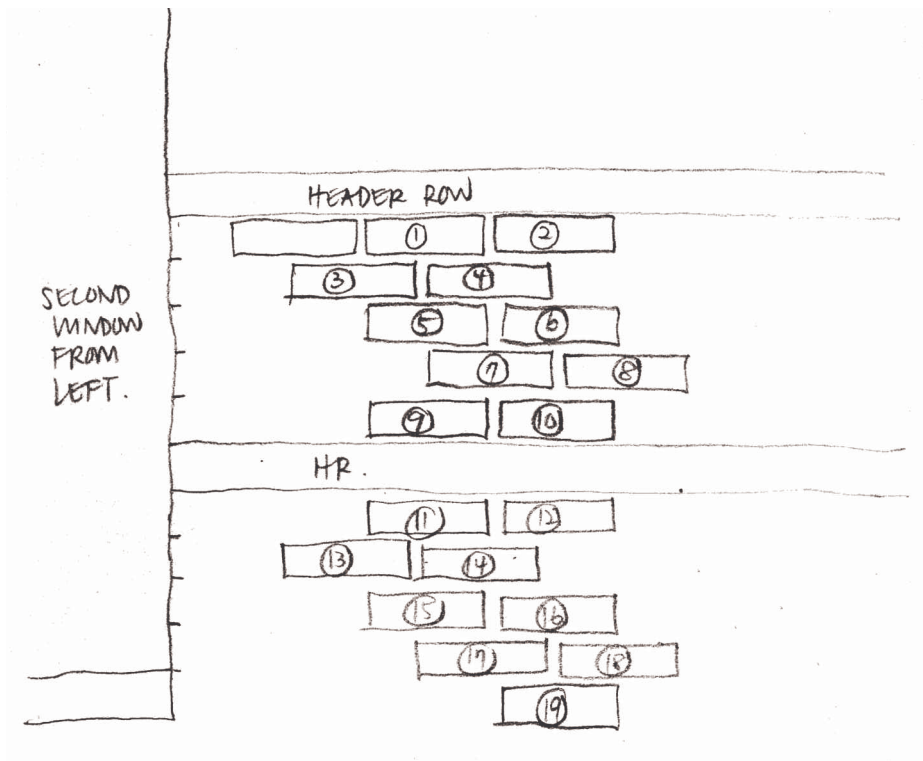
Main House West 4

BOND 5-course Common
FINISH Painted
DATE April 18, 2018 [Measure 26]
NOTES Documentary evidence in 1819 Annual Report describes a “shed” addition to the west [Northwest quadrant] of the existing 1790s building [Northeast quadrant]. The 1819 shed addition likely only remains in the Flemish bonded brick at the Northwest corner of the Main House. As this wall is constructed with Common bond, it may be part of the 1843 building campaign, when the shed addition [Northwest quadrant] was expanded to two stories.
