MONROE HILL BRICK ANALYSIS

Aisha Sawatsky
ARH 5604 Field Methods in Historic Preservation
Louis P. Nelson, University of Virginia
May 13, 2018

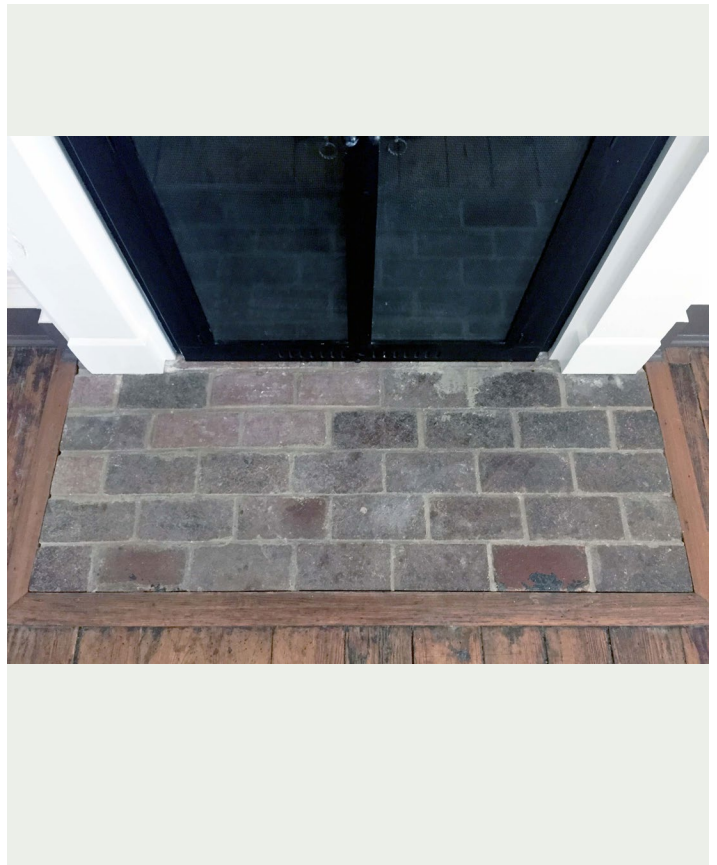
Main House Upper Floor, NE Hearth

BOND Running
FINISH Rubbed
DATE April 12, 2018 [Measure 18]
NOTES Currently master bedroom.
Documentary evidence of a significant expansion from 1822–1825 likely consisted of a second floor over the original 1790s construction [Northeast quadrant].
Some bricks appear to have been replaced in the outer hearth, the newer bricks possibly are those with a lighter color tone.

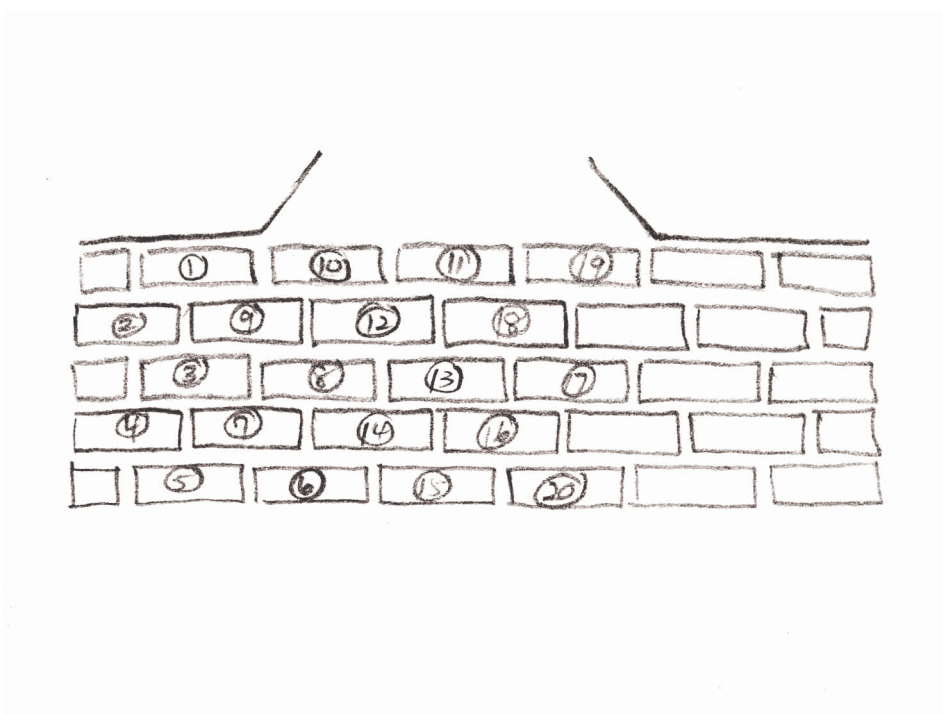
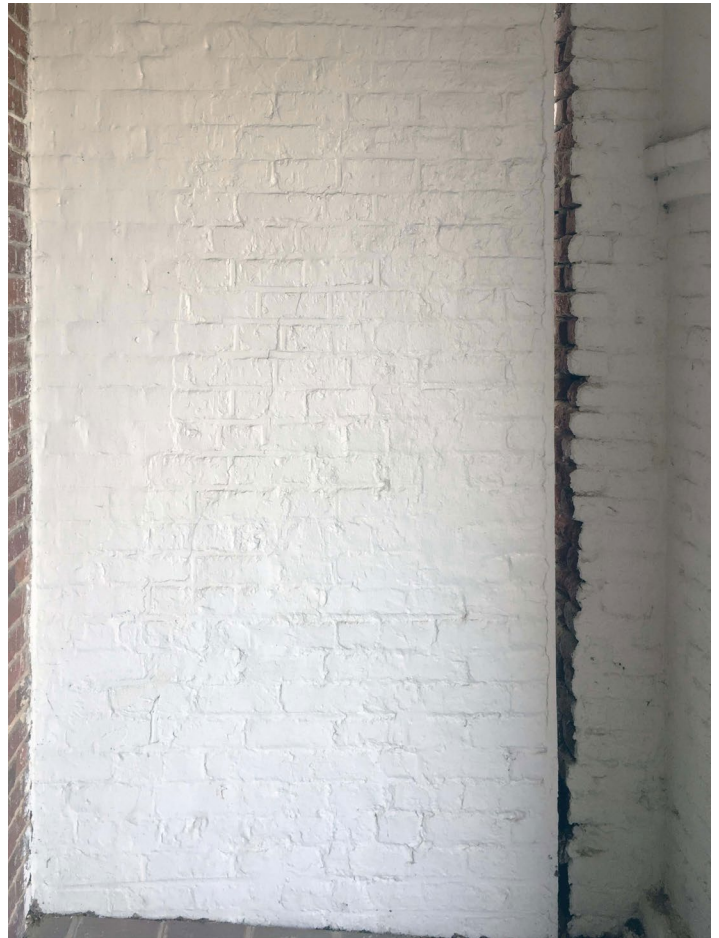
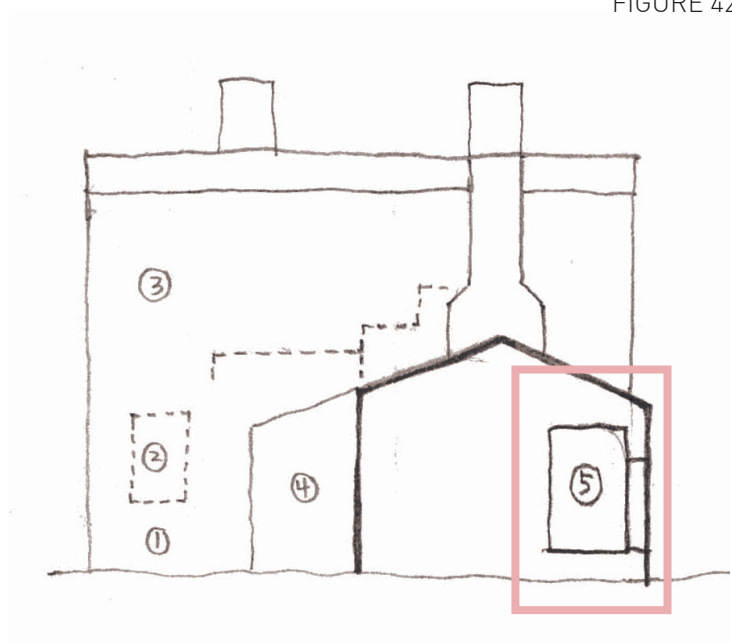
Main House South 5

BOND Unknown
FINISH Part plaster; all painted
DATE April 12, 2018 [Measure 23]
NOTES East end of Short Range arcade.
This wall is the only portion on the front half of the Main House that is not covered with render. Documentary evidence of a significant expansion from 1822–1825 likely consisted of a second floor over the original 1790s construction [Northeast quadrant] and a single-story addition towards the south [Southeast quadrant]. Due to overlapping constructions, this wall predates the Short Range (1848–1849).

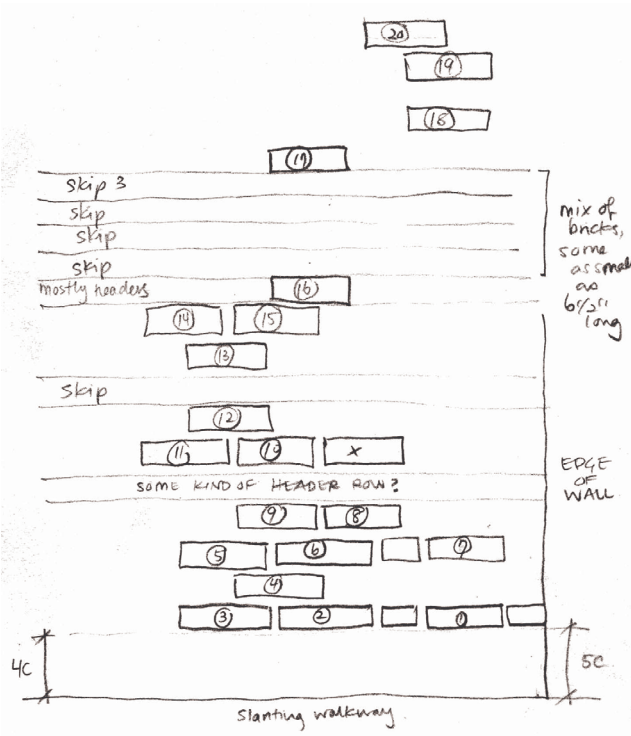
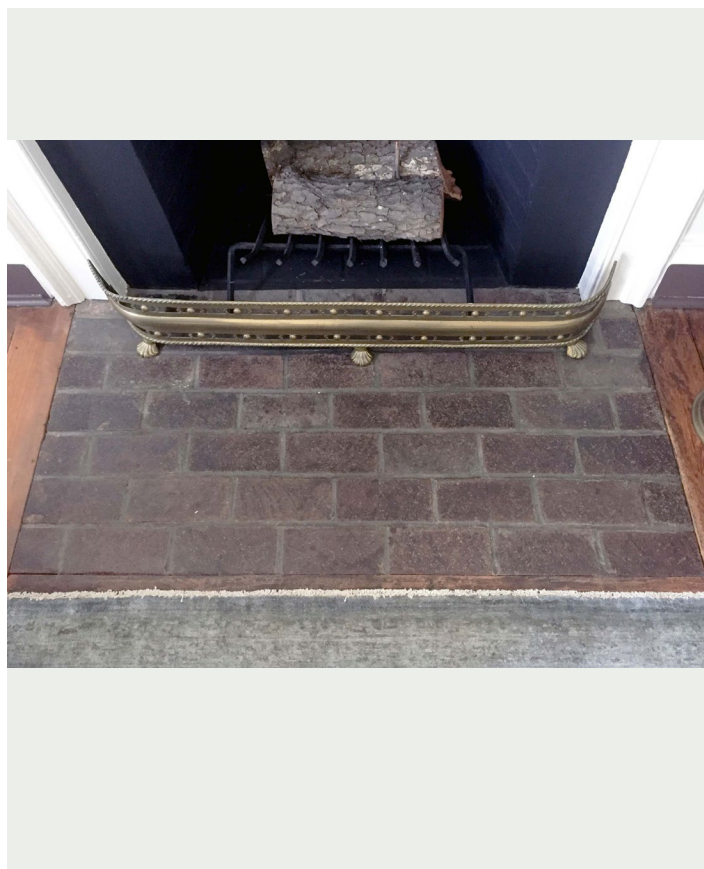
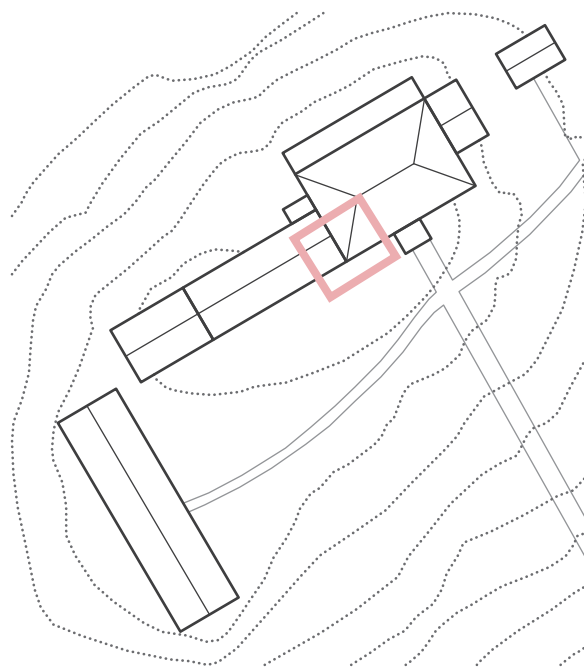
Main House Ground Floor, SE Hearth

| BOND | Running |
| NOTES | Currently front room. Documentary evidence of a significant expansion from 1822–1825 likely consisted of a second floor over the original 1790s construction [Northeast quadrant] and a single-story addition towards the south [Southeast quadrant]. No changes in brick are visible in the outer hearth, though the bricked-in firebox is likely a later construction. |

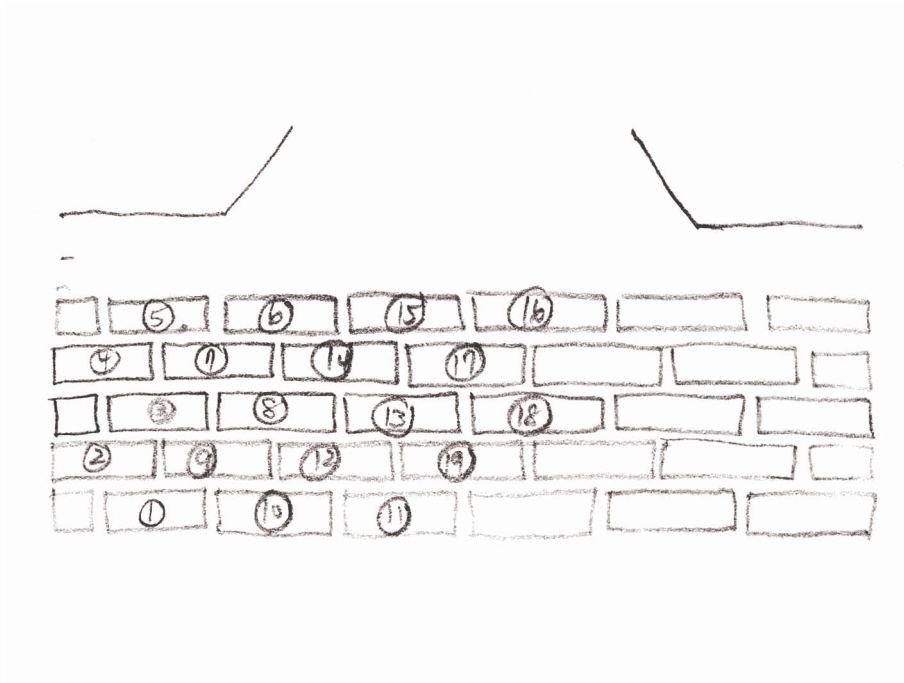
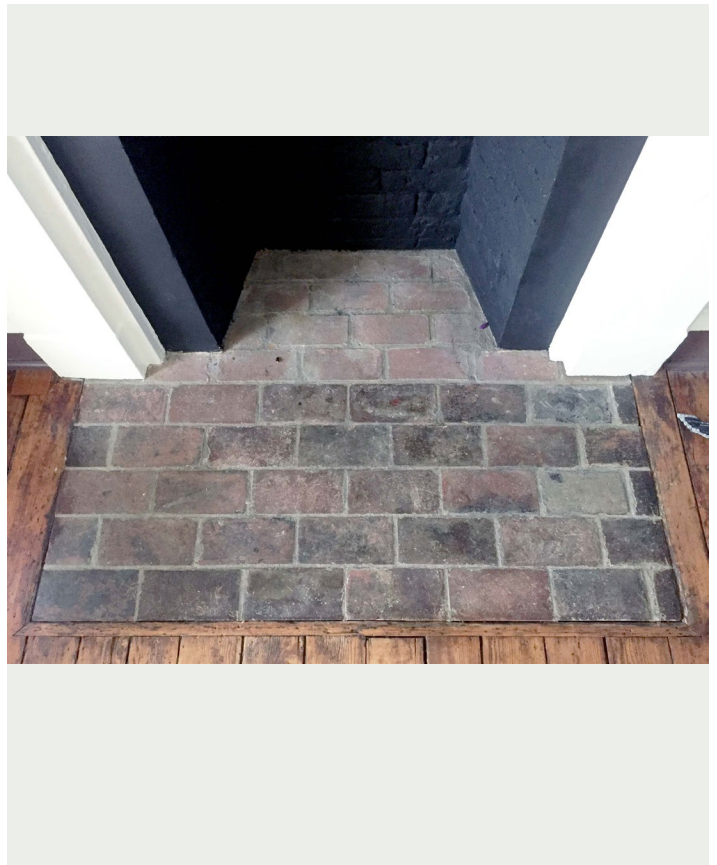
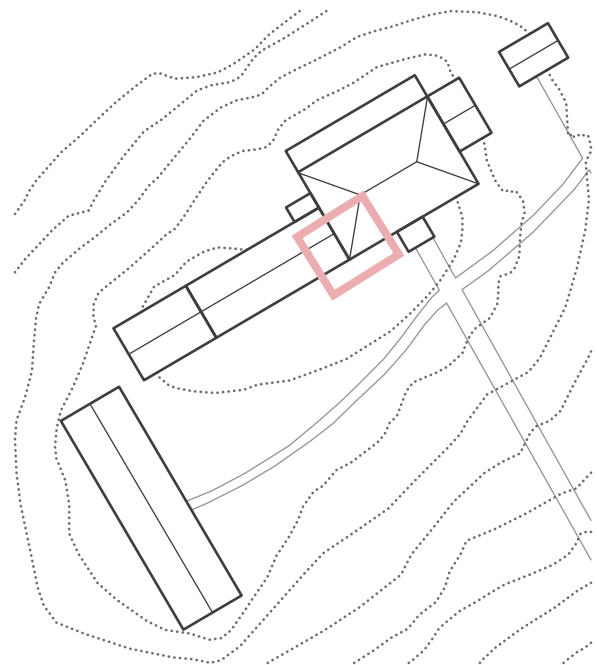
Main House Upper Floor, SE Hearth

BOND Running
FINISH Rubbed
DATE April 12, 2018 [Measure 15]
NOTES Currently boys' room.
Documentary evidence dates the front portico addition to January 1842, therefore the second floor across the front of the Main House must be completed by this time.
The firebox is currently bricked in, and there is a marked change in brick appearance between the inner hearth and the outer hearth. Possibly, the firebox and inner hearth are constructed simultaneously, at a later period to the outer hearth.

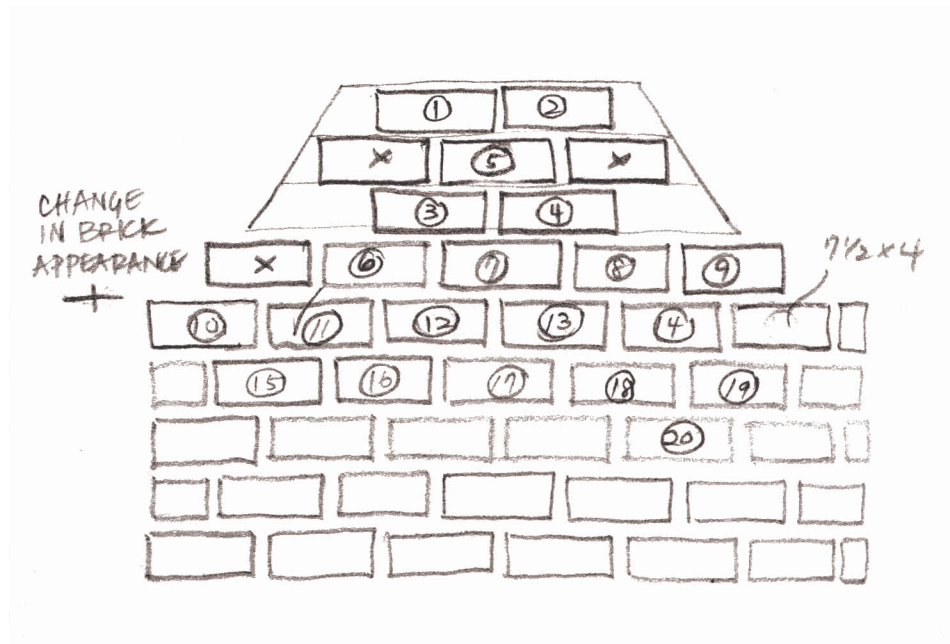
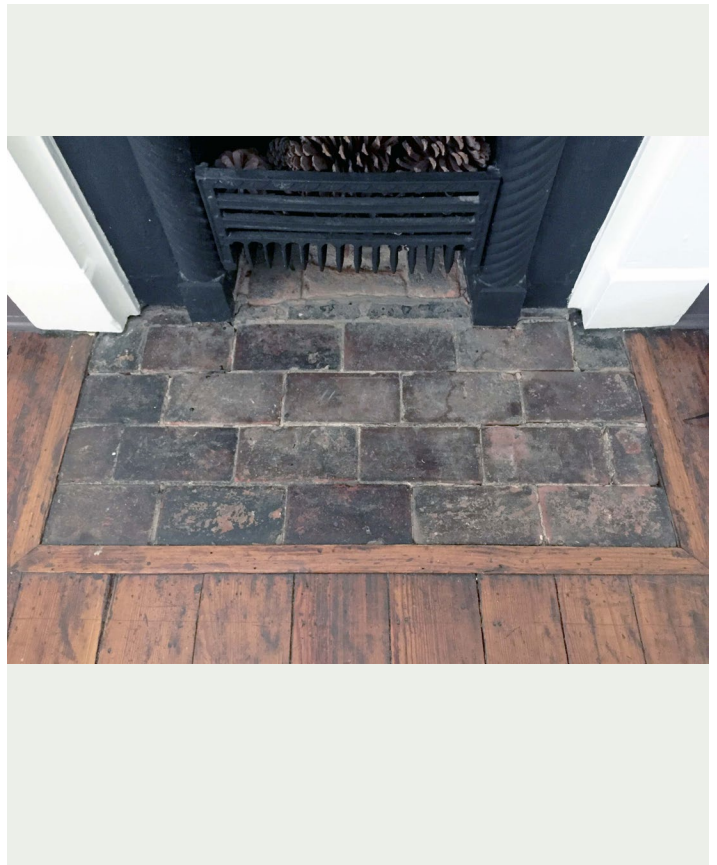
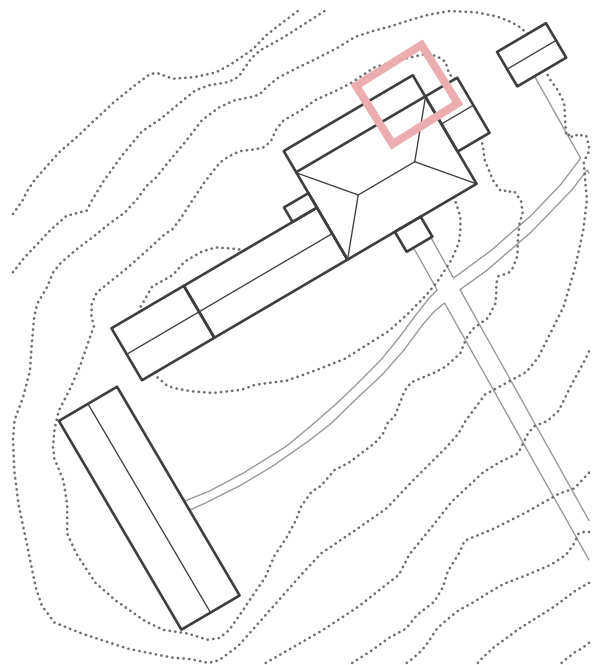
Main House Upper Floor, NW Hearth

BOND Running
FINISH Rubbed
DATE April 12, 2018 [Measure 17]
NOTES Currently master bathroom.
Documentary evidence suggests that this Northwest quadrant is the second-floor expansion to the existing “shed” addition that was completed as part of an 1843 building campaign.
No changes in brick are visible in the hearth, though the firebox and any possible changes in its masonry are blocked by an insert.

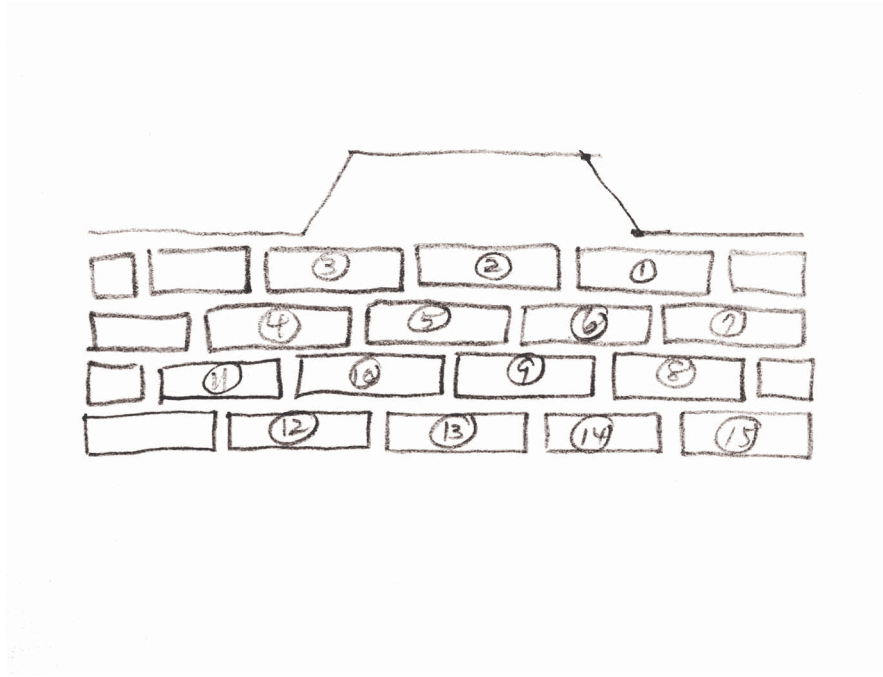
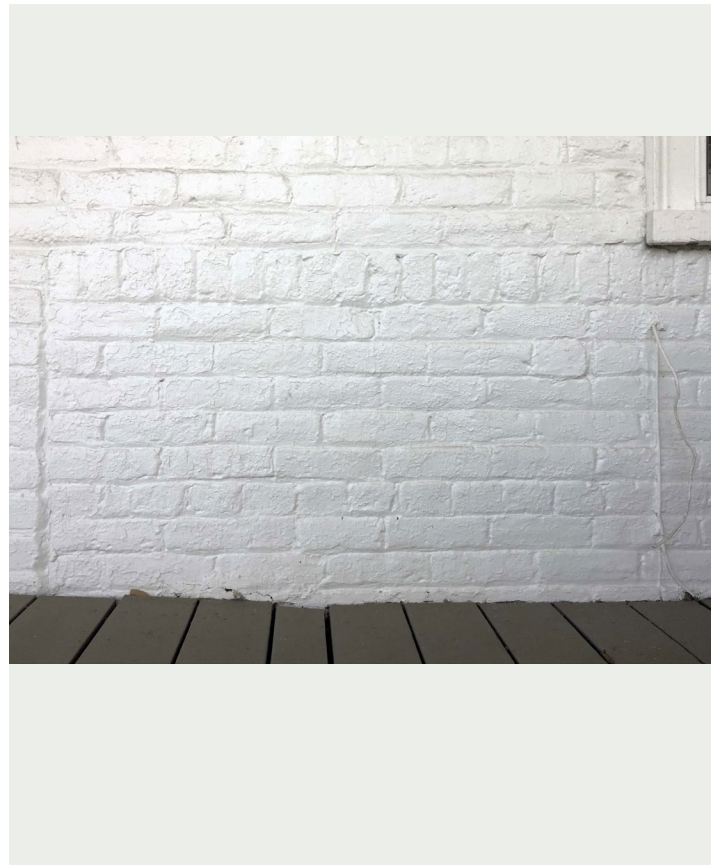
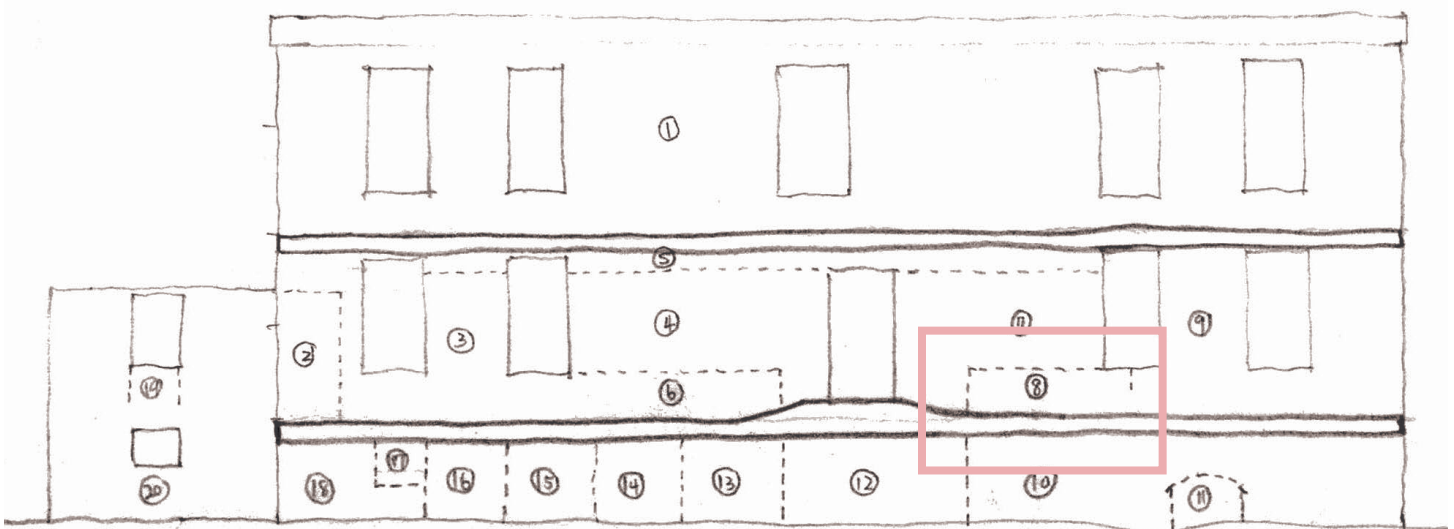
Main House West 8

BOND 5-course Common
FINISH Painted
DATE April 18, 2018 [Measure 28]
NOTES Soldier course, possibly from a preexisting garden wall that was incorporated into the Main House.
Documentary evidence suggests that the Southwest quadrant of the Main House is part of an 1843 building campaign, when the existing “shed addition” [Northwest quadrant] was expanded to two stories with a 1.5-shed addition beside to complete a rectangular footprint. This garden wall likely predates the 1843 building campaign.

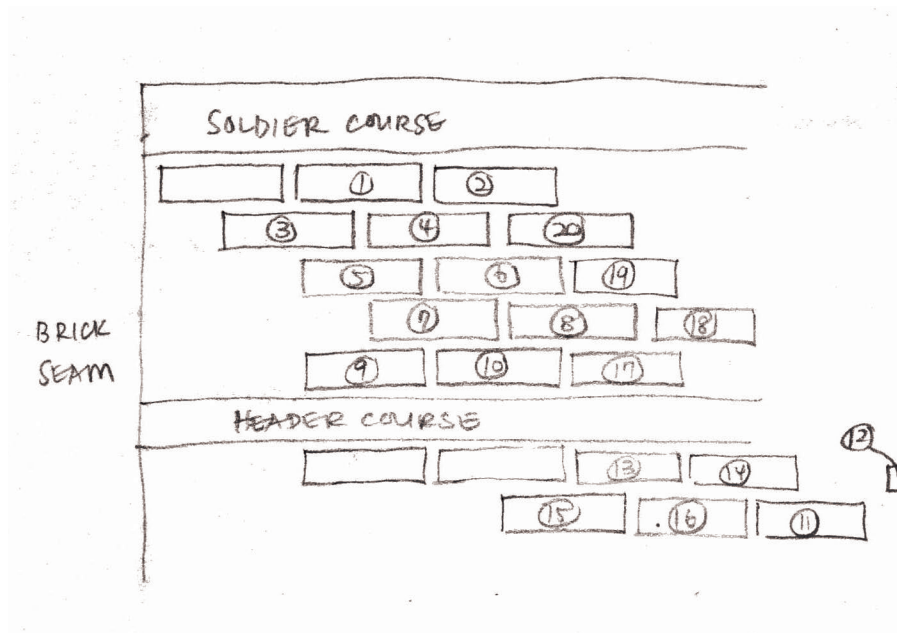
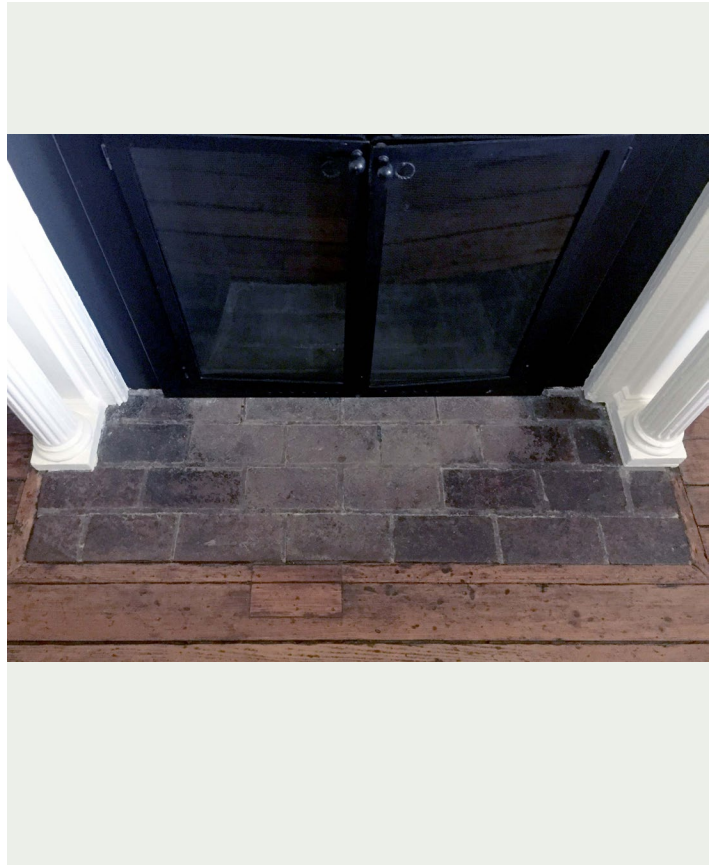
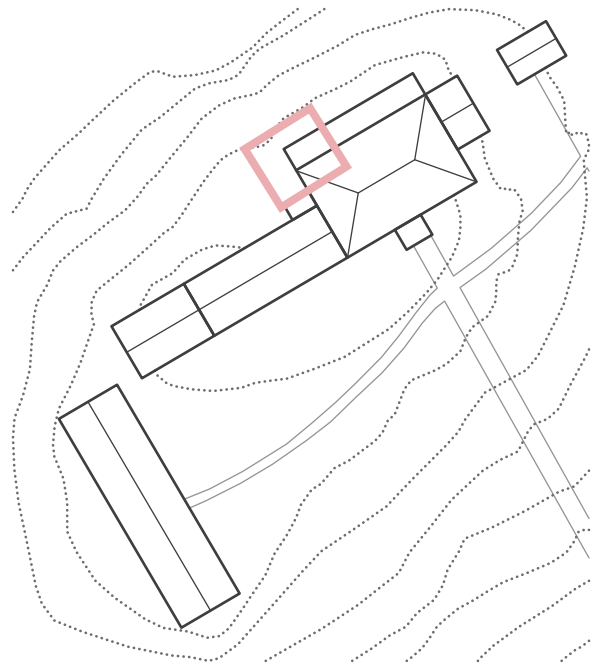
Main House Ground Floor, SW Hearth

BOND Running
FINISH Rubbed
DATE April 12, 2018 [Measure 20]
NOTES Currently back room.
Documentary evidence suggests that this Southwest quadrant of the Main House is part of an 1843 building campaign, when the existing “shed addition” [Northwest quadrant] was expanded to two stories with a 1.5-shed addition beside to complete a rectangular footprint. No changes in brick appearance are visible in the inner or outer hearths.

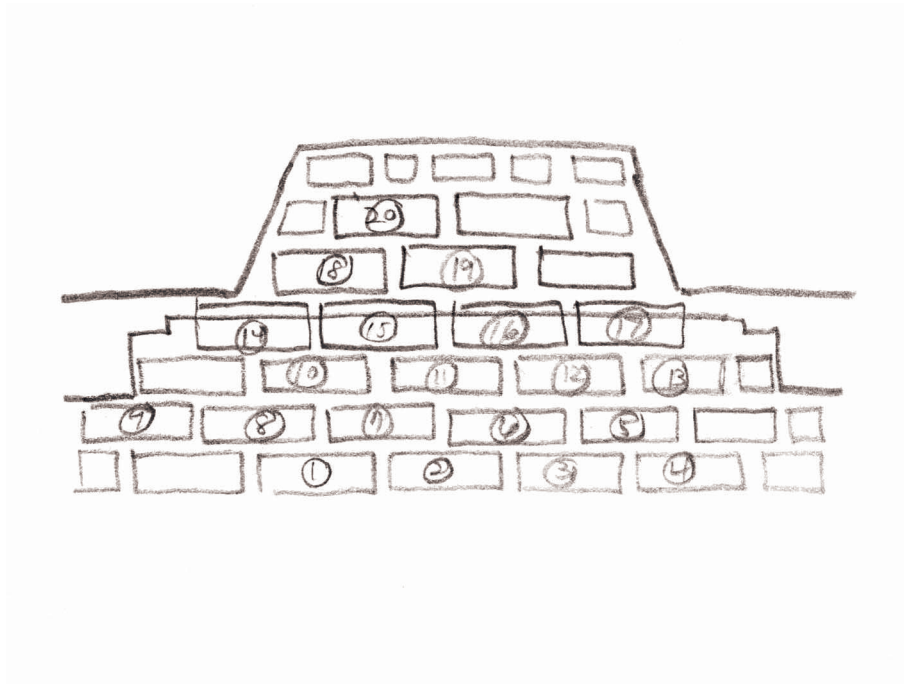
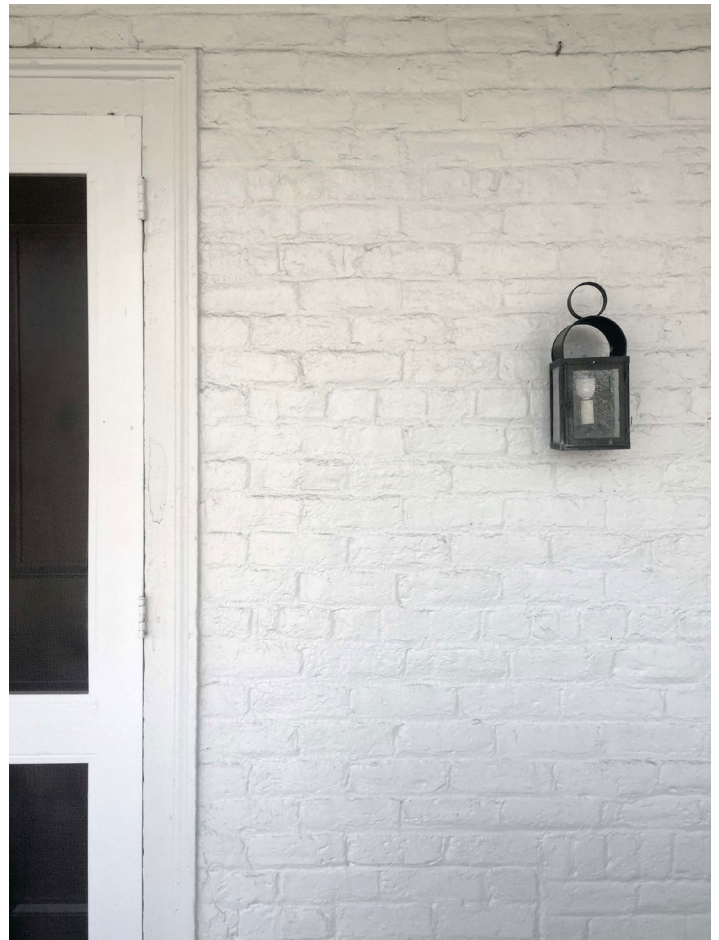
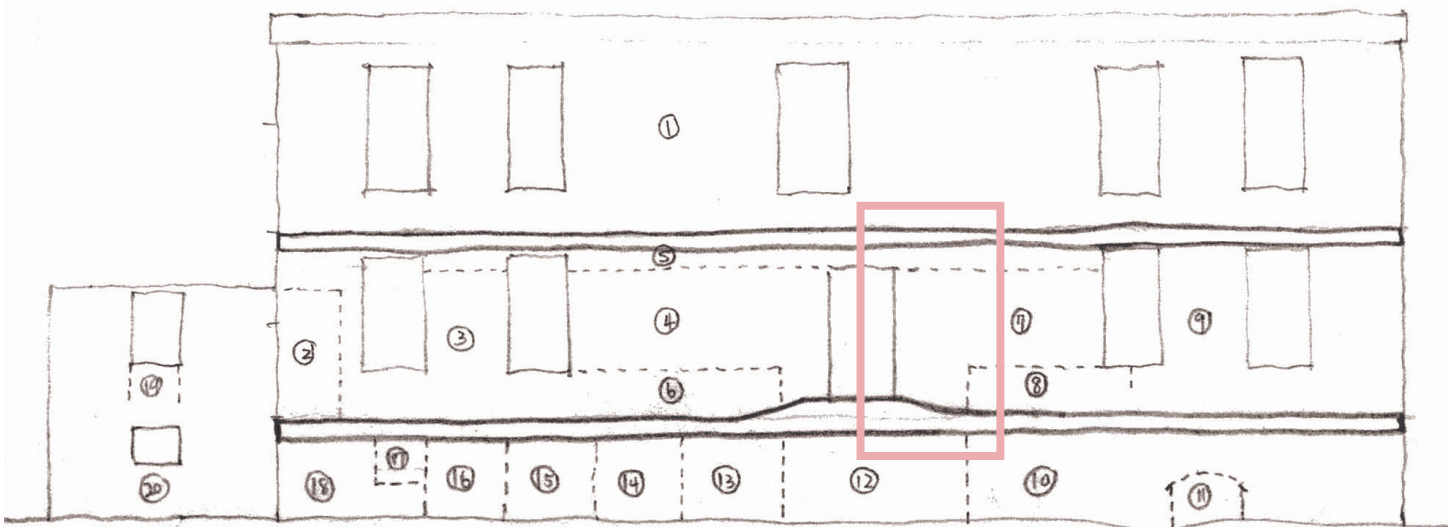
Main House West 7

BOND 5-course Common
FINISH Painted
DATE April 18, 2018 [Measure 25]
NOTES Documentary evidence suggests that the Southwest quadrant of the Main House is part of an 1843 building campaign, when the existing “shed addition” [Northwest quadrant] was expanded to two stories with a 1.5-shed addition beside to complete a rectangular footprint. Visible seams in the brick construction could indicate that the Southwest quadrant was constructed in separate building campaigns [see sketch for seam locations].

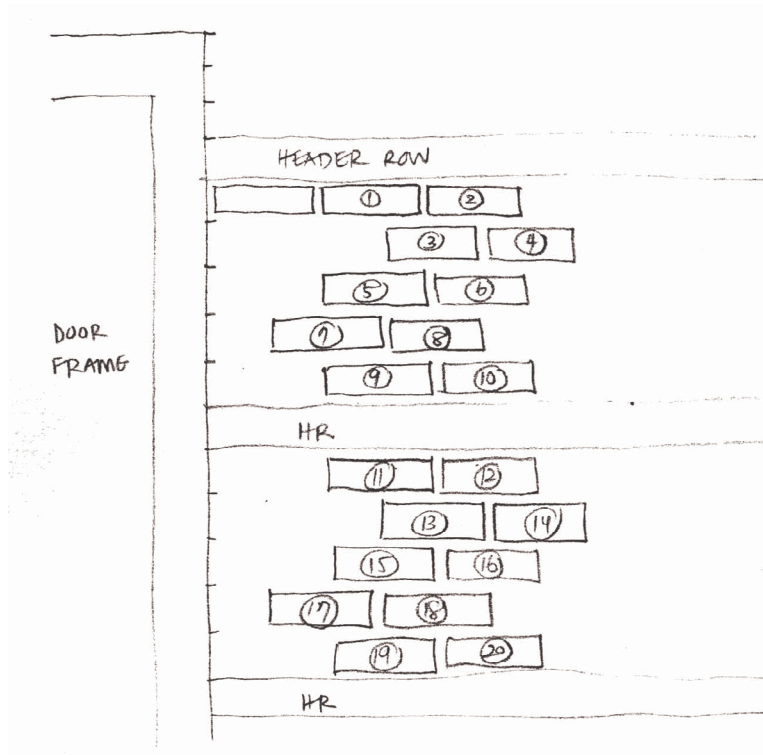
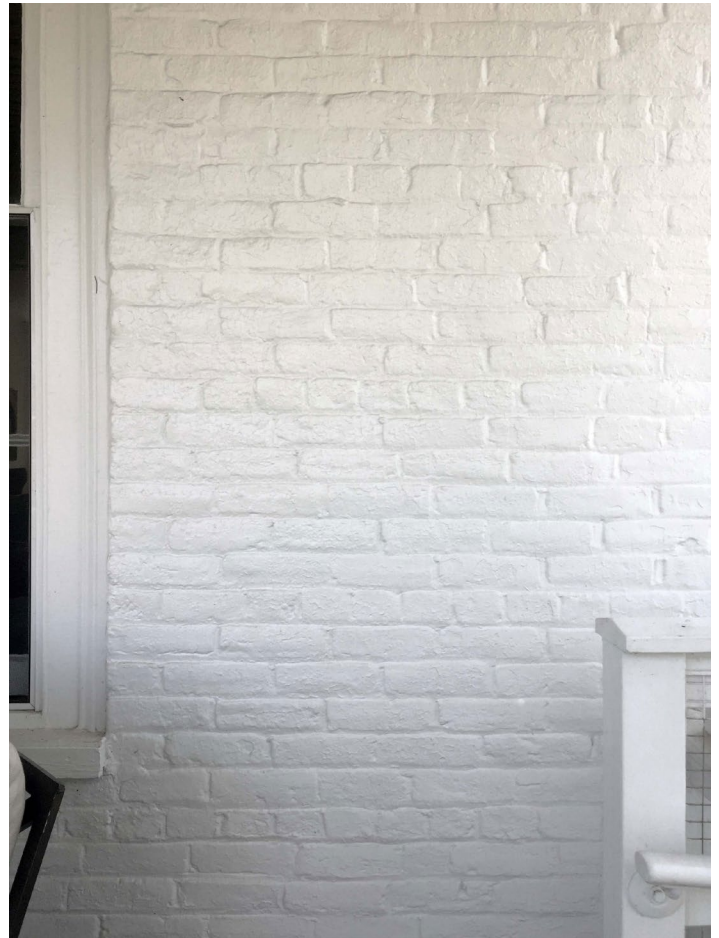
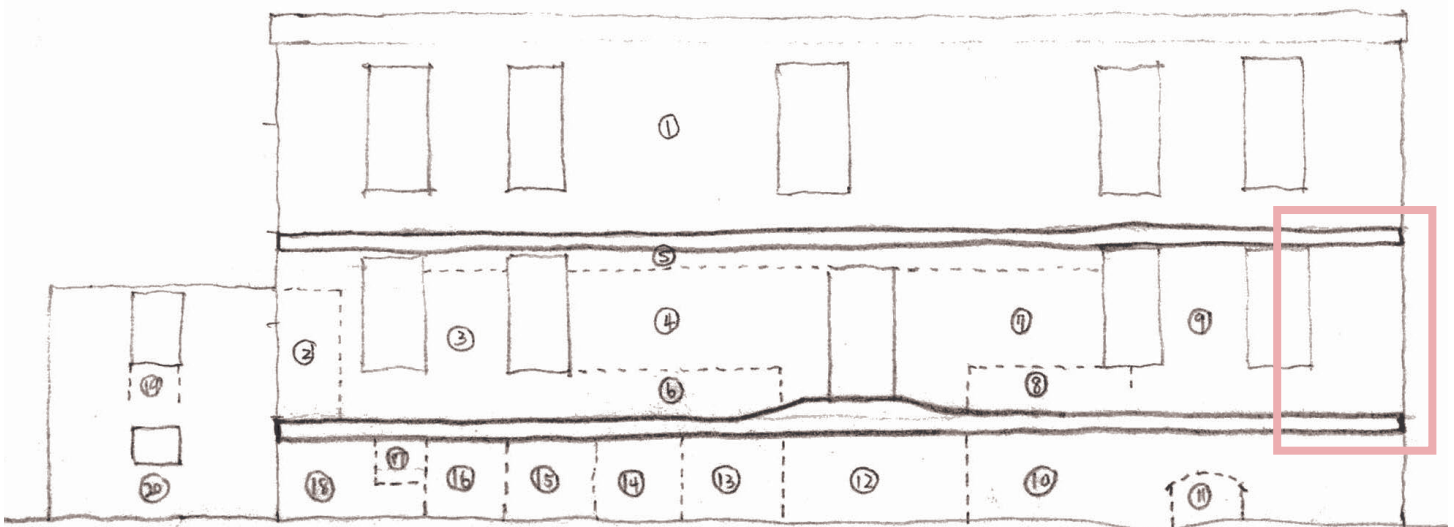
Main House West 9

BOND 5-course Common
FINISH Painted
DATE April 18, 2018 [Measure 24]
NOTES Wall right of fourth window from left [North].
Documentary evidence suggests that this Southwest quadrant of the Main House is part of an 1843 building campaign, when the existing “shed addition” [Northwest quadrant] was expanded to two stories with a 1.5-shed addition beside to complete a rectangular footprint. Due to overlapping constructions, this wall predates the lean-to addition (pre-1870s) but not necessarily the Short Range (1848–1849).

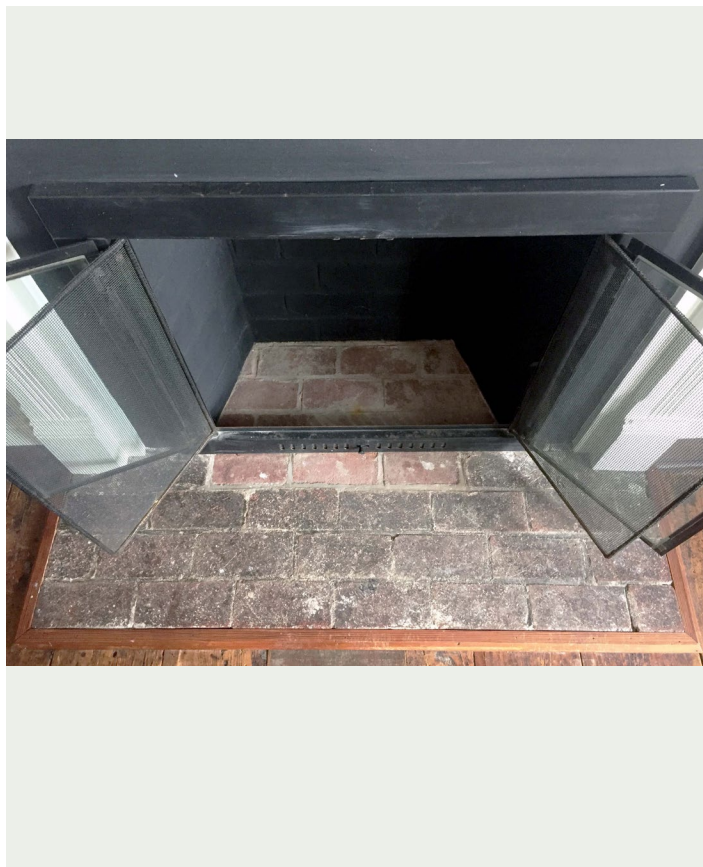
Main House Upper Floor, SW Hearth

BOND Running
FINISH Rubbed
DATE April 12, 2018 [Measure 16]
NOTES Currently Girl's room.
Documentary evidence dates the completed two-story rear of the house to after 1866, when Proctor Venable requested funds to pursue such construction. The firebox is currently bricked in, and there is a marked change in brick appearance between the inner hearth and the outer hearth. Possibly, the firebox and inner hearth are constructed simultaneously, at a later period to the outer hearth.

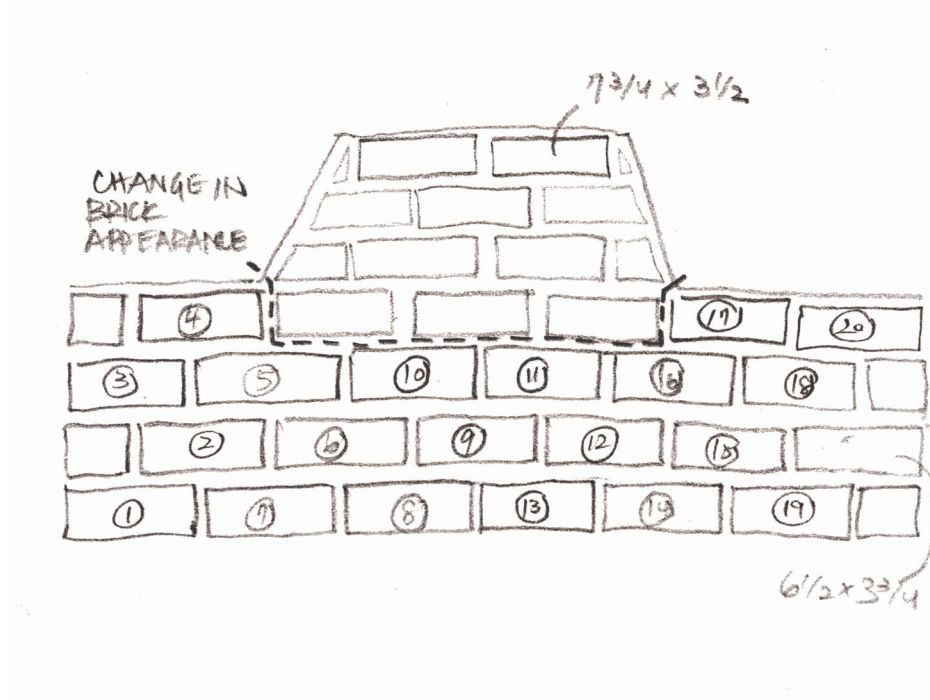
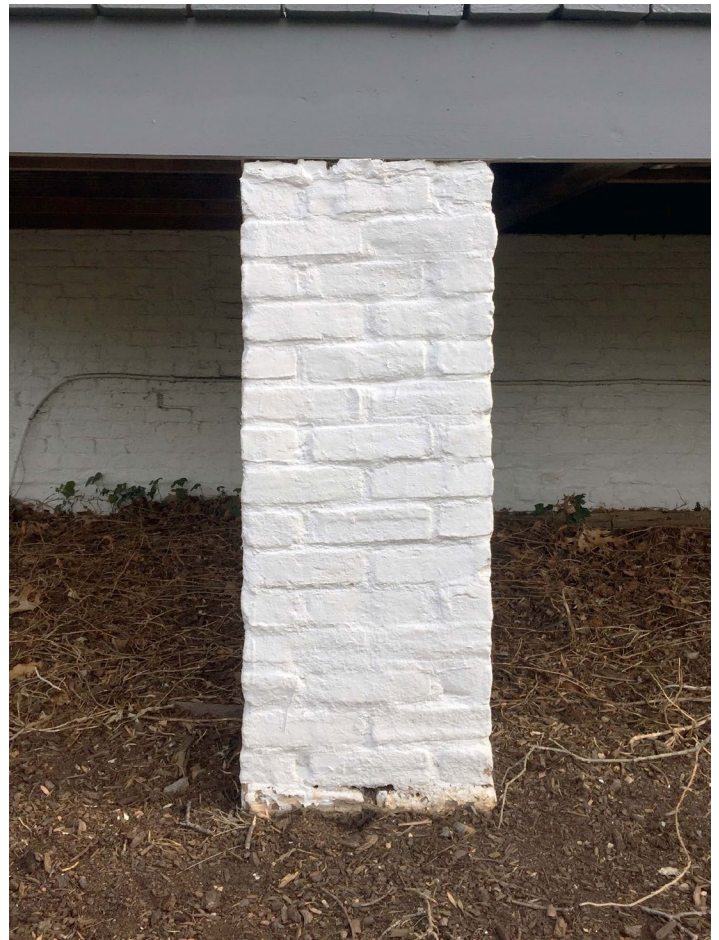
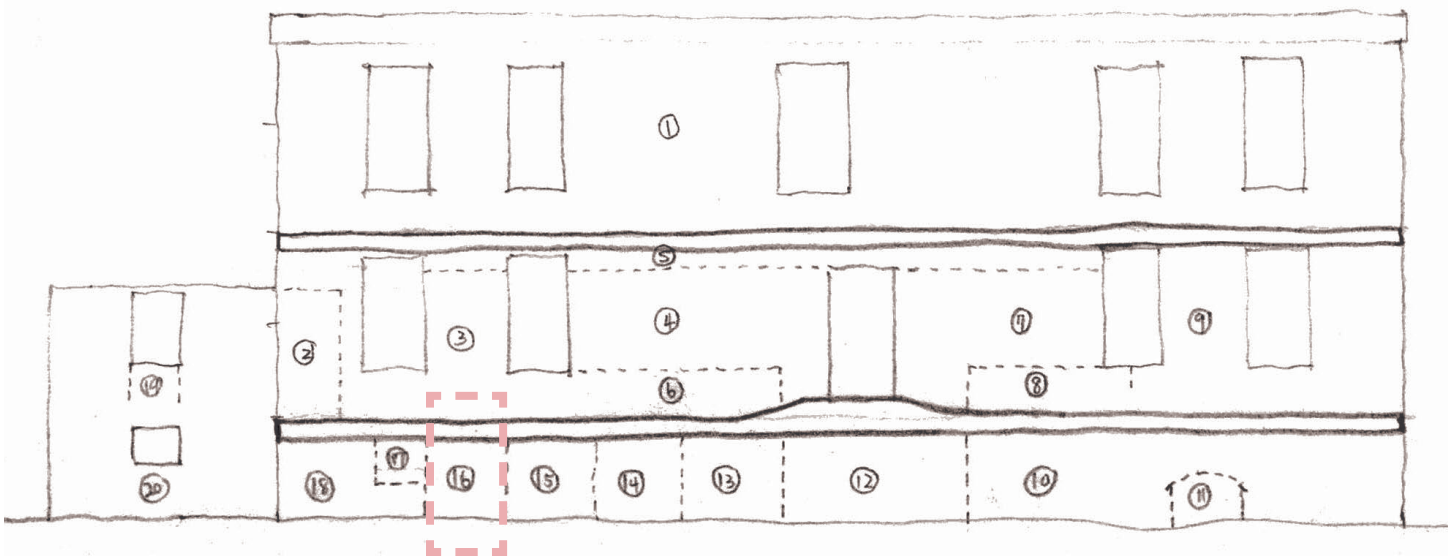
Main House West Pier

BOND Running
FINISH Painted
DATE April 6, 2018 [Measure 11]
NOTES Second porch pier from left [North].
Proctor Thomas Price requested funds for constructing front and rear porches in 1877, following up with another request in 1879. 1896 Sanborn map shows a rear porch of some kind, which disappears in the 1907 map and is not drawn again in any later editions.

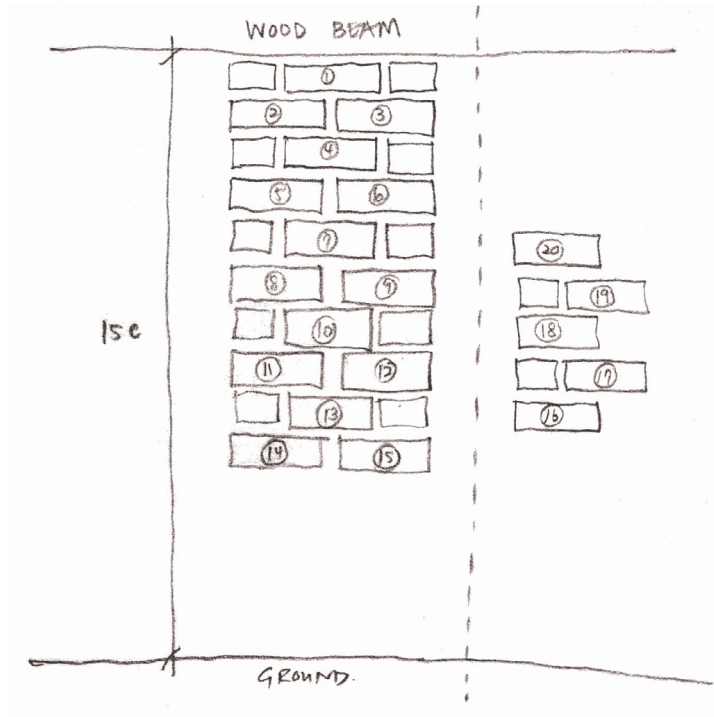
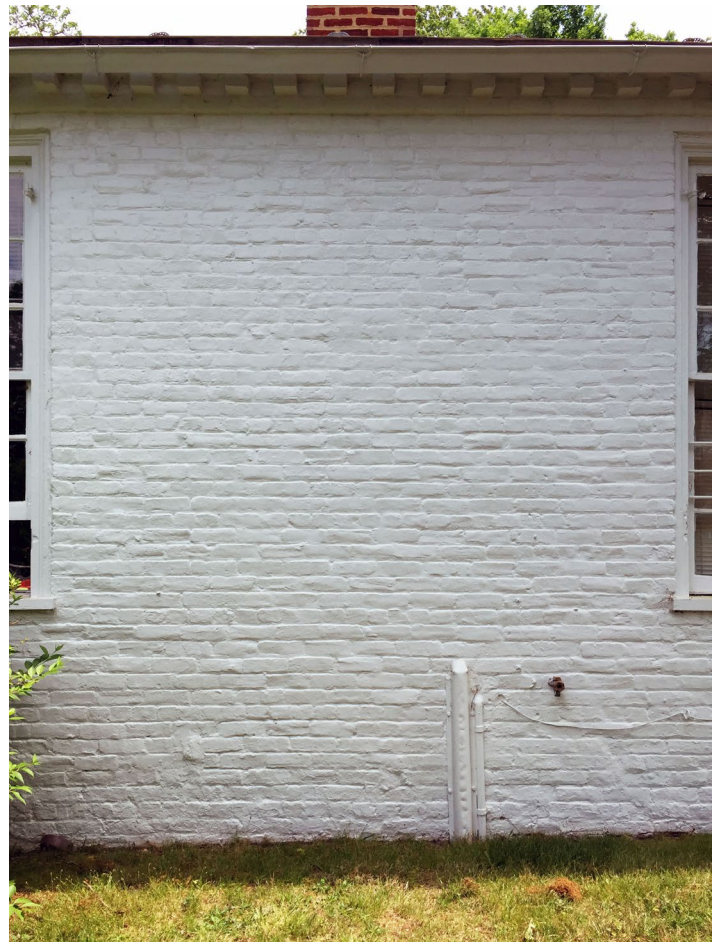
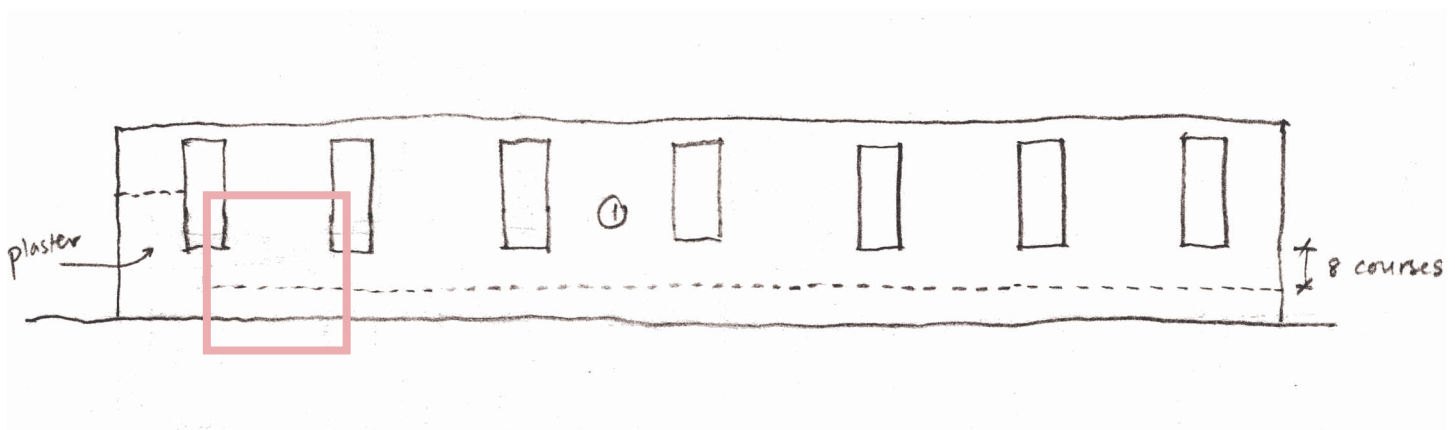
Long Range South 1

BOND 5-course Common
FINISH Painted
DATE April 6, 2018 [Measure 12]
NOTES Wall between first and second windows from left [West].
Both Ranges date to 1848–1849, from documentary evidence of payment to George W. Spooner for construction of state student dormitories between July 1848 and January 1849.

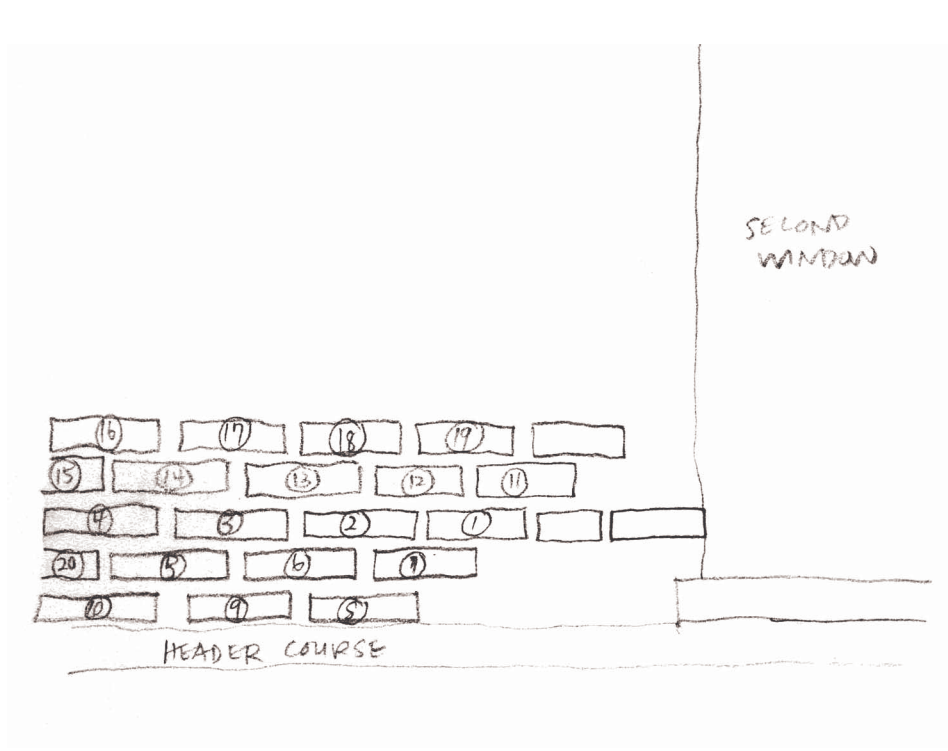
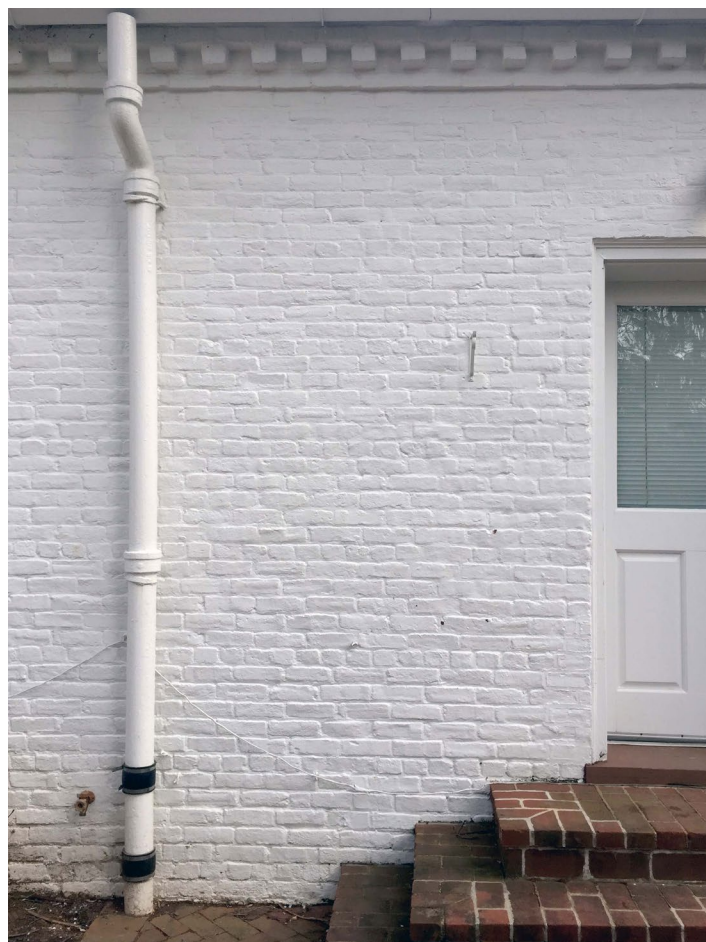
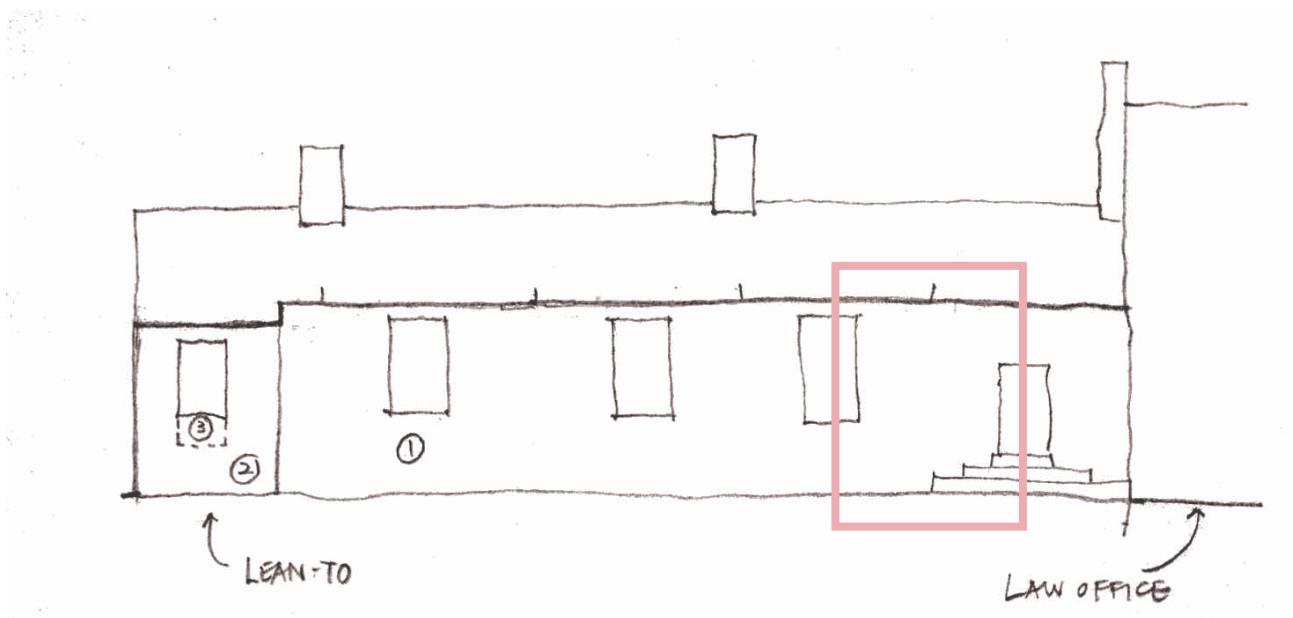
Short Range West 1

BOND 5-course Common
FINISH Painted
DATE April 6, 2018 [Measure 10]
NOTES Both Ranges date to 1848–1849, from documentary evidence of payment to George W. Spooner for construction of state student dormitories between July 1848 and January 1849.
