MONROE HILL BRICK ANALYSIS

Aisha Sawatsky
ARH 5604 Field Methods in Historic Preservation
Louis P. Nelson, University of Virginia
May 13, 2018

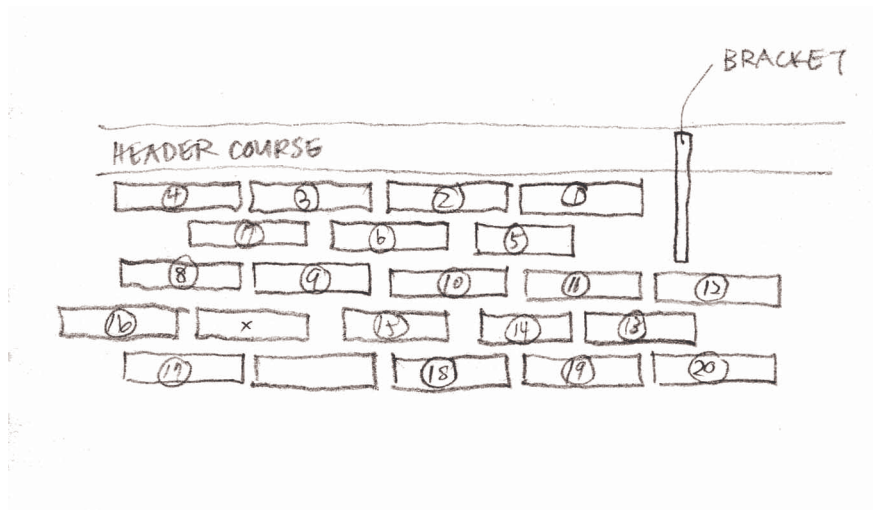
FIGURE 80

Short Range South 4

BOND 5-course Common
FINISH Painted
DATE April 6, 2018 [Measure 9]
NOTES Lean-to addition on West side of the Short Range.
Available maps show this addition from the 1870s [Anonymous map of the Academical Village ca. 1872–1876]. The addition is shown continuous with the Short Range rooms in the following map dates: 1872–1876, 1896, 1902, 1909. The addition is shown continuous with the Main House during: 1895, 1907, 1913, 1920, 1929. Currently, the addition is shown continuous with the Range rooms.

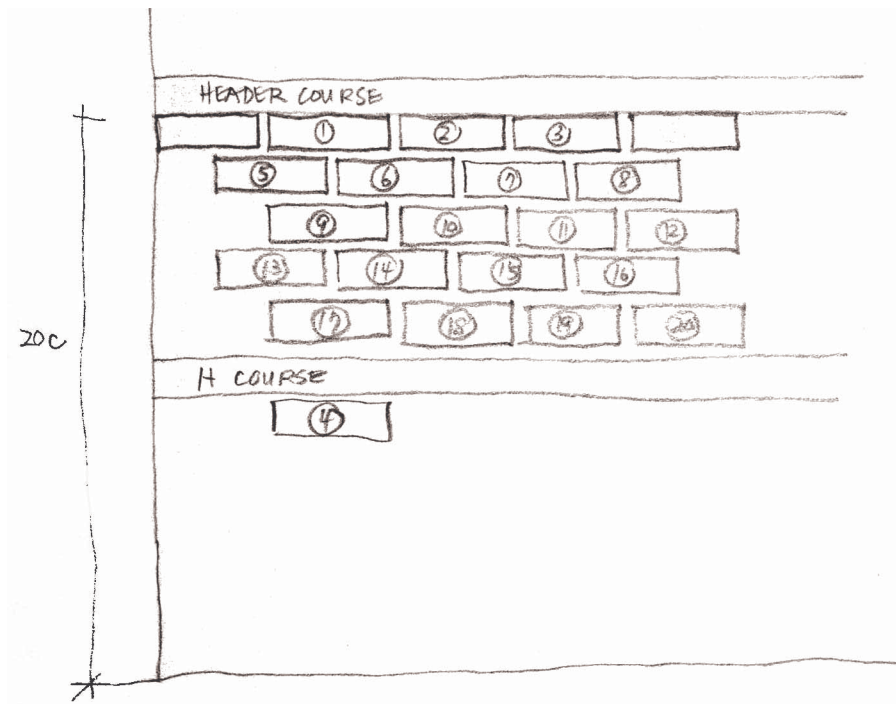
FIGURE 83

Kitchen East 1

BOND Running
FINISH Painted
DATE April 5, 2018 [Measure 5]
NOTES Sanborn maps show a structure in the current location of the kitchen as early as 1896. Other documentary evidence indicates that an 1881 building campaign may be associated with this structure. The fairly consistent Running Bond is disrupted several courses below the upper windows, possibly aligned with separate building campaigns between the upper and lower floors.

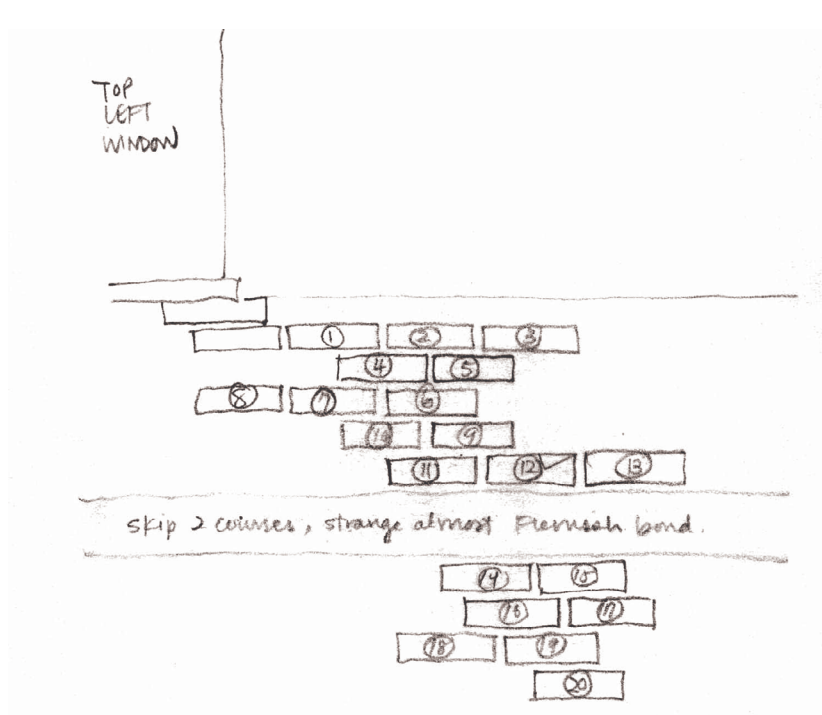
FIGURE 86

Kitchen North 1

BOND 6-course Common
FINISH Painted
DATE April 19, 2018 [Measure 31]
NOTES Sanborn maps show a structure in the current location of the kitchen as early as 1896. Other documentary evidence indicates that an 1881 building campaign may be associated with this structure.

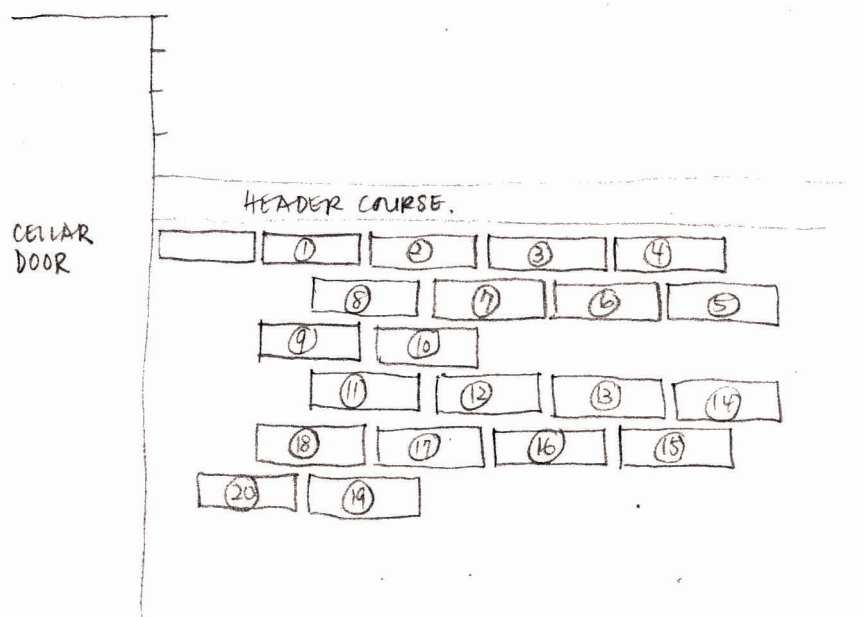
FIGURE 89

Kitchen North 3

BOND Uneven Common
FINISH Painted
DATE April 5, 2018 [Measure 6]
NOTES Chimney base.
Sanborn maps show a structure in the current location of the kitchen as early as 1896.
Other documentary evidence indicates that an 1881 building campaign may be associated with this structure.

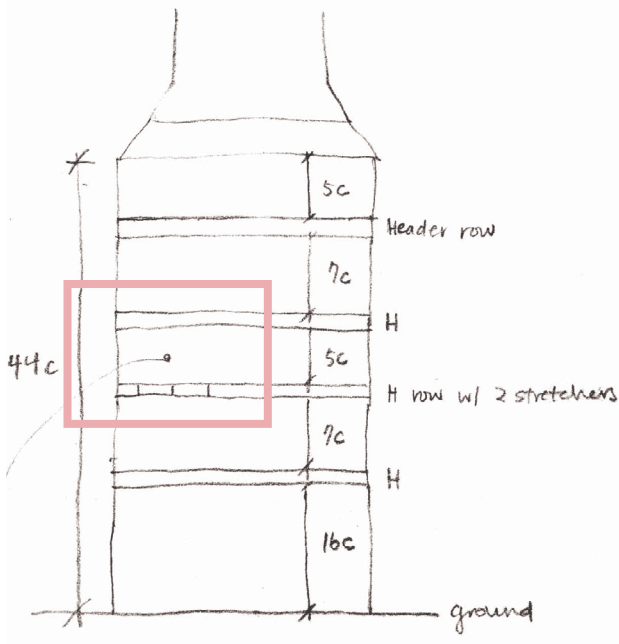
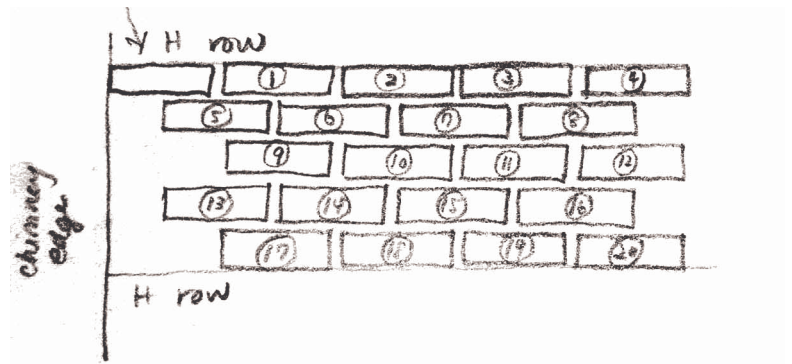
FIGURE 92

Kitchen West

Sanborn maps show a structure in the current location of the kitchen as early as 1896.

Other documentary evidence indicates that an 1881 building campaign may be associated with this structure.

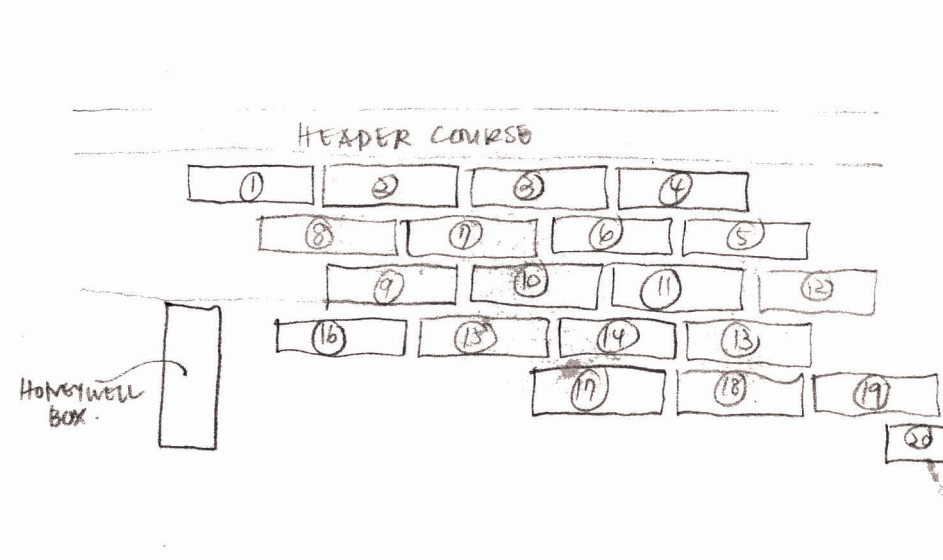
FIGURE 95

Garage South

BOND 5-course Common
FINISH Painted
DATE April 5, 2018 [Measure 7]
NOTES Documentary evidence of 1929 Sanborn map shows a single-story structure, marked "A" possibly for "automobile;" however the footprint is more square compared to the existing rectangular garage.
